**Subject:** ServiceRanger Database 47: Cannot See UltraShift *PLUS* Software 5569906

**Document Number:** MDIB0039

**Date:** November 19, 2012

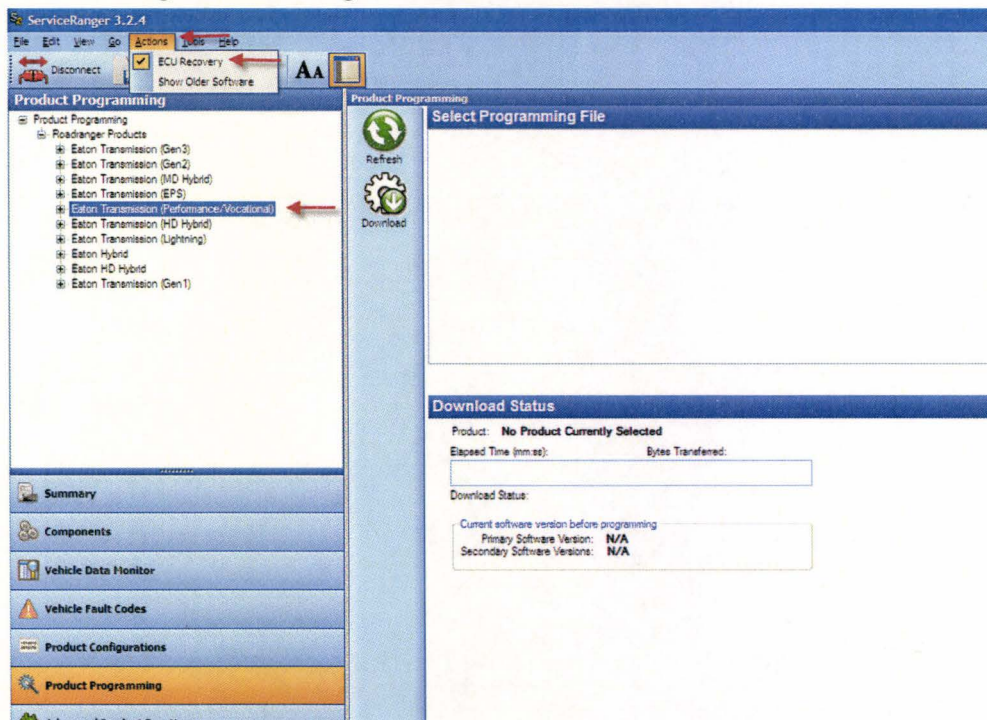
After updating to Database 47, the current production UltraShift® *PLUS* ECU software 5569906 is no longer available in the Product Programming function of ServiceRanger; no new software is displayed.

1. Key on.
2. Start ServiceRanger and connect to the vehicle.
3. Go to **Product Programming**
4. Select **Actions > ECU Recovery** from the menu bar.
5. Acknowledge the warning statement.
