Short Pin Installation During PDS

Section Pre-Delivery Service

YEAR(S)	MODEL(S)	ADDITIONAL INFORMATION
2014	CT200H

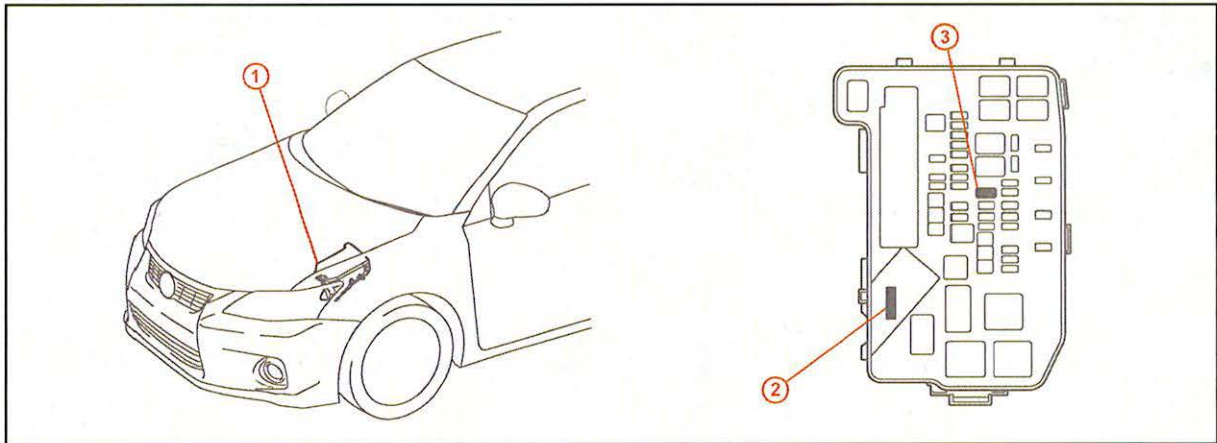
To minimize battery discharge during transportation and storage, the Short Pin has been removed at the assembly plant and temporarily stored in the engine compartment Relay Block.

1	Relay Block
2	Short Pin Storage Location

3	Install Short Pin Here (Original Location)
----------	--

Remove the Short Pin from the blank space of the Relay Block in the engine compartment and install the Short Pin as shown in Figure 1.

- The Short Pin does not function as a fuse, so only install it in the position shown above.
- If the vehicle is stored after PDS, disconnect the negative (-) battery terminal to prevent battery discharge. Refer to Service Bulletin No. [PG001-06](#), "Battery Maintenance for In-Stock Vehicles & Pre-Delivery".
