ARTICLES CONTAINED IN THIS ISSUE

QUALITY DRIVEN® SERVICE

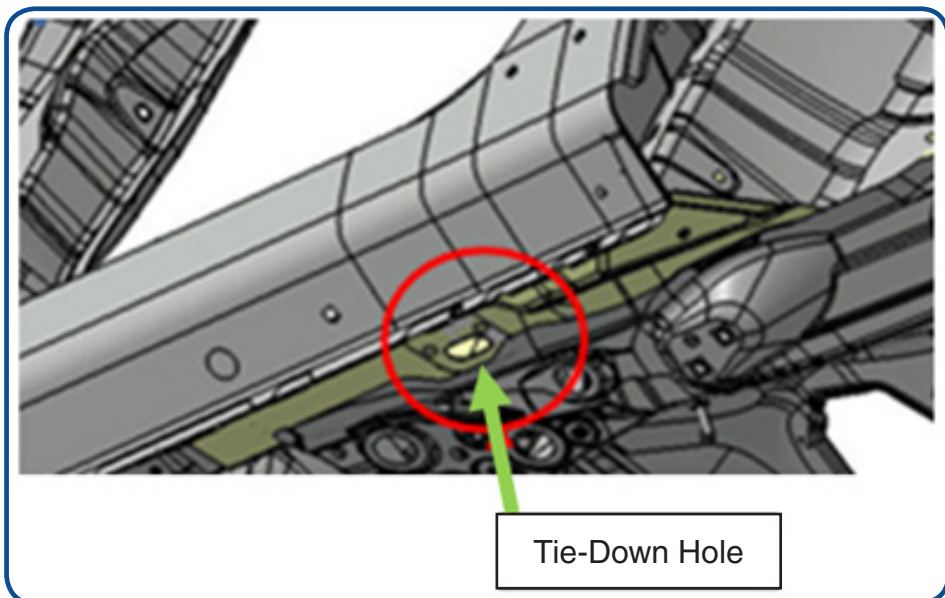
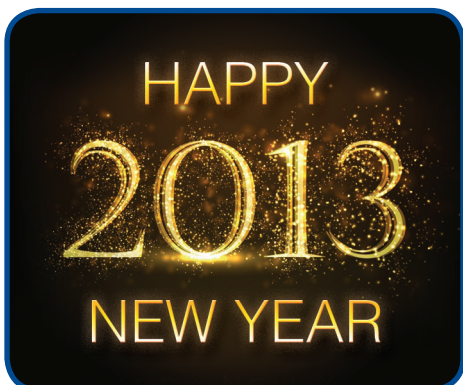
ADDITIONAL TIE-DOWN PLUG FOR 2012-13 IMPREZA AND XV CROSSTREK™ MODELS

Beginning with the VIN numbers listed in the chart below, additional plugs to be installed during PDI into the tie-down holes will be included with the plug set found in the glove box. These additional plugs will help prevent dust intrusion into the vehicle. The illustration provides the location ahead of the rear wheel arch on both sides of the vehicle. If needed, the plugs are available separately by ordering part number 90371CA010.

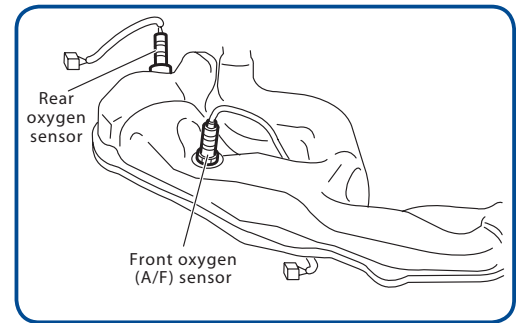
09 AIR FUEL RATIO SENSOR AND OXYGEN SENSOR REMOVAL

When replacing a catalytic converter on any model, the A/F sensor and/or Oxygen sensor can be reused in most cases. After the converter has cooled down, spray the threaded portion of the sensor with penetrating oil and allow it to soak for at least one minute or more. Remove the sensor using appropriate special tool or box wrench. When installing the new sensor always apply a small amount of anti seize compound to the threaded portion only prior to installation. Torque the sensor to the proper specification (15.5 ft-lbs).

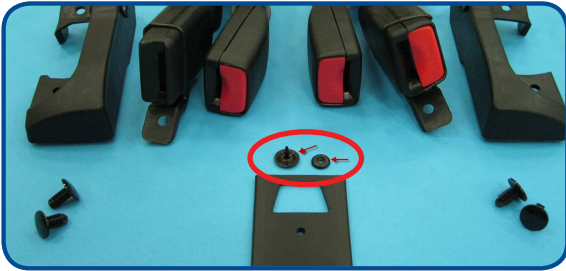
18 WQA-37 INFORMATION

Please be advised of the following kit part numbers 64665SC040AP and 64665SC040AR both contain a Tack for the rear seatbelt. If this tack is broken during installation it is available separately under part number 64715SC060AP or 64715SC060AR. Please direct any parts related questions to the Parts Information Coordinators.

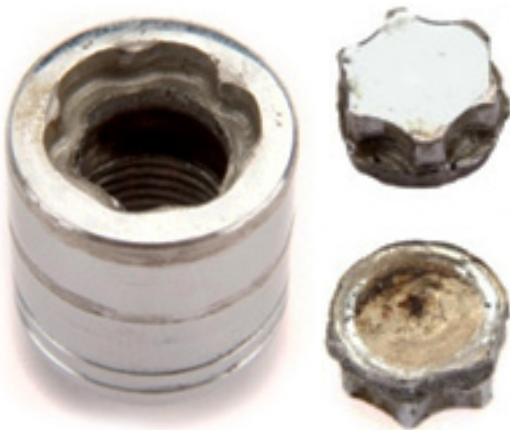
15 WHEEL LOCKS

Investigations performed by the vendor in to Subaru Wheel Locks B321SFG000 have found that improper application resulted in the failure. Wheel locks are not to be used on steel wheels or spare wheels. The following information should be followed whenever wheel locks are installed.

Use of wheel locks are for alloy wheels only. Use of wheel locks on steel wheels or temporary spare wheels may result in the condition as shown.

- Remove one lug nut from each wheel. If the studs are dirty, clean them with a wire brush prior to wheel lock installation
- By hand, install one lock on each wheel
- Using the special key supplied in the wheel lock set and a torque wrench, tighten the wheel lock to the proper specification listed in the Service Manual for the vehicle you are working on
- Retain the lug nuts that were removed in the lock package for use on the spare wheel if necessary

For ease of installation and removal, the wheel lock should always be the last lug nut tightened on each wheel and should always be the first one removed.

Use of an impact wrench may result in permanent damage to the wheel lock and key.

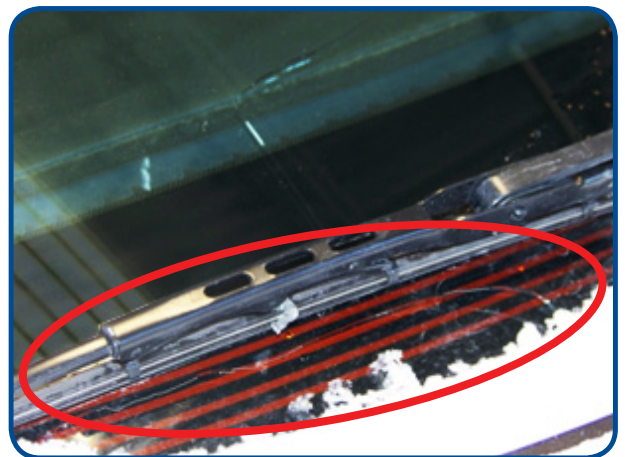
12 WINDSHIELD CRACKS ON THE INSIDE, A REMINDER

The Techline is beginning to see Authorization Requests submitted for windshield replacement where the glass is cracked on the inside of the vehicle. When cracked on the inside, it is often indicative of the wiper blade being dropped or allowed to slap back down onto the glass after clearing snow and ice or replacing a wiper blade / insert. This can easily be duplicated using a windshield that is already in need of replacement with damage in another area of the glass. The energy from the tip of the blade is transmitted into the glass through the outer layer of glass then the vinyl in the center and cracks the inside glass layer. These cracks will usually be found in the vicinity of where the wiper blade rests on the windshield. These types of failures are not stress cracks as often reported and not a matter for Warranty. The photo shows an example of this type of damage.
