Service Bulletin

Bulletin No.: PI0383B

Subject: Accessory Soft Tonneau Cover Loose

Models: 2004-2012 Chevrolet Colorado
2007-2013 Chevrolet Silverado
2004-2012 GMC Canyon
2007-2013 GMC Sierra

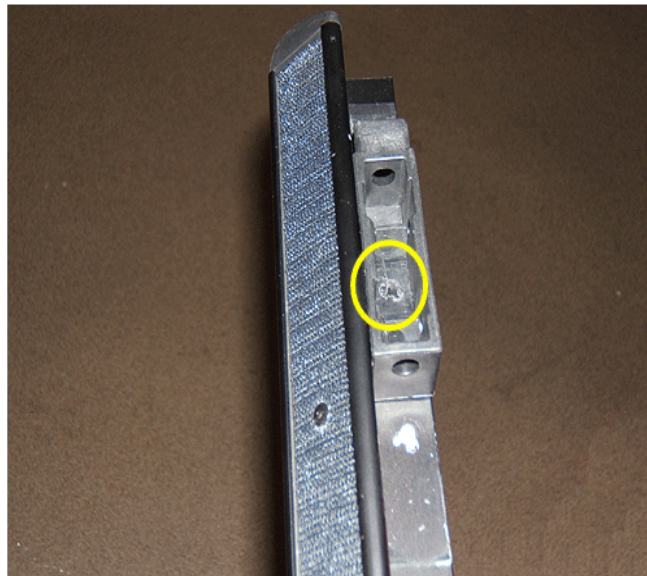
2582664

A rivet (location shown circled in the graphic above) that retains the pivot blocks to the side rail assembly may have loosened or detached.

Do This	Don't Do This
Install new pivot block rivets to side rail assembly.	DO NOT replace the tonneau cover or side rails.

Important: When a pivot block rivet is found to be loose on either end of a tonneau side rail, always replace the rivets on BOTH of that rail's pivot blocks.
