Reference SSM61977

Models Range Rover (All New) / L405

Title L405 Side Step Fitment Issues

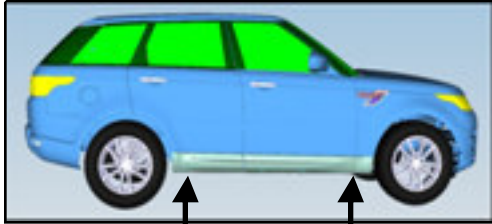
On all L405 vehicles built to date the thread forming bolts will not fit into the 8 off bosses (4 per side) in the body structure.

Content The current hole sizes in the body structure are undersized, preventing the bolts from fitting. This situation will be rectified and a clear VIN will be issued on a follow up SSM once introduced.

The 8 off bosses in the body structure need to be drilled out with a 9.3mm cobalt drill and then tapped out with an M10 tap. Please use a suitable lubricant whilst tapping out the bosses.

**THIS PROCESS TO BE CARRIED OUT BETWEEN STEPS 31 & 32 IN THE FOLLOWING FITTING INSTRUCTION:
Deployable Side Steps - CK5M-16B586-D FIT**

1. INCREASE EXISTING HOLES (1-4) TO $\varnothing 9.3\text{mm}$.
2. TAP HOLES USING M10 PLUG TAP.
