Subject:	Improper Engine Block Heater (Option K05) Usage - Continuous Power
Affected:	Chevrolet Express Cut-away Vans Chevrolet Silverado Chassis Cab GMC Savana Cut-away Vans GMC Sierra Chassis Cab Upfitted as an Ambulance (YF2) 2003 and beyond
	July 16, 2014
	•
Revision Date:	July 16, 2014

Bulletin #117

July 16, 2014

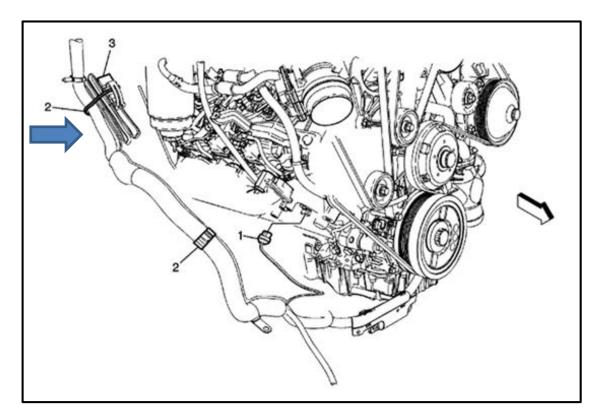
As shipped from GM, the available Engine Block Heater Cord is furled up and attached under hood as illustrated in Figure 1 (item #2 & #3).

Fleet customers, dealers, and secondary vehicle manufacturers/upfitters are reminded that the Regular Production Option (RPO) K05 Block Heater is to be used for Intermittent Cold Ambient starts when the outside temperature is between -18 degrees C (-0 degrees F) and - 29 degrees C (-20 degree F) – not to be continuously plugged into an "A/C" source.
