MULTI-MODEL (EQUIPPED WITH MAZDA CONNECT) DTC U0323/U0423/U3000 CANNOT BE DELETED

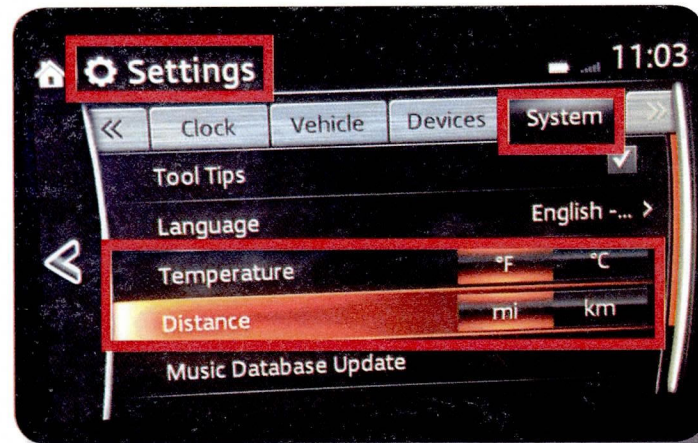
Some vehicles (with MAZDA CONNECT) may exhibit a condition where DTC U0323(PCM) / U0423(ABS) /U3000(IC) CANNOT be deleted when the TPMS warning light flashes and/or the TCS/DSC indicator lights are illuminated. This can happen if the ignition is turned OFF within 20 seconds after the ignition is turned ON in one of the following two situations.

1. The "ROOM" fuse (Engine compartment) is NOT installed when battery level is low.
2. The CMU (Connectivity Master Unit) is NOT connected.

1. Verify if the CMU and the "ROOM" fuse are installed properly.
2. Change either the Temperature or the Distance setting in MAZDA CONNECT System Settings, then turn the ignition OFF.

3. Turn the ignition ON and delete the DTC using M-MDS.
4. Return the original unit of Temperature or Distance in MAZDA CONNECT System Settings.
