SAFETY RECALL

Date	Number	Page
4.16	SC0399	1(4)

CRD 151 Carrier Yoke Nut Inspection

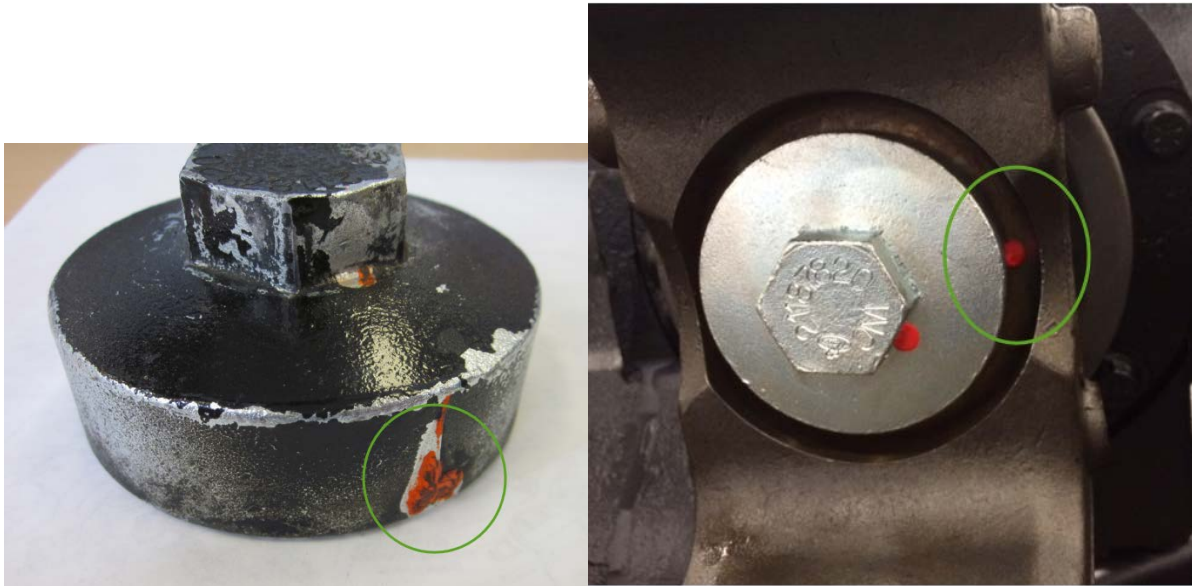
- a. Vehicles with CRD 151 axles in trucks produced since September 2012 will have tamper detection sealant on the nut and yoke. If this is cracked or shows to have moved the nut is loose. The sealant may be painted over and be difficult to see. When in doubt check the axial movement of the yoke and pinion.

5. If the seal is not leaking or there is no tamper sealant like in the picture then check the yoke and input shaft for excessive axial movement.
 - a. The input pinion bearing assembly is assembled with a preload and the yoke and input pinion should not show any movement when inspected.

6. If yoke/pinion is deemed to be loose then the vehicle **MUST** be placed out of service and the parts expedited for the vehicle to be repaired prior to the vehicle leaving.

7. If the seal is not leaking and the yoke and shaft are not loose then the vehicle can be placed back in service.
8. Prior to placing a vehicle back in service, if the tamper detection sealant is not present, clean an area on the nut and an adjacent area on the yoke. Paint a line across the joint between the yoke and the nut using a contrasting color paint marker. Until the yoke nut is replaced, visually inspect the paint line monthly for any indication of nut movement relative to the yoke. On any inspection, if the nut is found to move relative to the yoke, the vehicle **MUST** be placed out of service. Request parts to be expedited and perform repairs prior to the vehicle leaving.
