Engine Harness Changes
MP7, MP8, US2014
CHU, CXU, GU, LEU, MRU

FSB 284-056, Engine Harness Changes

(April 2015)

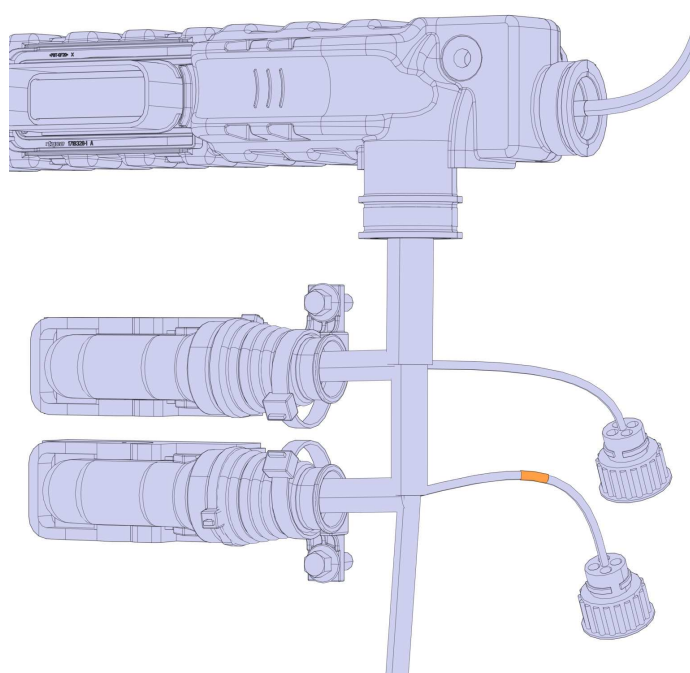
W2100467

- **MP8 Engine Only:** Yellow marking tape added to crankcase pressure sensor wire. Blue marking tape removed from oil pressure sensor wire.

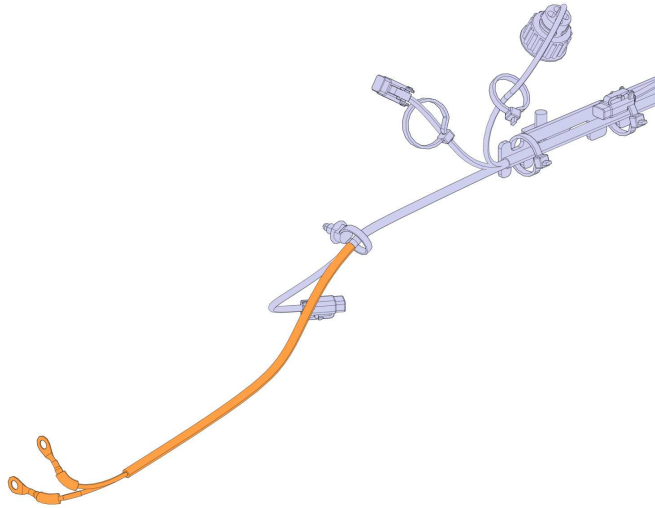
W2100052

- The starter solenoid wires now come from the front. Previous starter wire routed around the cold side of engine around the rear.

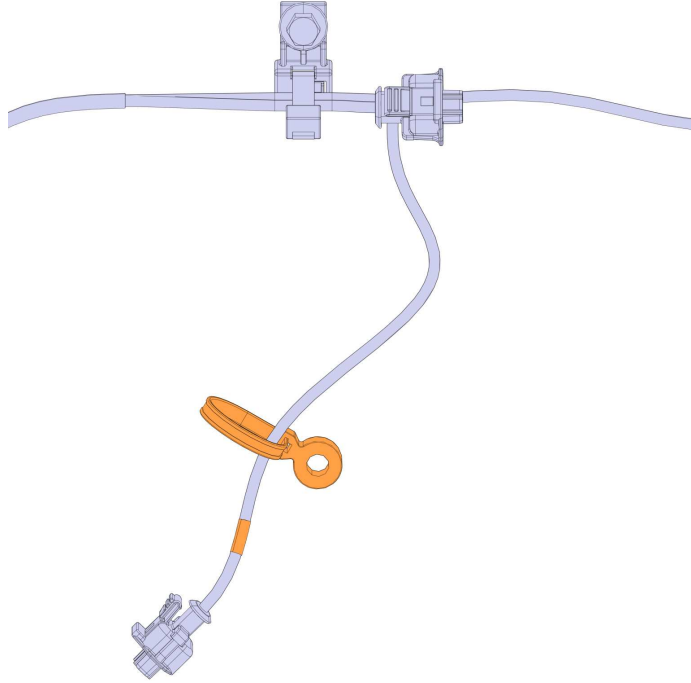
W2100055

- MP8 Engine Only: Crankshaft speed sensor has yellow marking tape on it so it is not confused with EGR valve sensor. Stud-mounted cable tie added.
