If There is a Loss of Power or if a Fault Code is Stored in the Fault Memory: Checking Wastegate Function (62/16)

Vehicle Type: **911 Carrera (991)**
911 Carrera S (991)

Model Year: **2017**

Subject: **Turbocharger – wastegate**

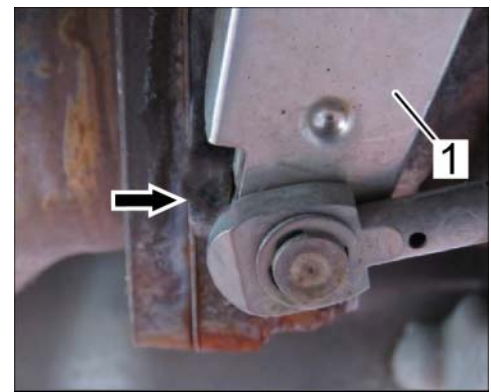
Checking stop

- 3 Check actuating lever.
 - 3.1 The actuating lever ⇒ *Checking stop -1-* must be at the stop ⇒ *Checking stop -arrow-*.
 - 3.2 It must be possible to move the actuating lever ⇒ *Checking stop -1-* against the spring force of the vacuum unit with your hand.
- If the actuating lever is stuck, replace the relevant turbocharger. ⇒ *Workshop Manual '213019 Removing and installing turbocharger'*
- If the actuating lever is at the stop and can be moved by hand, continue with Step 4.

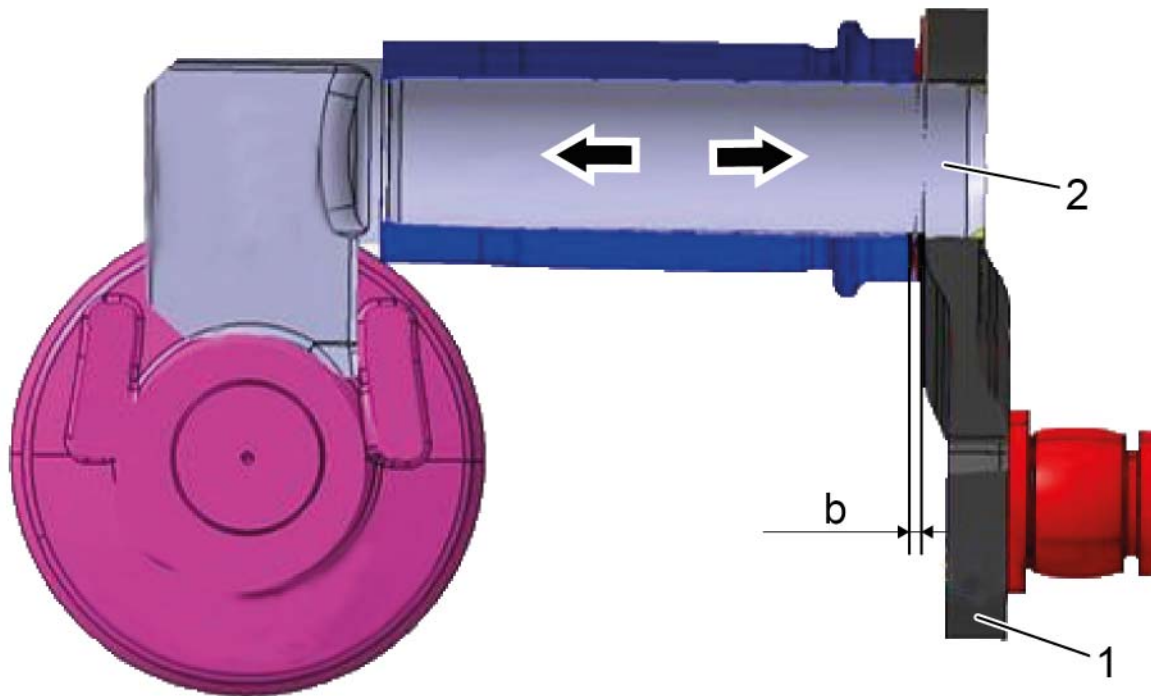
Checking wastegate shaft

- 4 Check wastegate shaft ⇒ *Checking wastegate shaft -2-*.
 - 4.1 Check that the wastegate shaft ⇒ *Checking wastegate shaft -2-* moves smoothly internally.
 - 4.2 Move the wastegate shaft ⇒ *Checking wastegate shaft -2-* using the actuating lever ⇒ *Checking wastegate shaft -1-* in axial direction ⇒ *Checking wastegate shaft -arrows-*.
The axial play ⇒ *Checking wastegate shaft -b-* of the wastegate shaft ⇒ *Checking wastegate shaft -2-* is about 0.5 mm.
A clear locking sound can be heard in both directions.
- If the wastegate shaft is stiff and/or if there is too much/not enough axial play, replace the relevant turbocharger. ⇒ *Workshop Manual '213019 Removing and installing turbocharger'*
- If the wastegate shaft moves freely and the axial play corresponds to the setpoint value, continue with Step 5.

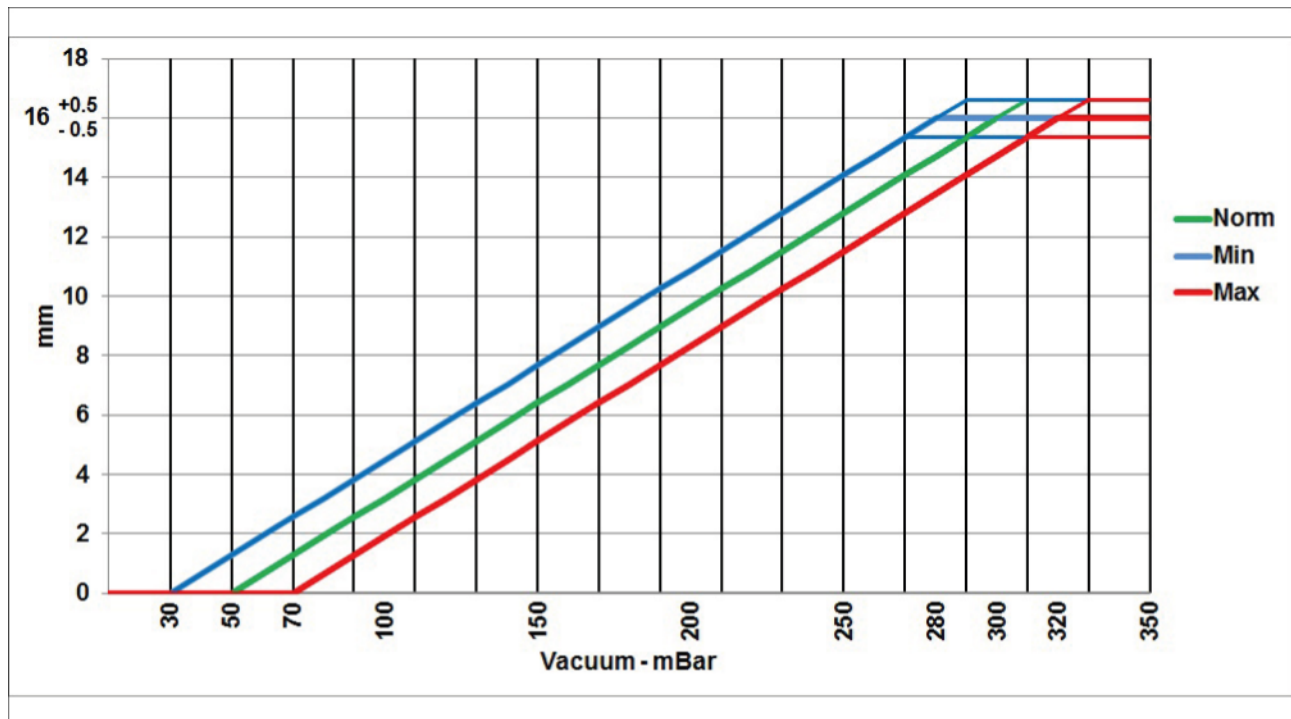
Nominal values

- 5 Perform vacuum test.
 - 5.1 Disconnect vacuum line from the vacuum unit for the wastegate adjuster.
 - 5.2 **9160/1 - Tester** must then be connected to the vacuum connection on the boost pressure control valve.
 - 5.3 Build up vacuum and compare setpoint values \Rightarrow *Nominal values*:
 - 5.3.1 The actuating lever must start to move within the specified setpoint value.
 - 5.3.2 The end position of the actuating lever must be reached within the specified setpoint value.
 - 5.3.3 The actuating lever must move evenly and without jerking.

- If the setpoint values are not reached and/or if the actuating lever does not move evenly, replace the relevant turbocharger. ⇒ *Workshop Manual '213019 Removing and installing turbocharger'*
 - If the setpoint values are reached and the actuating lever moves evenly, continue with Step 6.
- 6 Check actuating lever travel.
- 6.1 The actuating lever ⇒ *Lever travel-1-* must travel a total distance ⇒ *Lever travel-a-* of approx. 16 mm.
