Service Bulletin

Bulletin No.: 06-06-01-007G

Subject: Information On Identifying Duramax™ Diesel Overpower Engine Breakdown or Non-Function Due to Aftermarket Power-Up Devices vs. Non Overpower Engine Non-Function of Pistons, Cylinders, Valvetrain Components, DTC P003A or P111D Set

Models: 2001–2013 Chevrolet Silverado
2003–2009 Chevrolet Kodiak
2006–2013 Chevrolet Express
2001–2013 GMC Sierra
2003–2009 GMC TopKick
2006–2013 GMC Savana
Equipped With Duramax™ Turbocharged Diesel Engine RPO LB7, LBZ, LLY, LML, LMM, or LGH

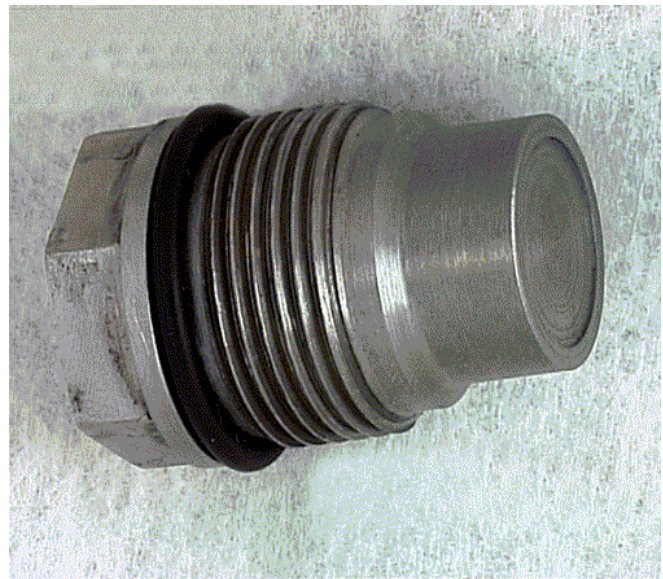
2159724

Aftermarket companies have developed a performance pressure relief fuel valve for Duramax™ diesel engines. Refer to above graphic illustration. The performance pressure relief fuel valve attaches to the fuel rail in place of the OEM valve and will not allow any fuel return to the tank, giving 100% of the fuel to be available for additional engine performance. This may cause additional fuel related driveability concerns and may set the following DTCs:

- DTC P1093 Fuel Rail Pressure (FRP) Low During Power Enrichment
- DTC P0087 Fuel Rail Pressure (FRP) Too Low

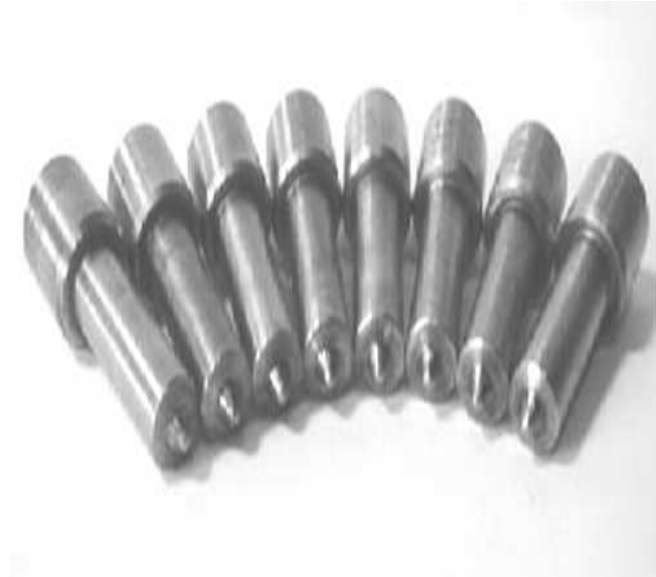
2160302

Aftermarket companies have developed a replacement performance/economy fuel injector nozzle. Refer to above illustration. The performance/economy fuel injector nozzles replace the OEM fuel injector nozzles. The aftermarket companies claim increased horsepower, improved fuel atomization, lower exhaust gas temperatures and increase fuel economy. This may cause additional fuel related driveability concerns and may cause internal engine damage to the pistons and fuel injector nozzles.

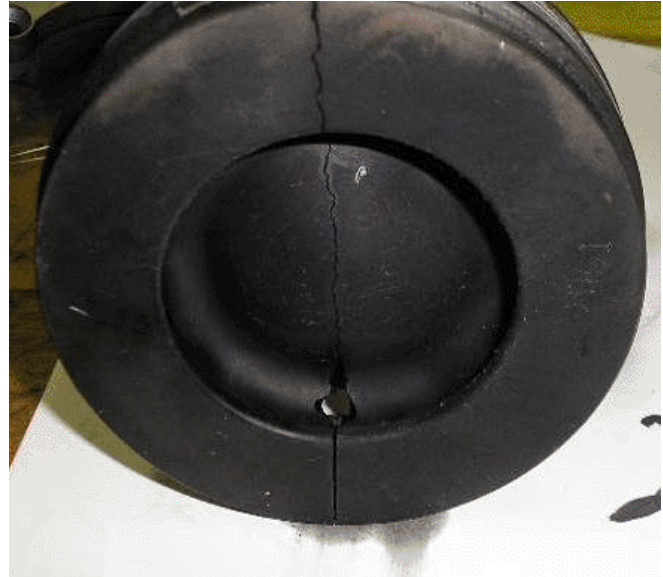
1771277

- Pistons will be cracked in the lip area, or a hole in the pistons.

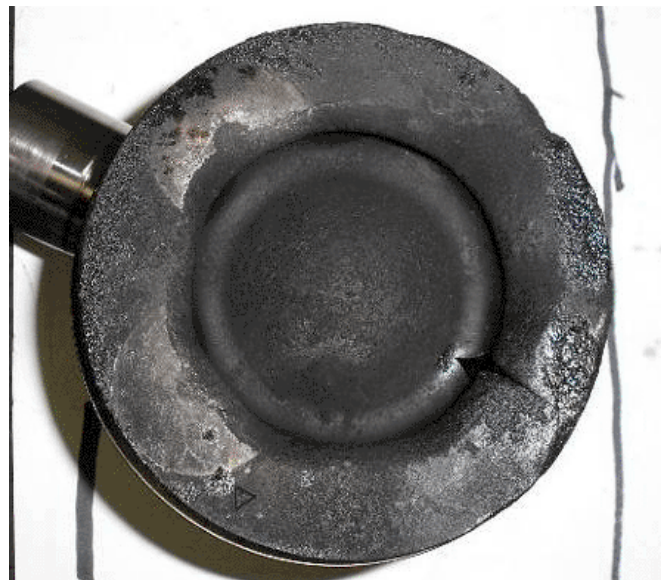
1771279

- Pistons can also be melted on the lip of the combustion bowl, or the top of the pistons can be melted.

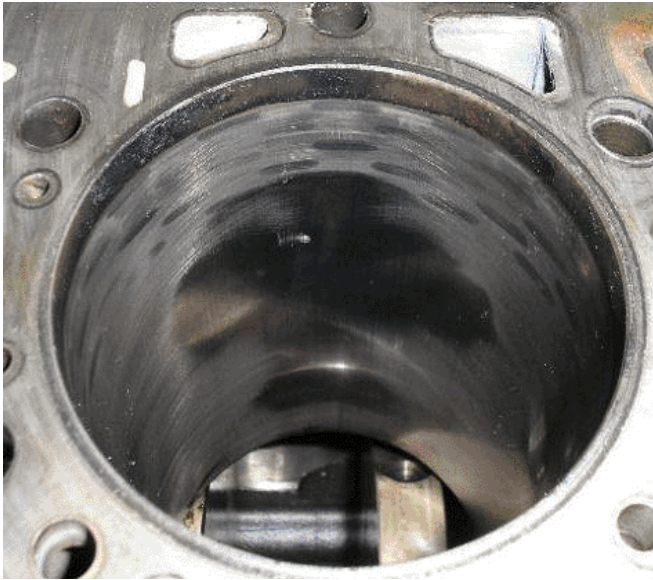
1771281

- Crosshatch will be polished off the cylinder wall in the major thrust face of cylinder below ring belt travel.

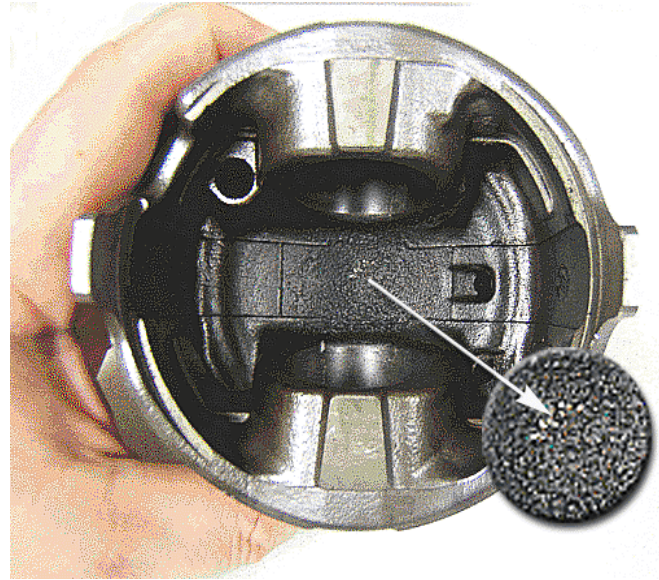
1797823

- Oil coking on the underside of the piston between the wrist pin bosses.

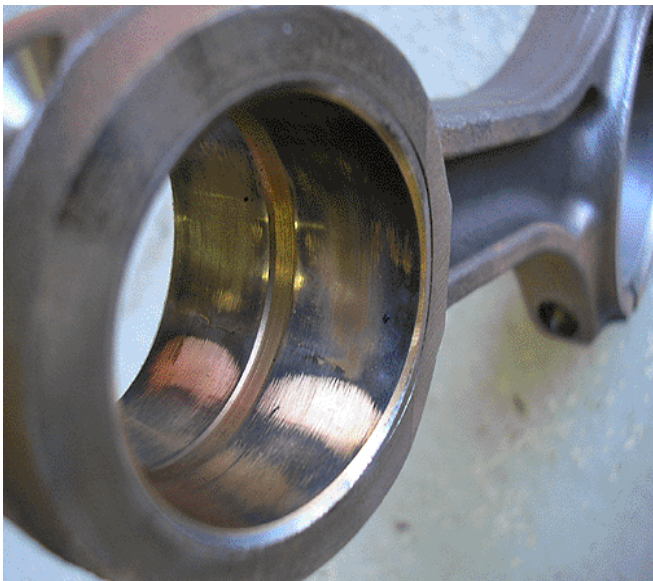
1806909

- Piston pin bore will show signs of scoring, the wrist pins will be discolored, and can have oil coking on them. The connecting rod bushing surface will have accelerated wear. The above illustration shows a connecting rod bushing.

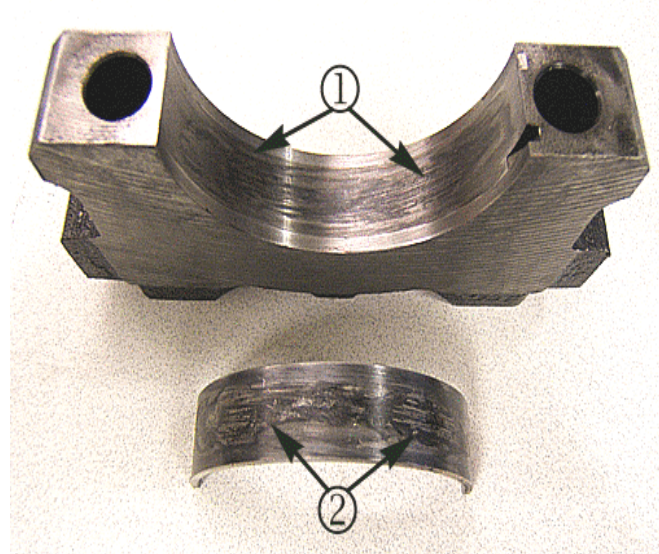
1797824

- Signs of bearing fretting will also be noticed on the connecting rod and main bearing caps. Refer to the above illustration for fretting of main bearing cap 1 and back side of connection rod bearing 2.

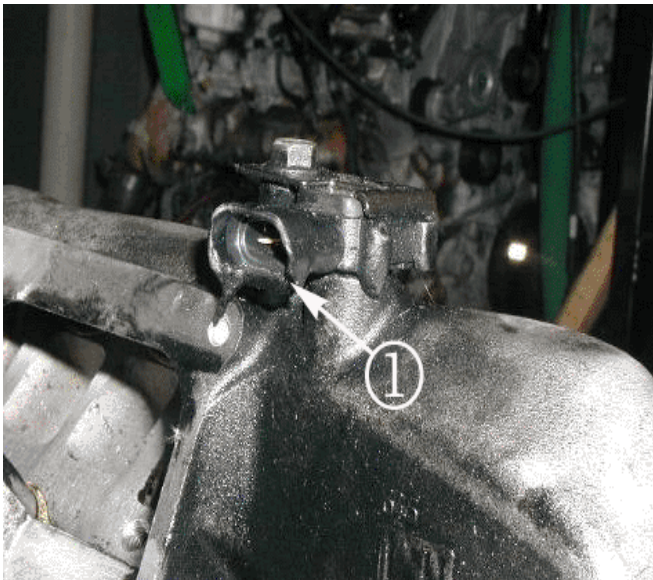
1771284

- Excessive heat in engine compartment caused by overpower device. Refer to above illustration (1).

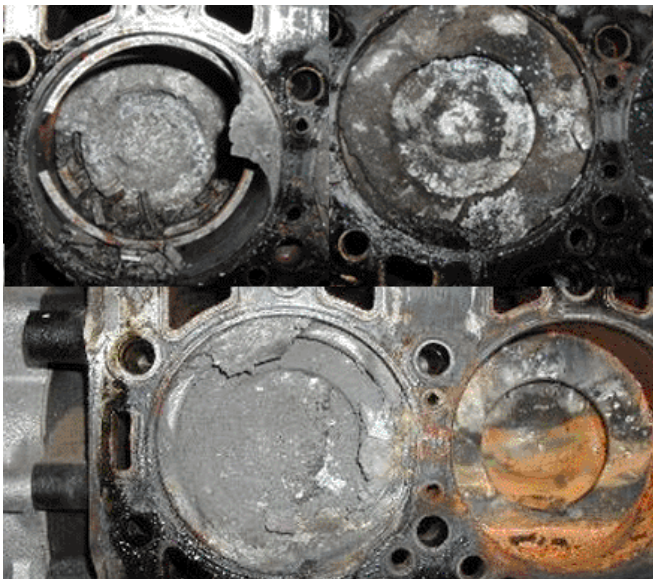
1771289

Overheat can be caused by a loss of coolant or a general cooling system failure. Some of the indicators of overheat are:

- Melted pistons.
- Head gasket breakdown or non-function.
- Warped cylinder heads.
- Crankshaft and connecting rod discolored.

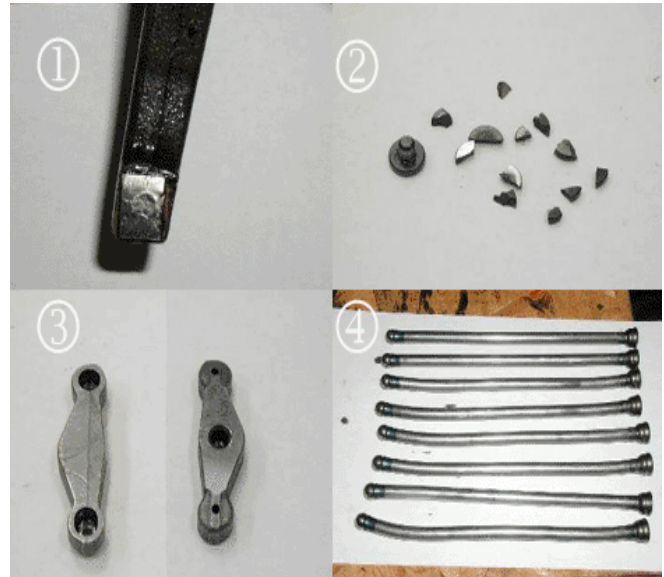
1771285

- Valve train damage.
- Pushrods that are bent (4).
- Broken valve bridge buttons after cylinder head removal (2).
 - Rocker arm tip damage (1).
 - Dry or rusted cylinders from the use of ether, propane or nitrous oxide.

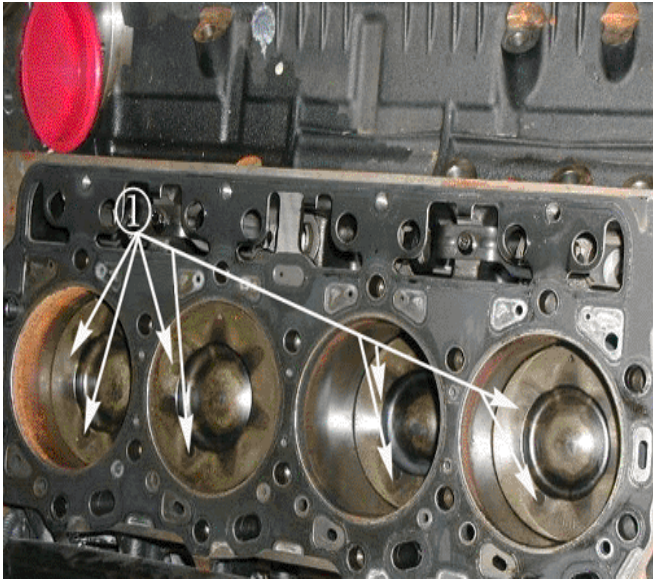
1771287

- Piston to valve contact.
- Cam gear pin shear.

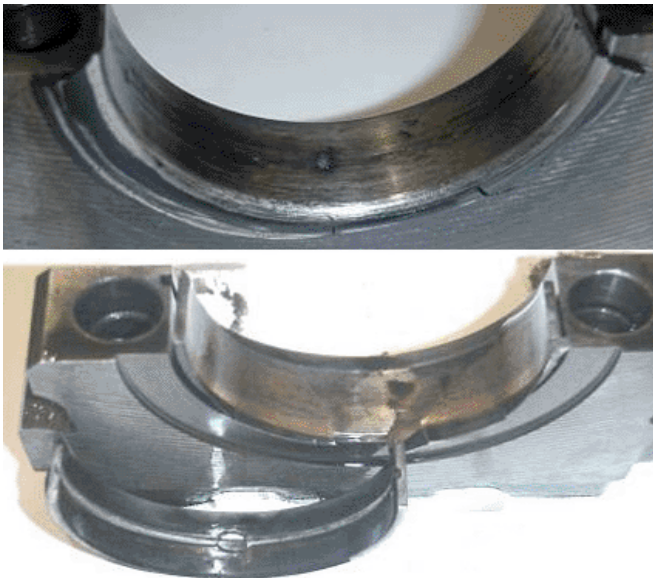
1771291

Lack of lubrication causes rapid bearing wear or bearing to seize.

Bearing failure. Spun main bearings.

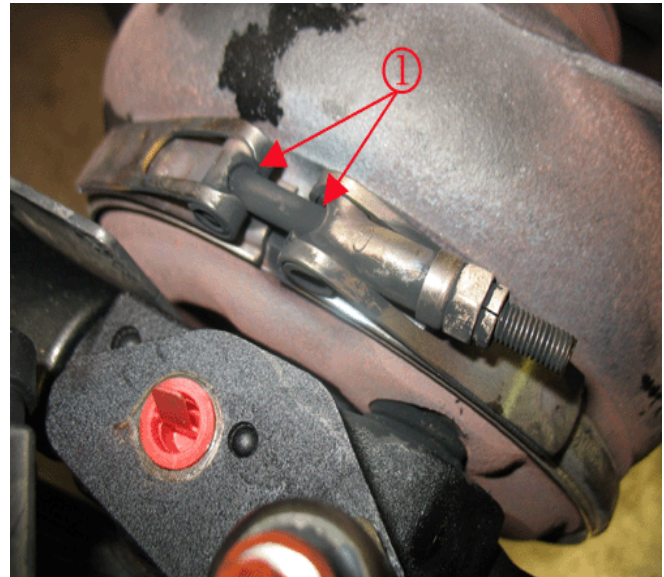
2336334

General Motors has identified a turbocharger (TC) failure mode involving Power-Up Kits that causes soot leakage and DTC P003A to be set. The Power-Up Kits create an over temperature condition from the increased exhaust gas temperatures that results in a permanent and excessive turbine housing distortion at the TC case halves.

1. A technician may observe one or more of the following conditions:
 - DTC P003A being set as Current or in History.
 - An unusual odor emanating from the TC due to an overtemperature condition.
 - Soot leaking and accumulating at the V-band clamp that secures the TC case halves together.
 - Limited or unresponsive travel when Commanding the TC Vane Pos. Ctrl. Solenoid ON and OFF with a scan tool.

2. If DTC P003A is found as Current or in History, **OR** there is evidence of soot leakage (1) in the area of the V-band clamp (1), then technicians **MUST** verify if the engine control module (ECM) has a Power-Up Kit aftermarket calibration installed or an aftermarket hardware device has been installed.

Refer to the latest version of Corporate Bulletin Number #08-06-04-006 for the calibration verification information and procedures.
