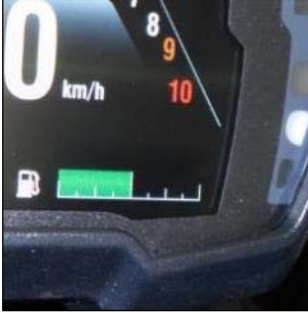
no.	Symptom	Subject	Photo	Trouble Code (Diagnostic Trouble Code)	Part no.	Notes/Indications/Corrective action
5	<p><u>Only in case of motorcycle just delivered by DMH</u></p> <p>Upon first battery connection, few fuel level marks are displayed on the instrument panel with empty tank</p>	Display of fuel level

<p>It is not necessary to replace the fuel level sensor.</p> <p>There is no error in the control unit</p>		<p>This possible mismatch is due to the fuel level management strategy <u>when the fuel is drawn from the tank</u> (at the end of the production line or during a Service operation).</p> <p>The fuel level sensor detects the level in the central part of the tank (blue area); in the upper and lower part of the tank (green areas) the fuel level is therefore calculated by the software. When fuel is drawn, the software could not recognise the level decrease and continue to display on the instrument panel a fuel quantity that is not actually inside the tank.</p>

<p>A new BBS software with relevant update for the DDS 2.0 diagnosis instrument will be made available to introduce a function that allows to reset the fuel level indication displayed on the instrument panel.</p> <p>To have a fuel level indication displayed on the instrument panel actually corresponding to the quantity of fuel inside the tank it is <u>necessary to fill in the tank with at least 8 litres of fuel</u> so that the fuel level sensor starts reading the correct level. Turn the motorcycle's key to ON and if the fuel level indication does not change, add some fuel in the tank; in fact, it could happen that the previously poured fuel quantity is not enough to allow a correct fuel level reading by the relevant sensor.</p>

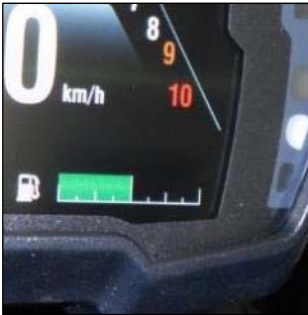
no.	Symptom	Subject	Photo	Trouble Code (Diagnostic Trouble Code)	Part no.	Notes/Indications/Corrective action
6	With fuel tank almost full, due to continuous fuel top ups, the fuel level displayed on the instrument panel continues to decrease	Display of fuel level

<p>It is not necessary to replace the fuel level sensor.</p> <p>There is no error in the control unit</p>		<p>This possible mismatch is due to the fuel level management strategy <u>in case the tank is continuously topped up with fuel (after a consumption lower than 5 litres) starting from a completely full tank condition.</u></p> <p>In this condition, the real level of the fuel stays always in the top side of the tank (top green area) and is not read by the fuel level sensor. The fuel level displayed on the instrument panel is calculated with a software strategy; in the unlikely case that the top up happens in a frequent way, the fuel reserve could also be displayed.</p>

<p>A new BBS software with relevant update for the DDS 2.0 diagnosis instrument will be made available to introduce a function that allows to reset the fuel level indication displayed on the instrument panel.</p> <p>Meanwhile, to match the fuel level indicator shown on the instrument panel with the fuel quantity inside the tank it is <u>necessary, starting from a completely full tank condition, to use at least 6.5 litres of fuel</u> so that the fuel level sensor starts reading the correct level; as soon as the level sensor will restart the reading, the indication of the fuel level displayed on the instrument panel will be instantly updated.</p>

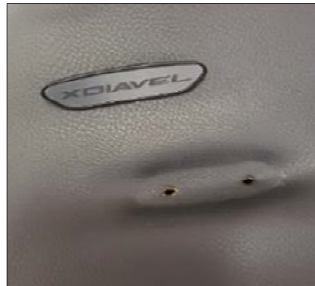
11	<p>Possible rider seat plate detachment</p>	<p>Rider seat plate</p>

<p><u>Should the rider seat plate detach, do NOT replace the seat.</u></p> <p>To secure the plate again it is necessary to refit the clips Part. no. 85044251A available at our spare part warehouse.</p> <p>To fit the clips Part no. 85044251A follow the procedure indicated below:</p> <ol style="list-style-type: none"> 1) Working on the seat lower side, make an opening on the thermal protection in correspondence of the plate fastening area, paying attention not to damage the elastic band; 2) Position the plate by inserting the 2 pins in the relevant holes on the seat; 3) Fit the 2 clips Part. no. 85044251A on the plate pins using a box wrench to make the operation easier.

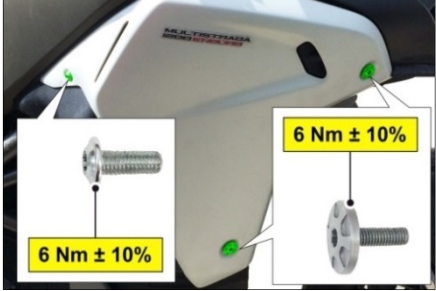
3	<p><u>ONLY for bikes shipped in crates</u></p> <p>Possible contact during transport between crate pipes and RH and LH aluminium side covers</p>	Aluminium side covers

<p>The first batch of shipped bikes could be affected by the problem. Should you detect the defect, fill out a Youtech request with relevant pictures, and then replace the part under warranty.</p> <p>Please, be informed that, starting from 16/05/2016 we have started shipping bikes with disassembled RH and LH aluminium side covers.</p> <p>During pre-delivery, it will thus be necessary to fit RH and LH aluminium side covers by tightening retaining screws to a torque of <u>6 Nm ±10%</u>.</p>

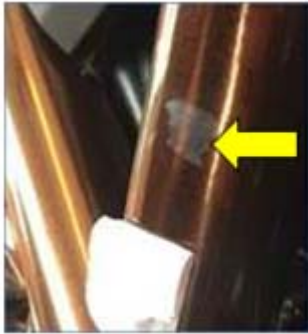
no.	Symptom	Subject	Photo	Trouble Code (Diagnostic Trouble Code)	Part no.	Notes/Indications/Corrective action
1	<p>During pre-delivery</p> <p>Possible frame clear coating detachment during white adhesive protection removal</p>	<p>Clear coating of the frame</p>

-		<p>It is recommended to remove adhesive protections performing a hot removal procedure, following one of the indications listed below:</p> <ol style="list-style-type: none"> 1) heat the engine for 5 minutes and remove the adhesive protections with engine hot; 2) heat the adhesive protections with a domestic heating gun for 1 minute (max 200°C at a distance of 20-30 cm) and remove protections. <p style="text-align: center;"><u>Avoid cold adhesive protection removal.</u></p> <p>Should the clear coating of the frame detach, it is necessary to fill in a Youtech request and attach some pictures.</p>
