Service Bulletin

Subject: Inspection and Repair Guidelines for Dust Intrusion into Passenger Compartment

Models: 2010-2017 Chevrolet Equinox
2010-2017 GMC Terrain

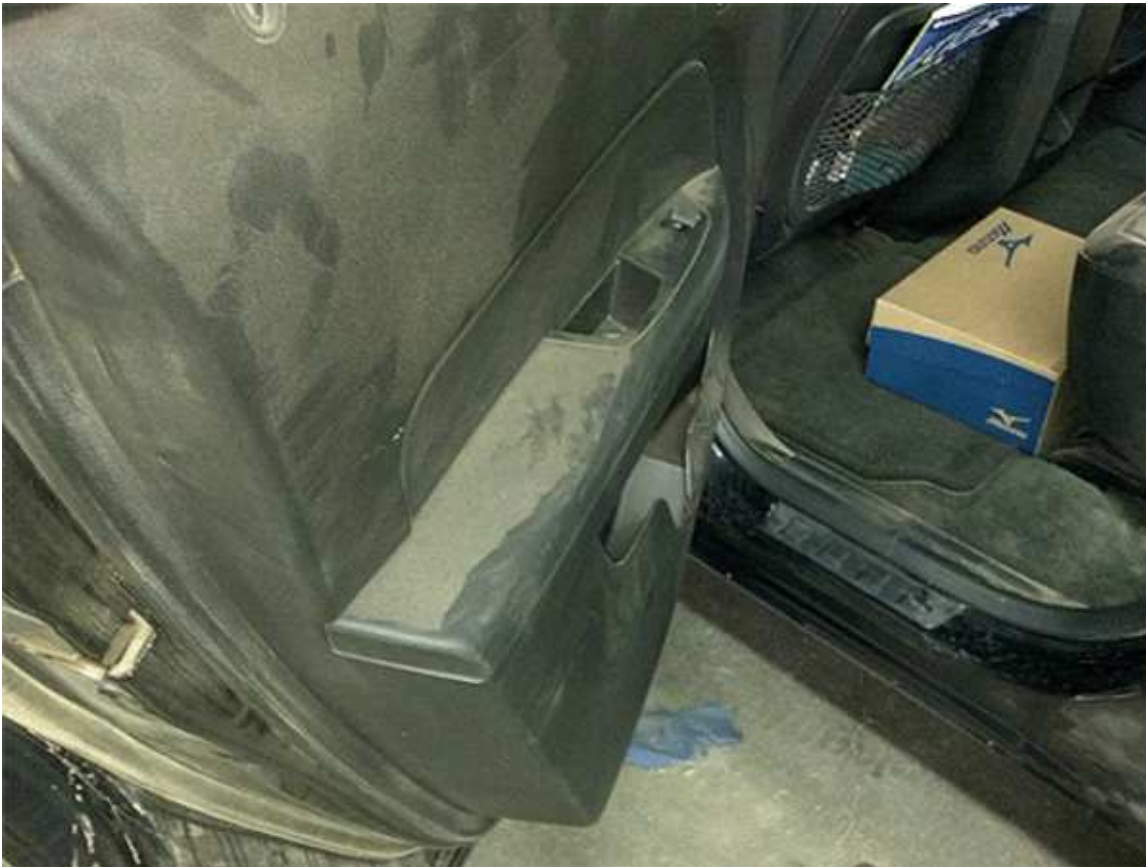
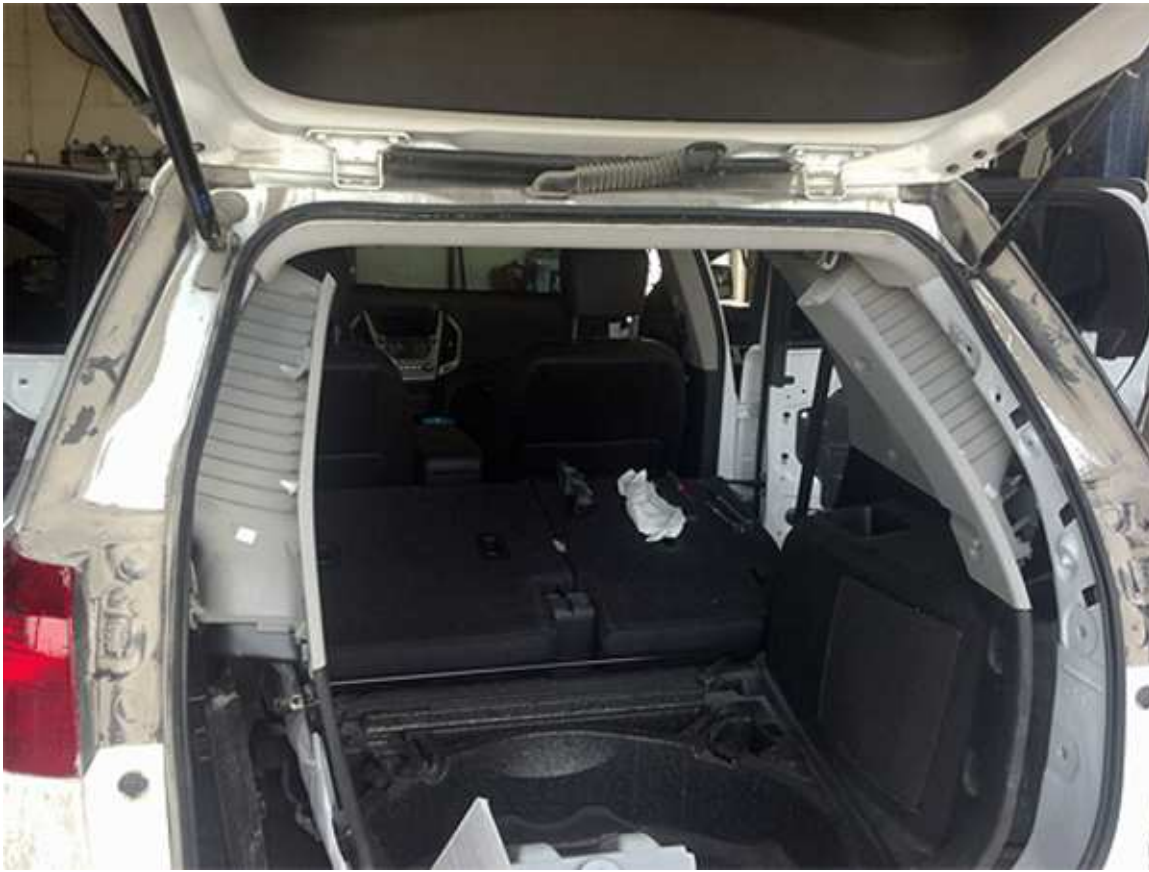
Some customers may comment that excessive dust is entering into the passenger compartment through the side doors or rear liftgate areas. This is usually found to occur when the vehicle is driven in high dust areas. Examples of this condition are shown in the graphics below.

The cause of this condition may be that the dust/debris is working past the side door or liftgate sealing surfaces.

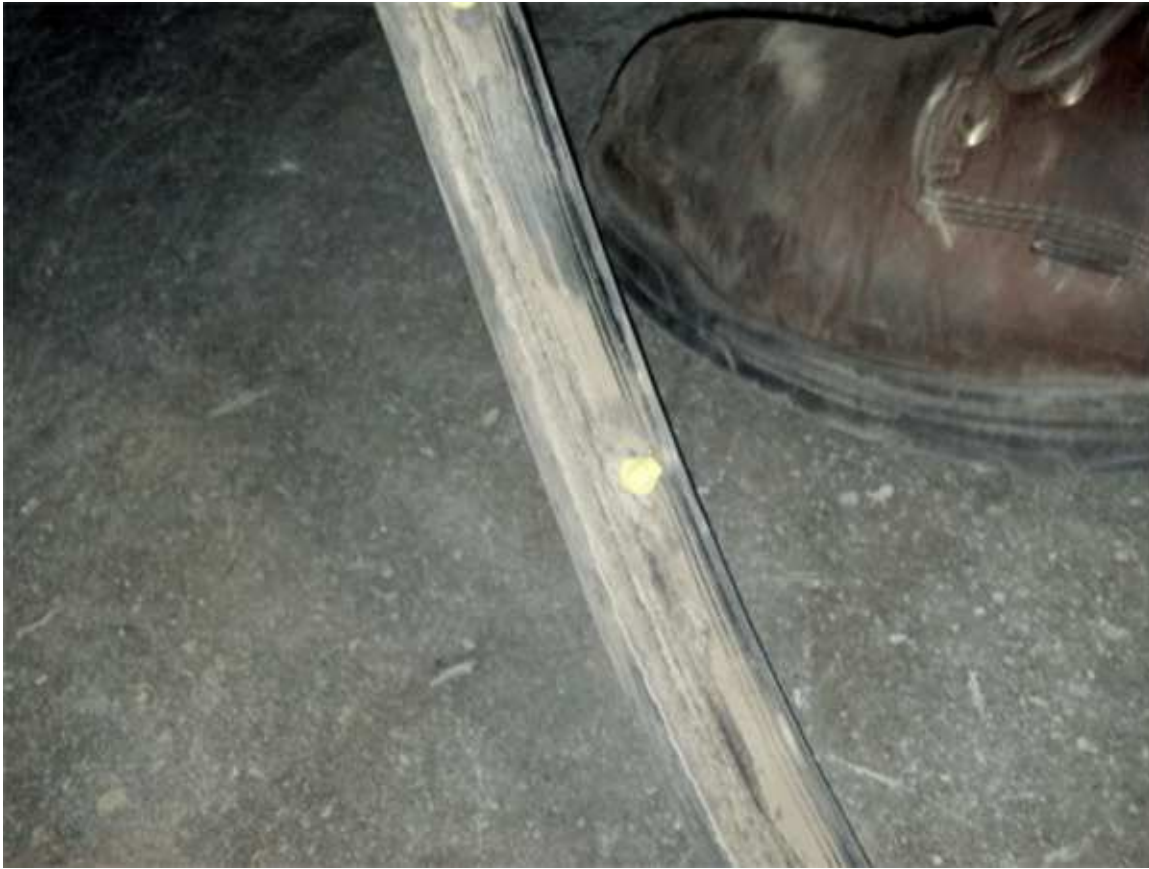
Note: A vehicle will sometimes show evidence of dirt/dust being pulled past the backside of the rocker moldings as shown above. A double sided tape is added to the moldings to help eliminate this condition.
