Summary of CM2350 Loose Bracket Issue

August 28th, 2015

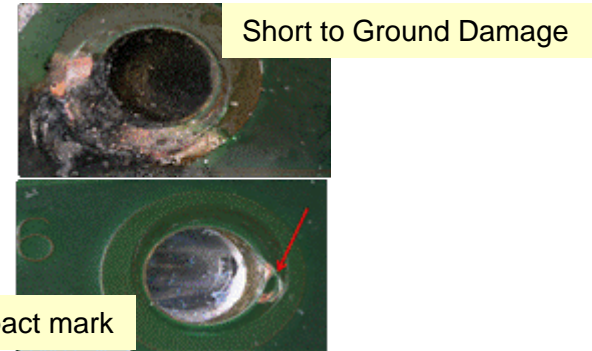
- 8 CM2350A modules with Vboost short to ground.:
 - 3 Plant returns at programming station with communication error.
 - 3 Plant returns due Engine Test Station fault codes related to ECM.
 - 2 OEM returns, failure mode is ECM blowing 30A fuse.
- These 8 ECM's are showing a short to ground damage around the area of any of 3 specific screw locations, the concentration diagram is shown below.
- The ECM's are manufactured in two final assembly lines (A and B), all 8 confirmed failures were manufactured through Screw Cell of line A.
- A screw feed error from line A caused a screw contact to the PCB during the screw insertion, which result in ECM with the Vboost short to ground failure.

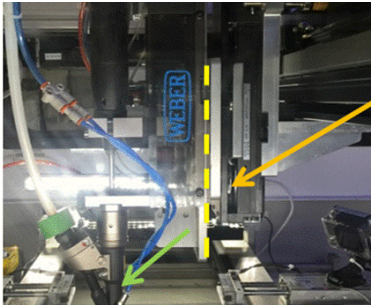
- The EOL test was not capable to detect Vboost short to ground condition and there was no system to detect screw hitting the PCB during the screw feed process.
- At the Screw Cell line A, the bracket that holds the screwdriver in place had loose screws, and therefore, the Screwdriver was found offset from the PCB Screw hole. The screw hit and damage the edge of the PCB Hole creating a Vboost Short to ground Failure.
- The Preventive Maintenance plan did not include the verification of the bracket screws.

Location of loose bracket
At screw cell

- Loose bracket of Screw Cell line A was fixed by tightening the screws on the bracket and adding Loctite to the screws (Completed on 7/22/2015).
- The screw/process retry option was removed from the screw cells from operators (Completed on 7/24/2015).

- Update Preventive Maintenance plan to include the verification of bracket screws. Documented as PM Plan completion (Completed on 8/17/15).
- Develop Preventive Maintenance plan to include the verification of all critical screws of all machines of ECM line. (Due Date: 9/28/15).
- End of line ECM test update to detect the Vboost to ground short (Completed on 8/14/15).
 - Fault insertion (red board) process added to confirm test coverage at the beginning of every shift.
- Add steel plate to bracket of screwdriver cells to increase support points. (Completed on 8/28/15)
- Add this Cause of the failure mode into the PFMEA, update Control Plan. (Completed on 8/28/15).
- Update MQV to include this failure mode and lesson learn will be considered for future models. (Completed on 8/28/15).

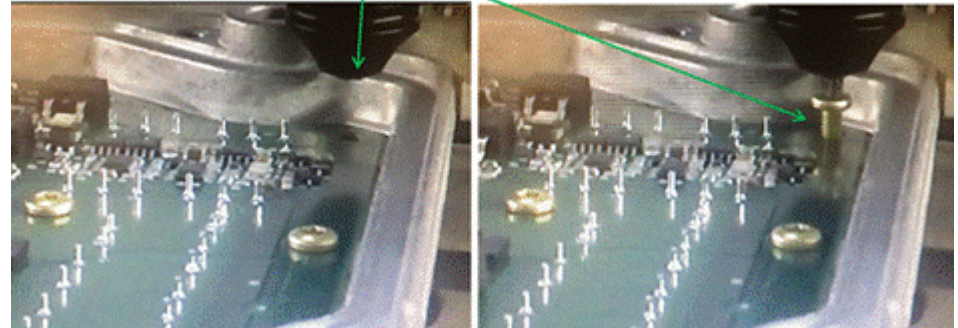
Screw could hit PCB hole creating PCB damage

- Change screw feeding process (Completed on 7/28/15):
 - Before condition: 1. Feed screw into driver → 2. Driver moves to position in relative to PCB screw hole → 3. Driver moves down → 4. Drive screw to torque.
 - After condition: 1. Driver moves to position in relative to PCB screw hole → 2. Driver moves down → 3. Feed screw into driver → 4. Driver screw to torque.
- End of line ECM test update to detect the Vboost to ground short (Completed on 8/14/15).
 - Fault insertion (red board) process added to confirm test coverage at the beginning of every shift.
- Add slow motion cameras to screw cells of both lines (Completed on 8/14/15).
 - Initially, once every 2 hours, a Quality Controller verifies the screw insertion process by recording a slow motion video.
