GROUP
Engine

MODEL
Sorento (BL)
2003~2006MY

NUMBER
PS233

**SUBJECT: UNUSUAL FUEL TRIM VALUES AND/OR MISFIRE CODES
AFTER INCORRECT ENGINE REPAIR**

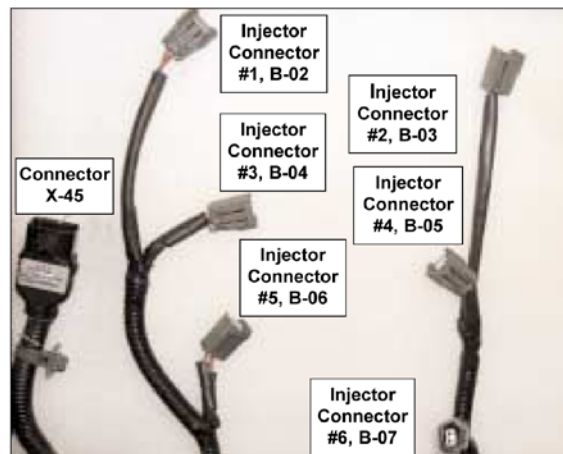
Injector connector B-06 (fuel injector #5, right bank) is closest to X-45: Use it for identification purposes. Route the harness connectors to the proper location and retest. Refer to the sample screenshots on page 2 to verify the condition. Note that these screenshots are from Hi Scan Pro (GDS screens will show similar information).

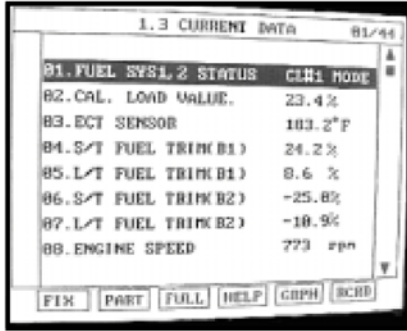
Current Data
(INCORRECT)

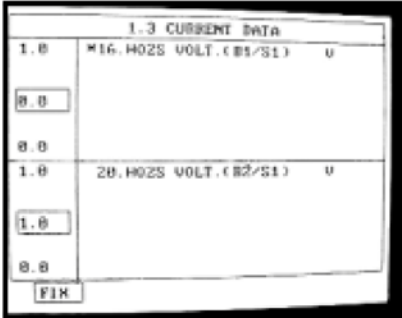
Output Voltage
From HO2s
(INCORRECT)

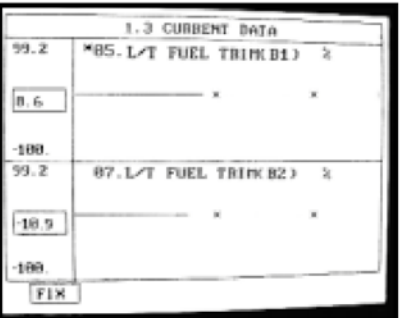
Fuel Trim Data
(INCORRECT)
