GROUP	MODEL	
Engine	2011-2012MY	
	Sportage (SL)	
	Turbo	
NUMBER	DATE

TECHNICAL OPERATIONS

SUBJECT: EWGA INSPECTION AND ADJUSTMENT PROCEDURE

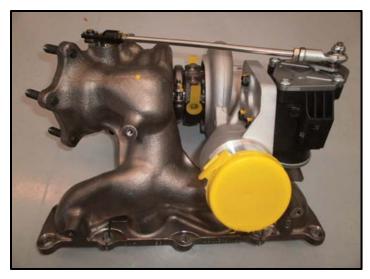
On some Sportage (SL) vehicles equipped with 2.0 T-GDI engines, the Malfunction Indicator Lamp (MIL) may illuminate with a stored, or active, P2562 DTC - Turbocharger Boost Control Position Sensor 'A' Circuit Range / Performance. In some instances, the voltage reading for the closed throttle wastegate actuator may be too high or too low and may need to be adjusted. If you encounter a vehicle with this DTC and you have completed the diagnostic test procedures according to KGIS, then follow the adjustment procedure outlined in this article to resolve the concern.

Turbo and Boost Pressure Actuator Assembly
