<b>GROUP</b> <b>Engine</b>	<b>MODEL</b> <b>2017MY</b> <b>Forte (YDm)</b>
	<b>NUMBER</b> <b>PS461 Rev 1, (9/13/2016)</b>	<b>DATE</b> <b>August 2016</b>

**SUBJECT:** DTC P0014 – EXHAUST CAMSHAFT POSITION TIMING OVER-ADVANCED OR SYSTEM PERFORMANCE

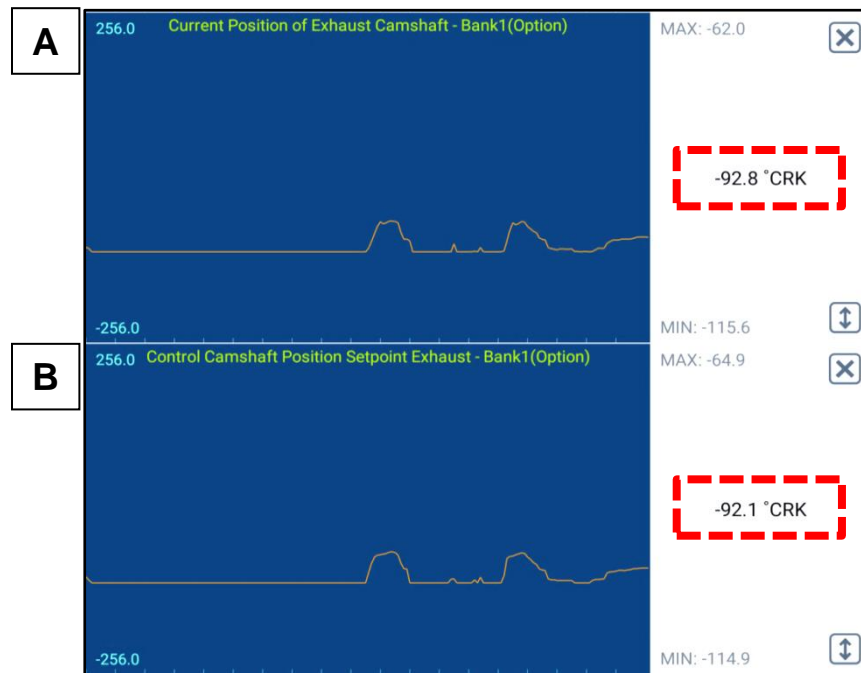
7. With the vehicle in park, slowly rev the engine from idle to 4000 RPM and back to idle in about 10 seconds. During this process, compare the current (A) and control (B) angles of the exhaust camshaft to ensure that the difference is less than 5 degrees.

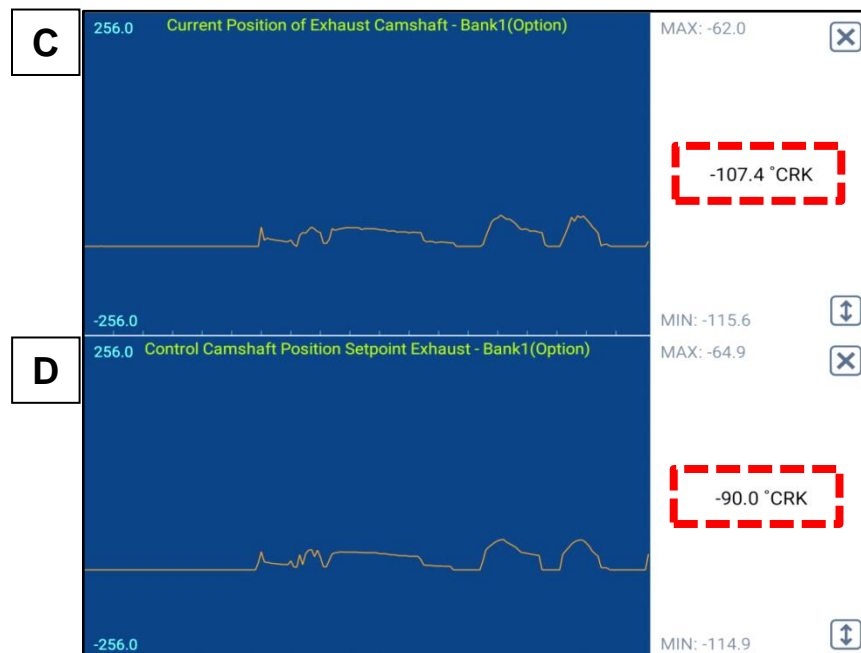
8. If the difference between current (C) and control (D) angles is greater than 5 degrees, hold the engine speed at the incident RPM until the difference in angles is less than 5 degrees.

9. Address any other fault codes that were found in the system during step 1.
10. If after two attempts this relearn procedure is unsuccessful, proceed with normal DTC diagnostics by referring to “KGIS → Engine → Engine Control → P0014 ‘B(Exhaust)’ Camshaft Position – Timing Over-Advanced or System Performance (Bank 1)”.
