DENSO Driving Assist & Safety Eng. Div.3
Driving Assist & Safety Quality Assurance Div.

To HONDA NORTH AMERICA, INC.
Market Quality Department.

Title Filed claim investigation result for Airbag sensor (G2)

Part Name : SENSOR ASSY, SATELLITE SAFING (rep)
Part Number : 77975T6A J110M2 (rep)

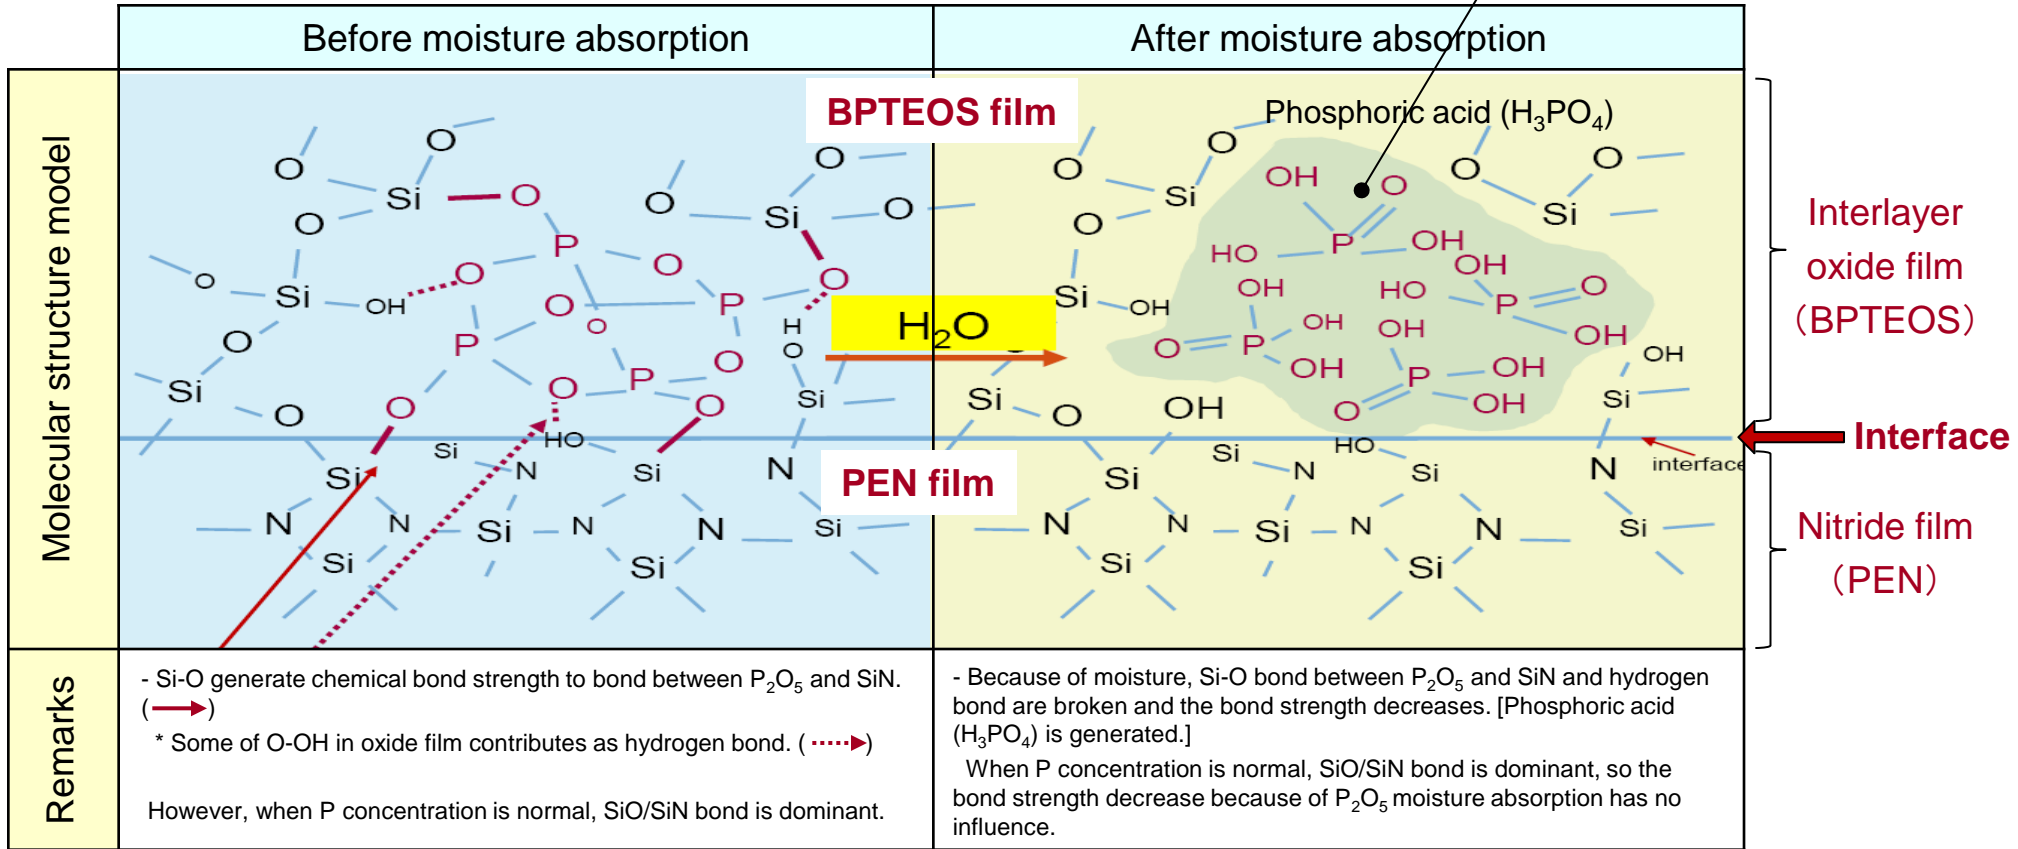
Mechanism of bond strength decrease

- in case of **normal P concentration** ⇒ P area is **small** ⇒ bond strength > Tensile stress ⇒ No delamination
- in case of **rich P concentration** ⇒ P area is **wide** ⇒ bond strength < Tensile stress ⇒ **Delamination**

P concentration affects the interfacial bond strength.

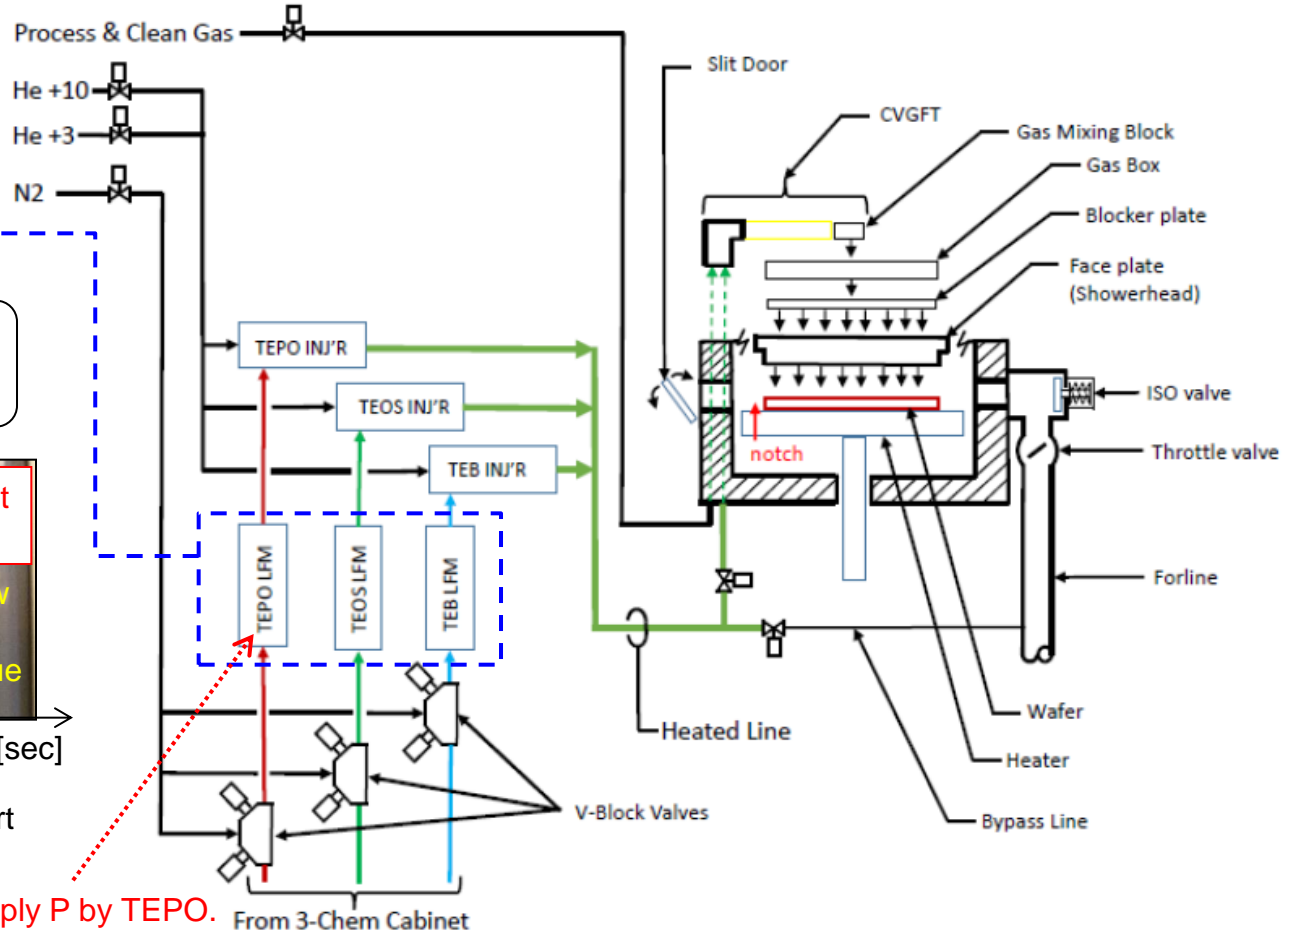
Gas injection setting profile

Supply P by TEPO.

Confirmed that the process change of TEPO flow setting was happened. → Next page

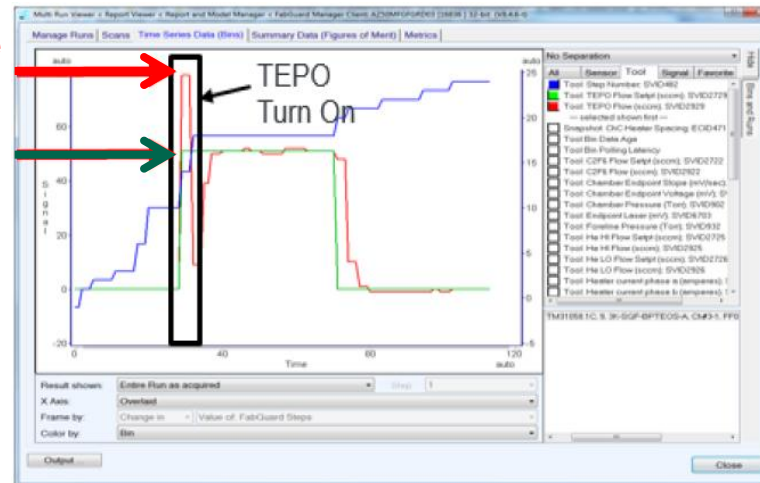
<TEPO flow volume setting value x Peak ratio >

* The above is the waveform of ratio ≈ 1.5 . (Created intentionally.)

Perform 100% monitoring of peak ratio for TEPO flow volume setting value in flow volume profile. (Sept. 1, 2015 ~)

Perform 100% monitoring to see that flow volume profile is not overshoot.

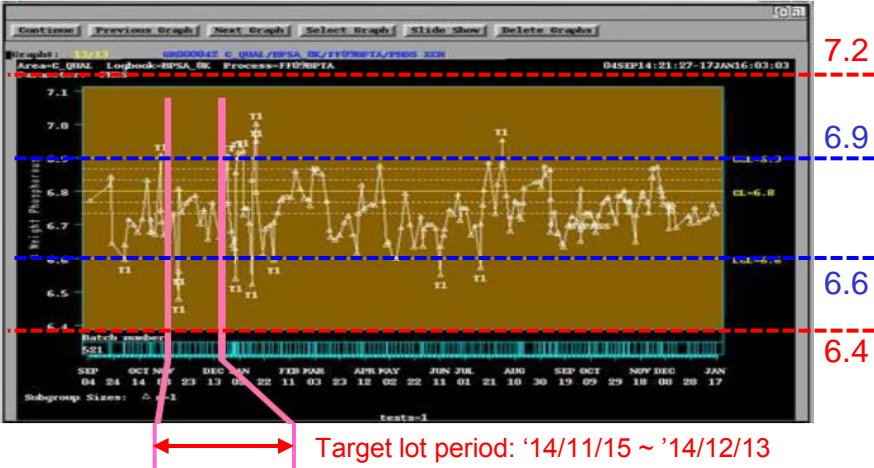
Cause	Countermeasure
<p>- P concentration has been controlled by X-ray fluorescence. In this method, only average value of P concentration in deposition direction can be obtained, and local P concentration increase cannot be detected.</p> <p>* No knowledge that increase of local P concentration causes delamination.</p> <p>Process control width: 6.6 ~ 6.9wt% (Product spec: 6.4 ~ 7.2wt%)</p> <p><X-ray fluorescence P concentration near target lot></p>

<p>→ During the target lot period, P concentration (average value) increase was not detected.</p> <p>* Correlation between P concentration (average) by X-ray fluorescence and P concentration (local) by SIMS is weak.</p>	<p>- Introduce SIMS to control local P concentration. ('14/12/17~) (Continue concentration control by X-ray fluorescence.)</p> <p>Control item: P concentration peak Control value: MAX 9.2% Control interval: 2/week or after every maintenance * Chamber A: 1/D (under special control)</p> <p>Measuring position: Center of wafer (Set as a result of investigation of distribution in wafer surface)</p>
