PRODUCT CAMPAIGN BULLETIN

APPLICABILITY: 2016MY Legacy and Outback Models
SUBJECT: Propeller Shaft Attaching Bolt Torque

NUMBER: WQV-57
DATE: December 09, 2015
NHTSA ID: 15V-794

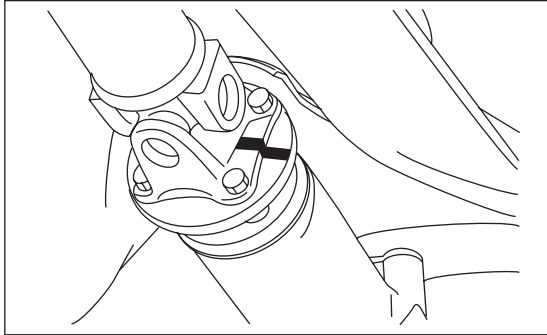
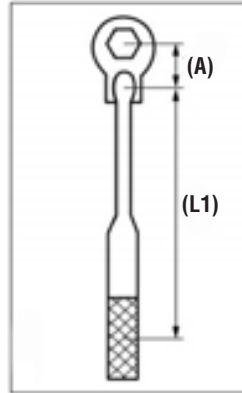
TIGHTENING TORQUE
31 N.m (3.2 kfg-m, 22.9 ft-lb)

- Due to the location of the nuts, extra care must be used to avoid damage to the dust cover on the differential seal due to contact with tightening tool. If the dust cover is deformed or damaged, differential replacement may be required as this cover is not serviceable. To avoid this condition, SOA recommends the use of an appropriate torque extension tool along with a standard torque wrench. When using a torque extension, be sure to adjust the torque value appropriately to compensate for the length of the extension used. A formula is provided below.

- Raise the vehicle.
- Closely inspect the 4 propeller shaft rear flange bolts / nuts by confirming a sufficient amount of torque is required to LOOSEN them (confirm the bolts / nuts are not loose or only finger-tight).
- If any of the nuts are found to be loose or only finger-tight, thread damage may have occurred to the bolt and replacement of that bolt, nut and washer is required.
- If all 4 nuts, bolts and washers require replacement, always confirm the paint marks of the flange and yoke (A) are aligned as shown in the illustration below before reinstalling the new hardware.
- Once it has been confirmed the bolts / nuts are not loose or any bolts / nuts found to be loose have been replaced (including a new washer), torque the 4 flange nuts to the specified value in the Service Manual: 31Nm (22.9 ft. lbs.) to complete the procedure.

$T = L1 / (A + L1) \times T1$
T = New Torque Specification
L1 = Length of the torque wrench from the center of the handle to the center of the socket mount.
A = Length of the adapter from the middle of the socket mount to the middle of the wrench.
T1 = Original torque specification
Example: $T = 37.5 / (4+37.5) \times 420$
 $T = 37.5 / 41.5 \times 420$
 $T = .90 \times 420$
 $T = 378$
