Reference	SSM72201
Models	XJ / X351
Title	X351 Side Rear Window Electric Sunblind (LWB Only)
Category	Body
Last modified	06-Mar-2015 00:00:00
Symptom	102000 Window/Glass
Attachments	SSM Attachment Example.pdf

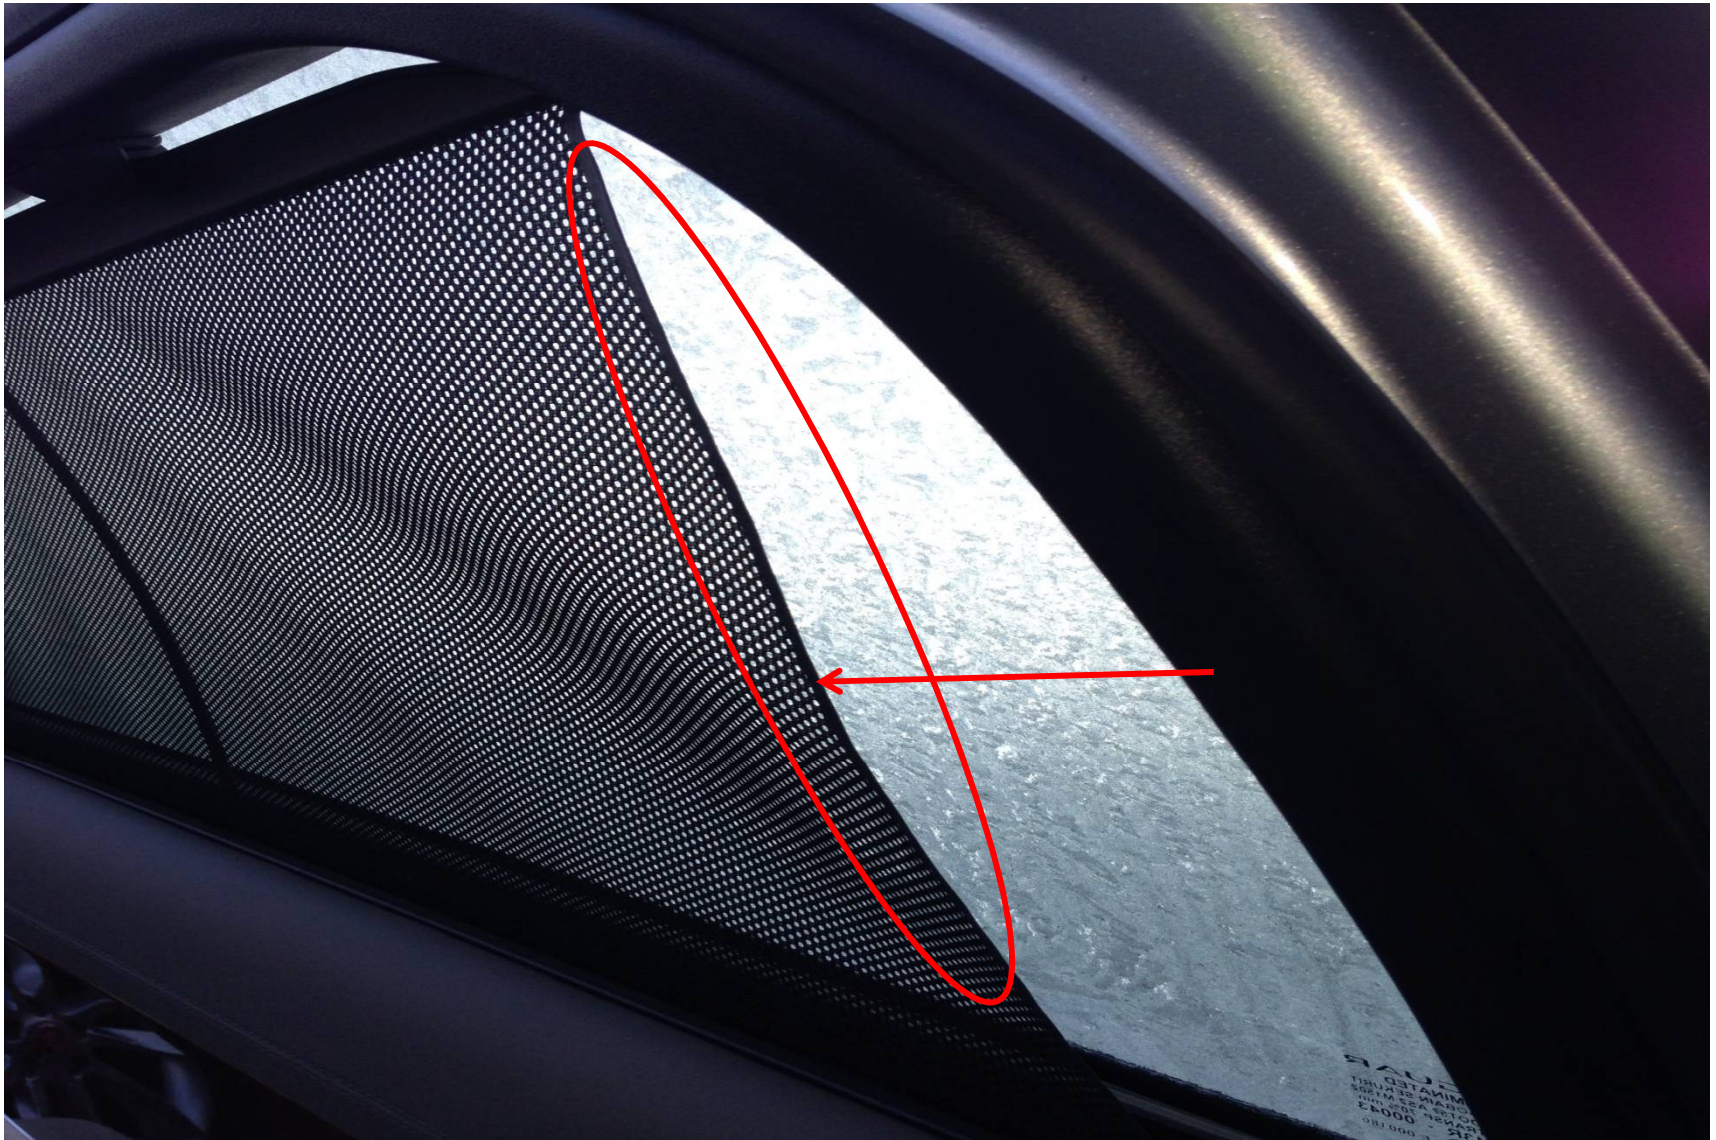
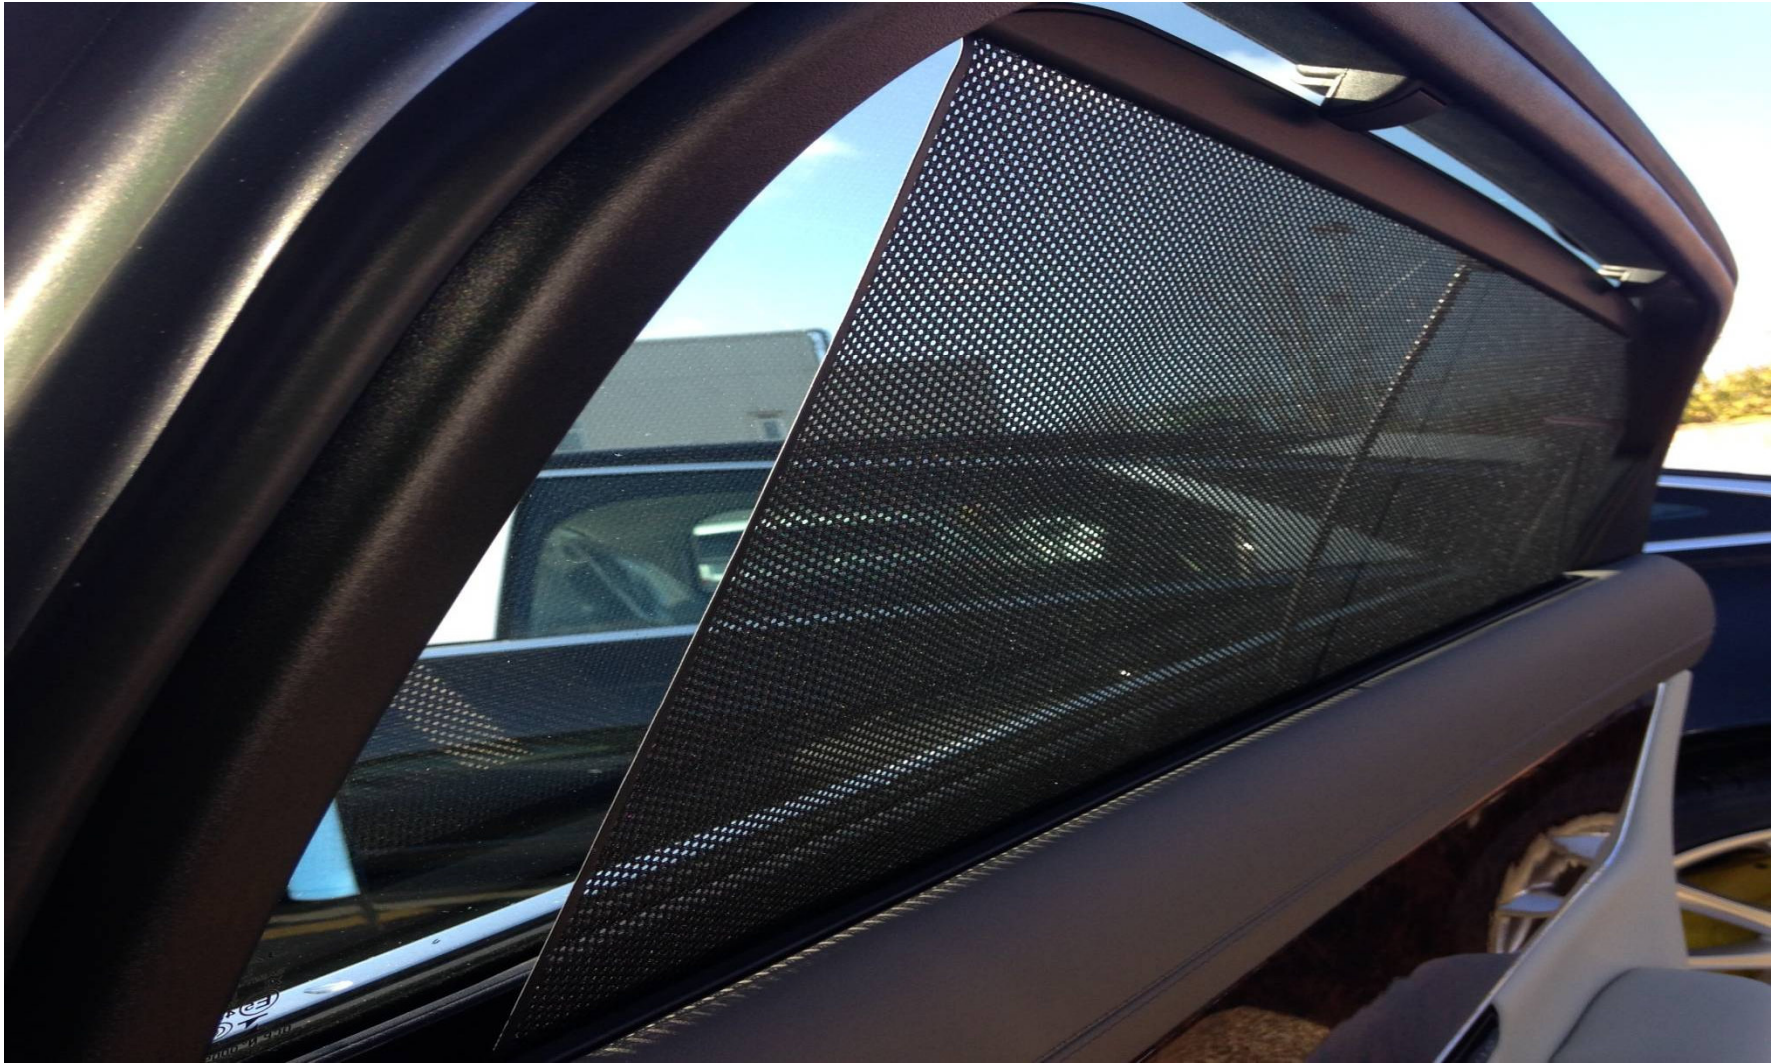
Content **Issue:** JLR engineering are currently receiving a number of EPQR's regarding X351 rear door electric sunblind's not operating at PDI or following battery disconnect causing the loss of the single press function and also the sunblind material will appear distorted on the front edge. **Please view example PDF attachment.**

Cause: Rear door sunblind module is not Initialized at PDI or the module has lost the power feed/earth feed.

Action: Please carry out rear sunblind Initialization (Topix section 501-05) or using the SDD service functions sunblind Initialization routine.

PLEASE NOTE – The rear windows must be initialized before the sunblind Initialization routine as this will cause the routine to fail.
