BULLETIN NUMBER:
IB16-J-002

GROUP:
ENGINE

POSSIBLE CAUSES FOR ENGINE OIL DILUTED WITH DIESEL FUEL

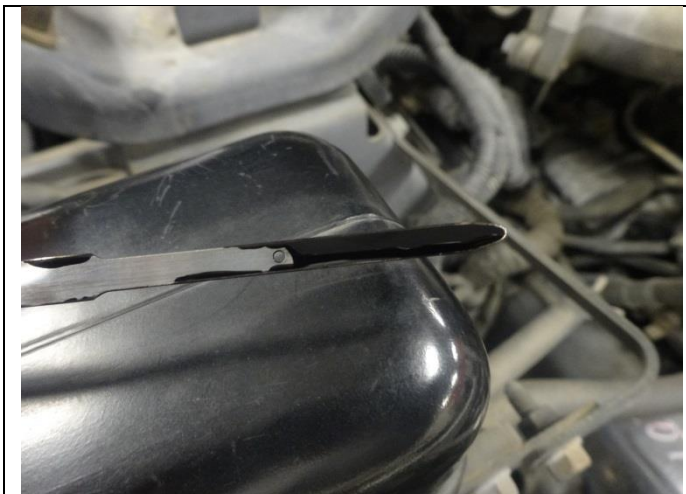
Figure 1.

1. Engine oil is overfilled during maintenance.

Refer to figure 1 for correct oil level on a dipstick.

When refilling the engine oil, refer to the Workshop Manual (WSM) for the oil capacity of the engine you are servicing. Fill the engine with about 80% of the oil capacity. Start the engine to allow the oil filter to fill. Turn the engine off and allow the oil to drain down for several minutes, then check the dipstick. Continue to add oil as necessary to bring the level up to the full mark on the dipstick.

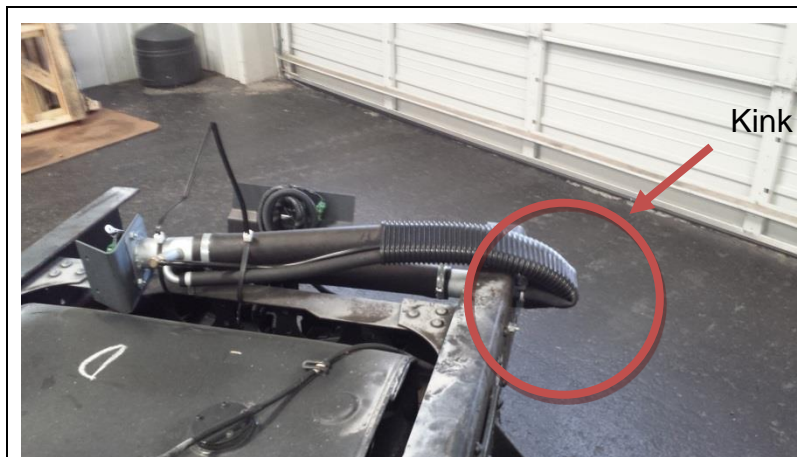
Figure 2.

2. Fuel tank fill and vent hoses are kinked during temporary transport or during vehicle upfit.

If the fuel tank fill and vent hoses are kinked, a vacuum will build up inside the fuel tank while the engine is running. This condition may cause the fuel tank to contract, potentially blocking off the fuel return line at the bottom of the fuel tank. This, in turn, will increase fuel pressure in the fuel return line, causing the fuel pump seal to release fuel into the crankcase.

Refer to figure 2 for an illustration of improperly installed and kinked fuel tank fill and vent hoses during transport.
