# TECH TALK

Volume 226 - December, 2016

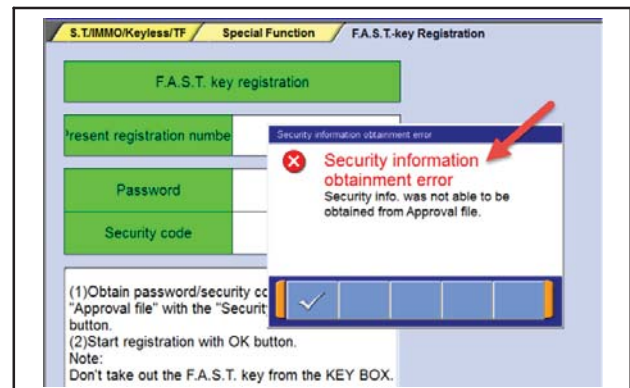
When all keys are lost, a security permission file is required to gain access to the KOS system of the vehicle to program new keys. A *Security Information Obtainment Error* may be encountered during key registration (see error message below).

This occurs when the downloaded security permission file (not to be confused with the Key Registration Password) for the vehicle is incorrect or corrupt.

If you run across this error using the downloaded security permission file, use the following steps to obtain a new security permission file.

1. Download the security permission file again and attempt to use it again to confirm the file is not working correctly.

2. Confirm you are seeing the error screen shown above.
3. Once the error screen is confirmed, generate a *Security application file* from the vehicle. This file will be used to obtain a new security permission file.

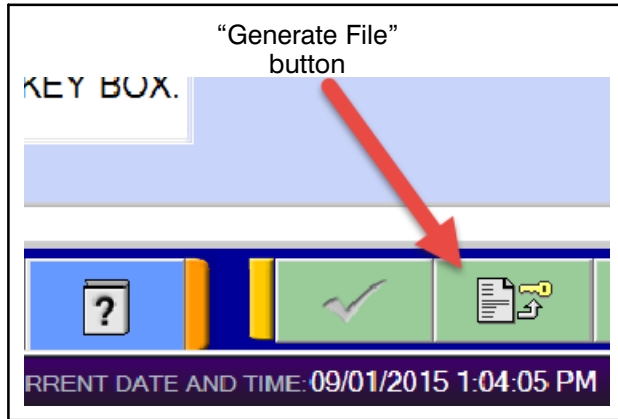
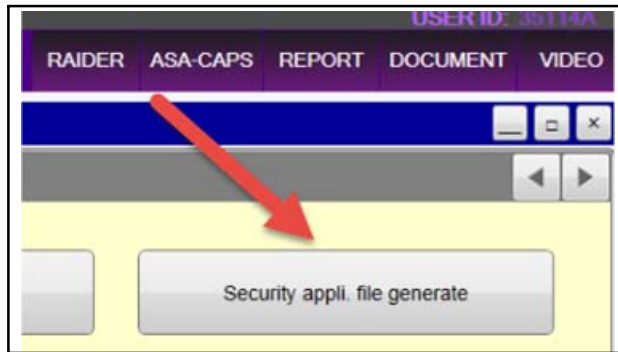
Depending on the vehicle, this is done by either clicking on the “generate file” button at the bottom of the screen, or by returning to a previous screen and clicking on the “Security appli. File generate” button. The file generated will automatically go into a folder in the scan tool.

4. Once the Security Application file has been generated, open a new Techline case for this vehicle.
5. Contact the MEDIC hotline (1-800-846-7575) to retrieve the file from the scan tool. Have MEDIC hotline attach the file to the Techline case and email it to: [mmnatechline@mmsa.com](mailto:mmnatechline@mmsa.com).

6. Call Techline (1-800-446-6064) to inform them of the case and the need for a new security permission file for the vehicle.
7. Techline will obtain a new permission file from MMC and attach it to the Techline case.

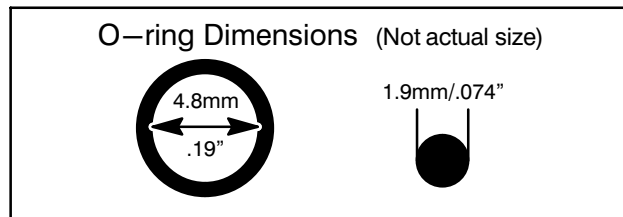
✓ **WINDSHIELD WASHER PUMP LEAKING AT FITTINGS** — 2013–15 Outlander Sport/RVR, 2014–15 Outlander.

If you find leakage at the washer pump forward of the right front tire, or the washer is inoperative, check if the washer pump fluid inlet/outlet assembly has become dislodged from the pump (refer to service manual Group 51 – Exterior —> Windshield Wiper and Washer, for information). Confirm if the o-rings on the pump outlets are in place. If o-rings are missing, it is NOT necessary to replace the entire washer pump.

Though not available from your facing PDC, suitable replacements can be sourced locally using o-rings made of EPDM (Ethylene Propylene Diene Monomer) rubber, with an I.D. of 4.8 mm and a material cross section of 1.9 mm (e.g. NAPA p/n - 727-2602).

Install the new o-rings to the outlet fluid connections and reinstall the outlet to the pump. If the o-rings are simply dislodged, but not lost, and they are NOT cut or damaged, they can be reused. If it is necessary to replace the gasket between the fluid tank and pump, it is available separately (PNC 84233, p/n 8260A161).

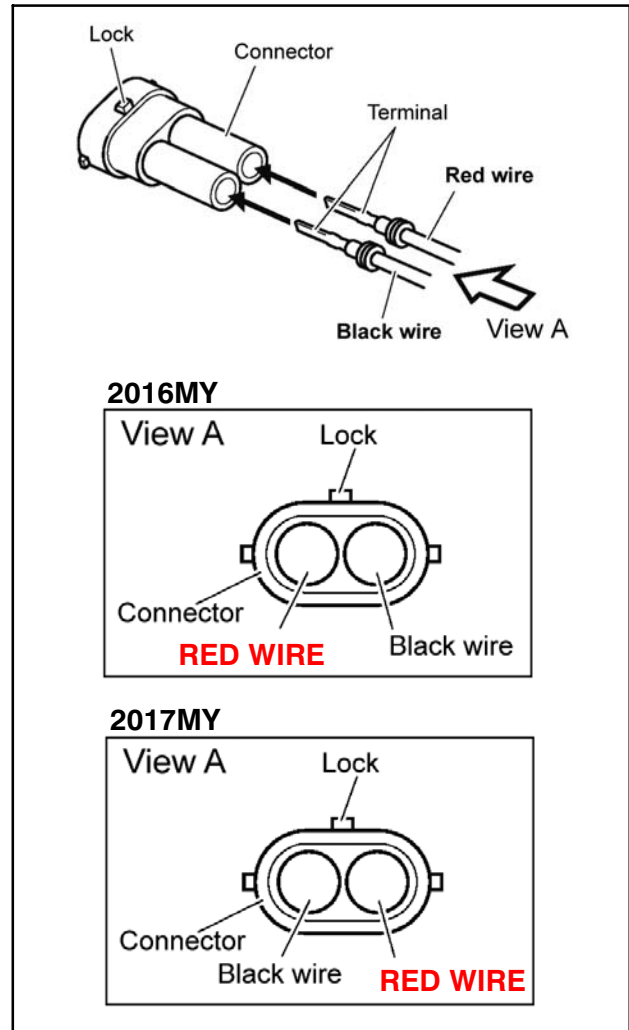
**LED FOG LAMP NOT WORKING**  
**(PN MZ581985EX)** — 2016-17 Outlander.

If a condition is found where the fog lamp is not working after installation, a possible cause is the fog lamp wire terminals are not positioned correctly for the specific model year (shown below).

For detailed instructions, please obtain a copy from your Parts coordinator who has access to the MMNA CAPS system.

CAPS:  
ACC -> Advanced Search -> Part number:  
MZ581985EX  
Refer to the instruction titled “Supplement” for model specific wiring details.
