TECH TALK

Volume 216 - February, 2015

Vehicle Technical Info

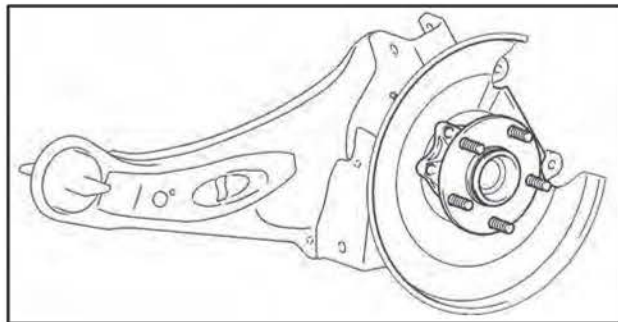
NOISE FROM REAR AXLE HUB — 2014-15

Outlander. MMNA is currently investigating the rear axle hubs on affected vehicles for a groaning/growling noise that gets louder as speed increases. If you confirm a customer report of this type of noise, please contact Techline BEFORE beginning repairs. Techline may ask that you replace the rear axle and trailing arm as an assembly and return them to assist in this investigation.

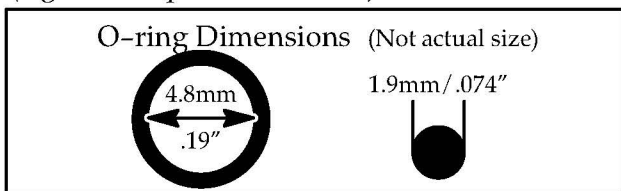
✓ WINDSHIELD WASHER PUMP LEAKING AT FITTINGS — 2013–15 Outlander Sport/RVR, 2014–15 Outlander (Added). If you find leakage at the washer pump forward of the right front tire, or the washer is inop, check if the washer pump fluid inlet/outlet assembly has become dislodged from the pump (refer to service manual Group 51 - Exterior —> Windshield Wiper and Washer for information). Confirm if the o-rings on the pump outlets are in place. If o-rings are missing, it is NOT necessary to replace the entire washer pump.

Though not available from your facing PDC, suitable replacements can be sourced locally using o-rings made of EPDM (Ethylene Propylene Diene Monomer) rubber, with an I.D. of 4.8mm and a material cross section of 1.9mm (e.g. NAPA p/n - 727-2602).

Install the new o-rings to the outlet fluid connections and reinstall the outlet to the pump. If the o-rings are simply dislodged, but not lost, and they are not cut or damaged, they can be reused. If it is necessary to replace the gasket between the fluid tank and pump, it is available separately (PNC 84233, p/n 8260A161).

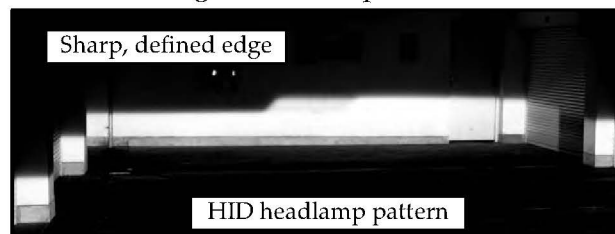
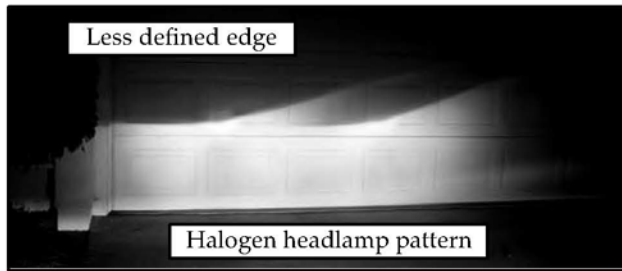
H.I.D. HEADLAMP MIS-ADJUSTMENT REPORTED — 2013–15 Outlander Sport/RVR. There has been a recent increase in warranty claims submitted for mis-adjusted headlamps. Statistics indicate that while only 6% of the subject vehicles were equipped with factory HID headlamps, they account for 42% of headlamp adjustment warranty claims. It's possible that customers do not understand the difference between the two types of headlamps and how they function.

HID headlamps have a very distinct pattern with a sharp “edge,” which is lower on the left side of the vehicle (road center line). When they are properly adjusted, the headlamps will light the road further down the vehicle's travel lane than standard halogen headlamps.

Before making any adjustments to the headlamps, consider the following:

- Is this the first vehicle the customer has driven with HID headlamps? If so, attempt to explain the facts to the customer.
- Using the previous photos, compare the headlamp adjustment to a known good vehicle by shining the headlamps on a blank wall.
- With a full fuel tank and the driver (approximately 150 lbs.) in position, the headlight switch should be in its base position (0 on the dial).

Confirm the value shown on the headlamp adjustment dial is appropriate for the vehicle's load. The number on the dial should be higher as vehicle load (passengers and cargo) is increased, and lower as vehicle load is reduced.

If you can't determine if the headlamp adjustment is appropriate for HID headlamps, use the procedures in the service manual and perform headlamp adjustment.

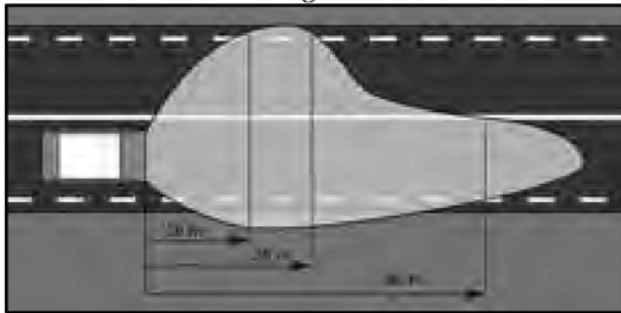
You can see from the following illustration that HID headlamps are better designed to light the vehicle's path, while limiting the amount of light shining into the opposing lane, reducing the distraction to oncoming traffic.
