### Updated Spec Manual on iN

## TRX

### Failed Oil Pump After Oil Drain Plug Repair

## S/B GL1800 #23: Tips For a Successful Recall Repair

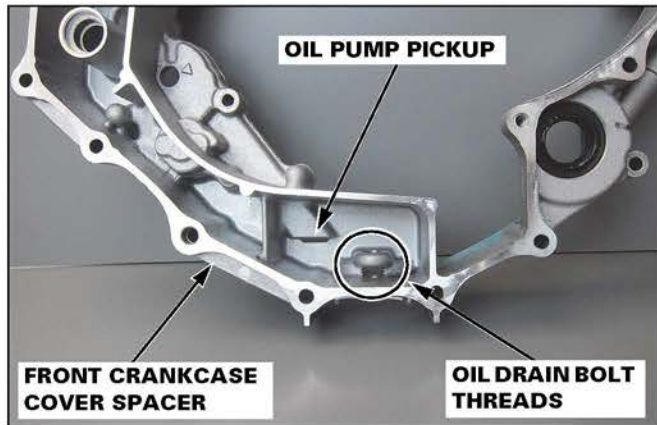
American Honda has seen a number of oil pump failures following the repair of stripped oil drain bolt threads. This is a result of shavings from the thread repair getting trapped between the inner and outer oil pump rotors, causing them to lock

up. The shavings enter the oil pump pickup that is located directly above the repaired oil drain bolt threads.

The best practice for repairing stripped drain bolt threads on these models is to replace the front crankcase cover spacer entirely, as it is virtually impossible to perform a reliable drain bolt thread repair on these models.

To prevent thread stripping in the first place, advise all technicians and customers to always install a new sealing washer when the oil is changed, and to use a torque wrench to prevent over-torquing the bolt.

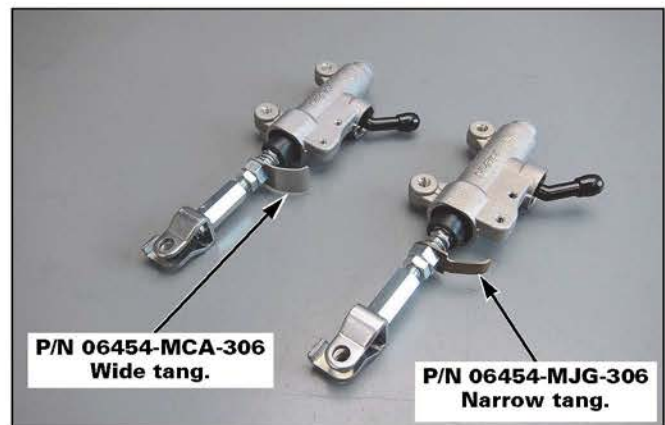
As stated in the background information of the Service Bulletin, one of the root causes of SMC trouble is deposits formed within brake fluid that is subjected to prolonged aging due to a lack of maintenance. Be sure to remind the customer that the Maintenance Schedule in their Owner's Manual states that brake fluid should be replaced every 2 years or 12,000 miles, whichever comes first; make a note of it on the on the repair order.

There are two different repair parts kits available depending upon model and year, so make sure you have the correct part number at hand because the rear master cylinders are not interchangeable.

After the repair is complete, make sure to apply a punch mark on the rear master cylinder lower mounting tab as indicated in the IDENTIFICATION section of the Service Bulletin.
