<b>Reference</b>	SSM72162
<b>Models</b>	Discovery Sport / L550 LR2 / L359 Range Rover Evoque / L538
<b>Title</b>	2.0GTDI Coolant pump leaks
<b>Category</b>	Engine
<b>Last modified</b>	28-Jan-2015 00:00:00
<b>Symptom</b>	402000 Cooling System Concerns
<b>Attachments</b>	weep chamber.JPG

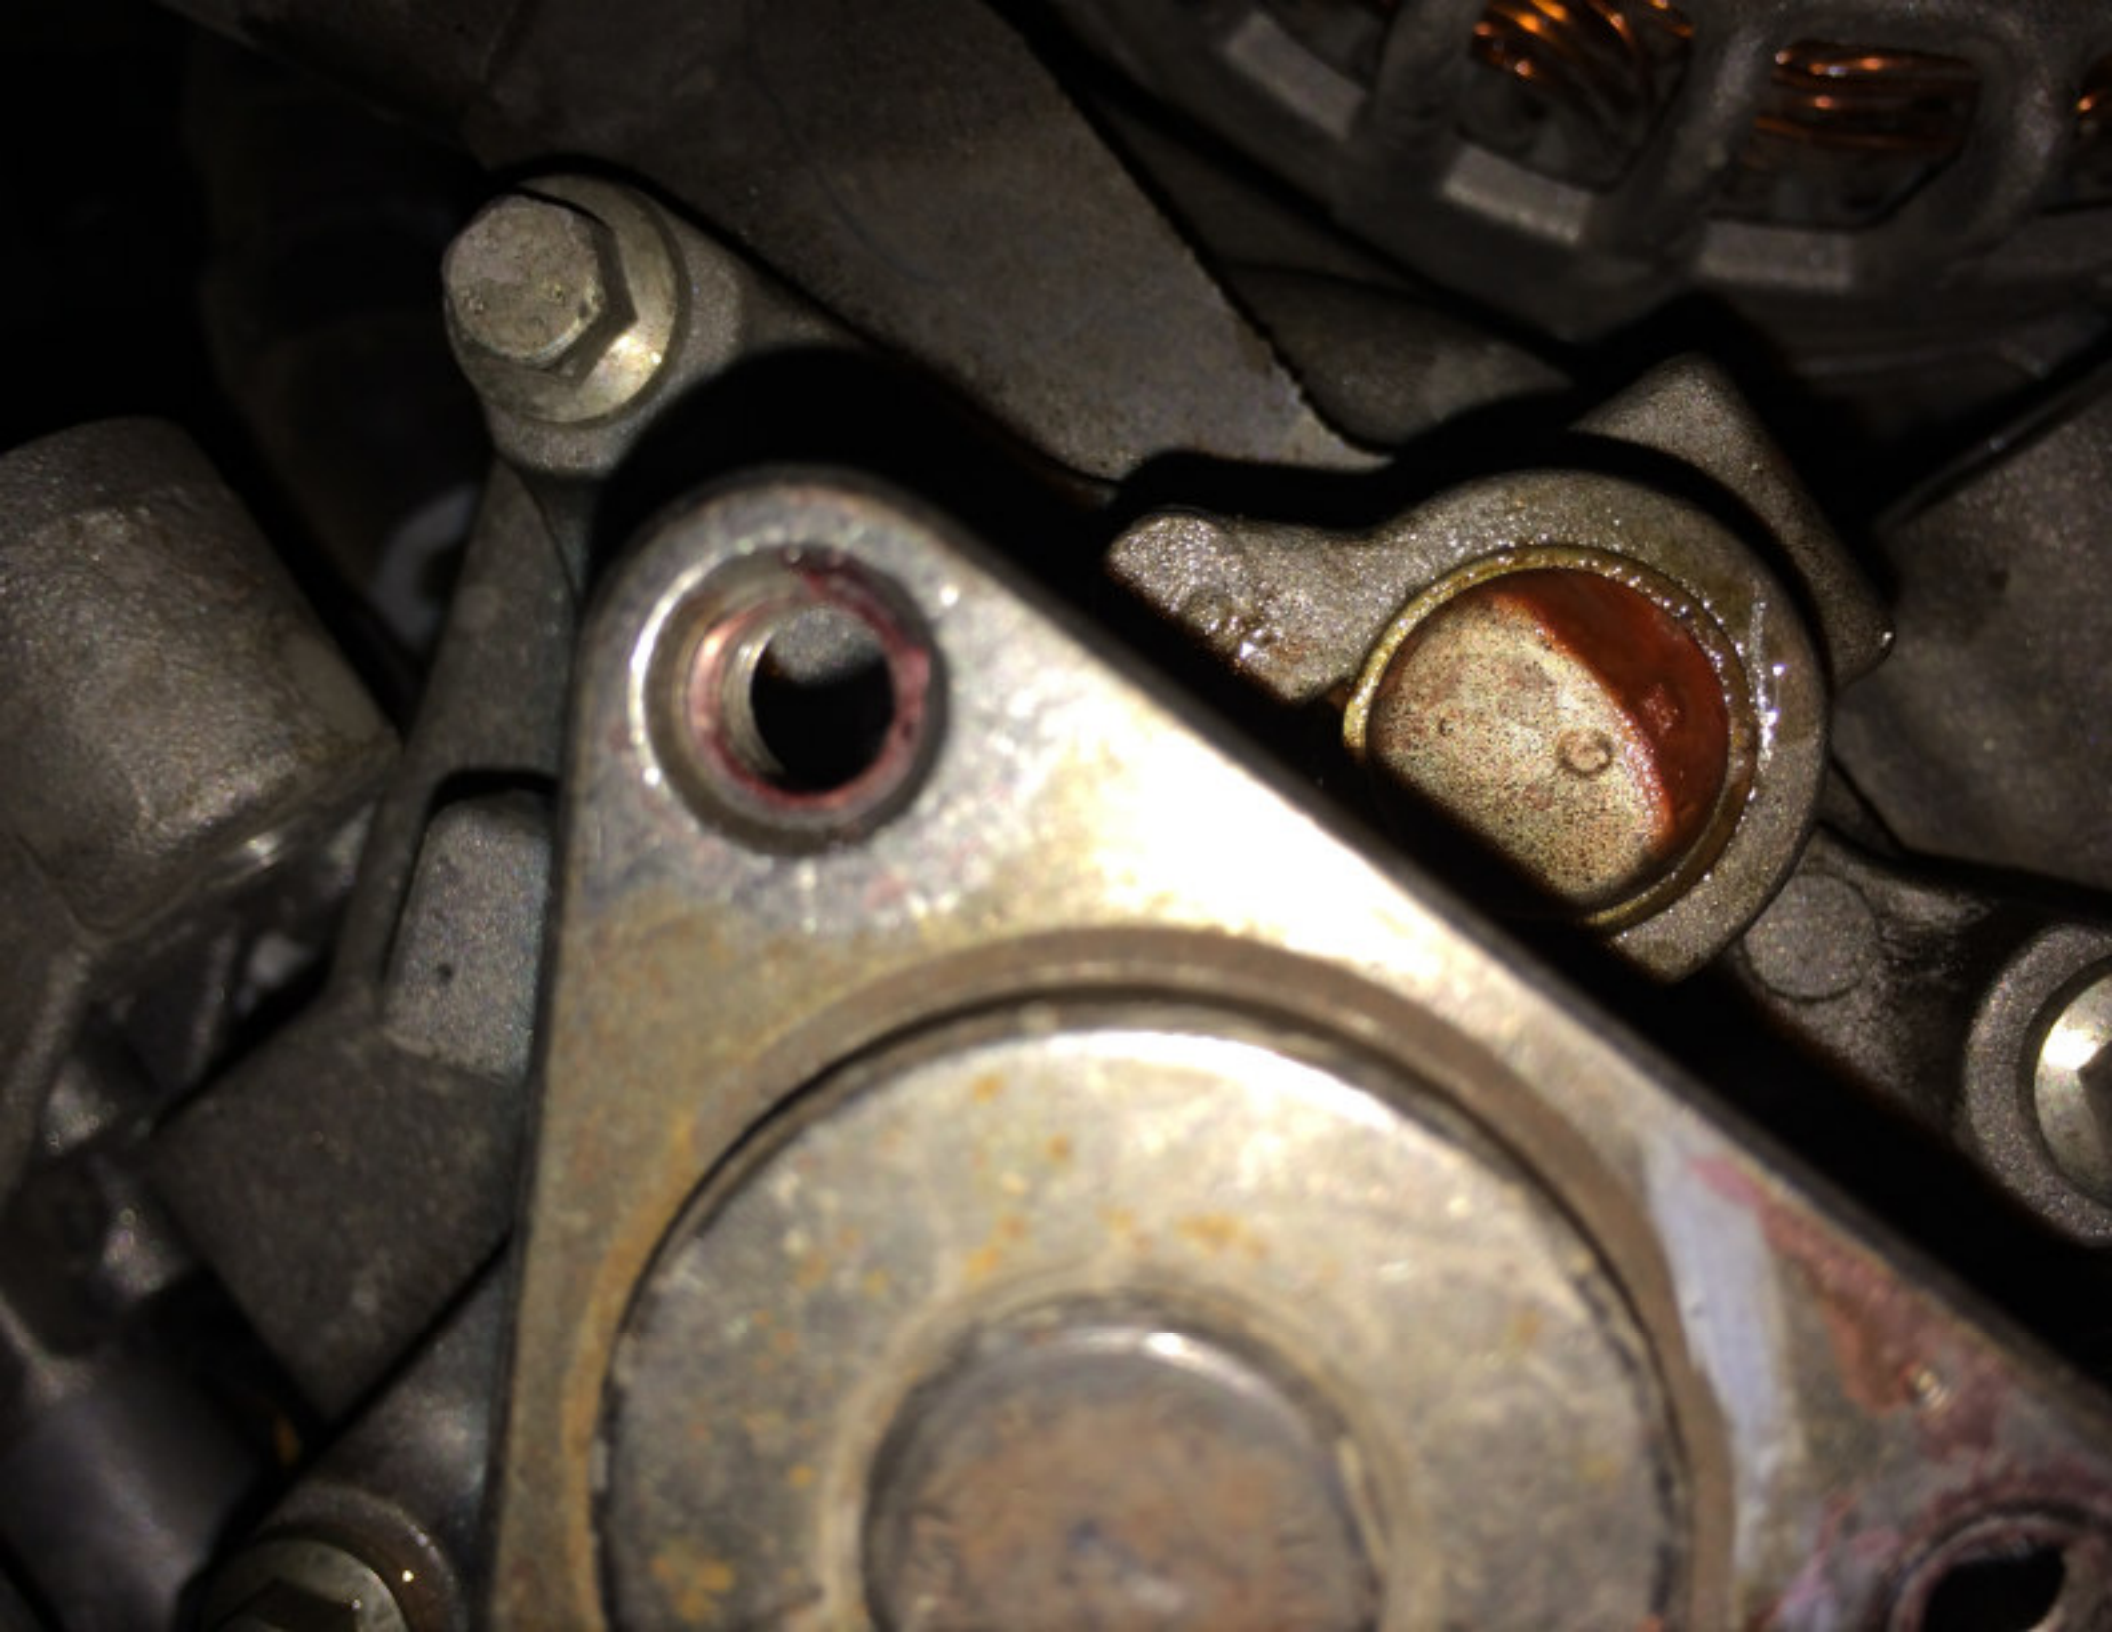
Vehicles fitted with 2.0GTDi engine.  
Coolant pump leaks from weep chamber. (see attached picture)

Corrosion inhibitors used, combined with the hot engine testing performed during production can lead to damage or premature degradation of the coolant pumps internal rotational seal. This allows too much coolant to seep past the pump bearings, flooding the weep chamber and eventually results in a visible leak.

Replace water pump with latest level part from Microcat.  
As the parts created for service stock are never subject to hot testing and are packaged using a different corrosion inhibitor they will not exhibit the same fault.
