TECHNICAL BULLETIN

Q484 UPS4815-1bNAS1

Update Prior to Sale: Missing Tailgate Badge

Discovery Sport (LC)

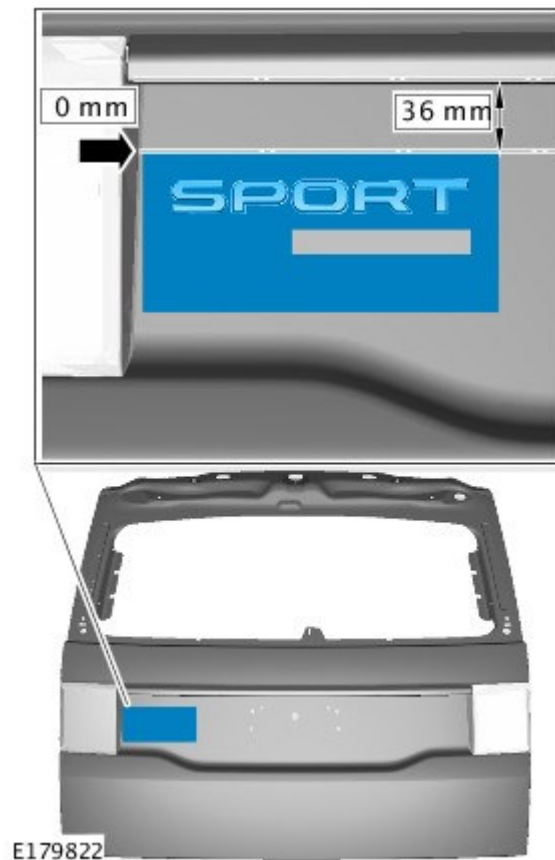
2.

**NOTE: only install the 'SPORT' element of the badge.**

**NOTE: make sure the vehicle body surface is clean and free of wax**

Remove the backing sheet and install the new 'SPORT' badge to the tailgate.
