LTB01030NAS2

TECHNICAL BULLETIN

SUBJECT/CONCERN:Squeak/Rubbing Noise From Front Right of Vehicle While Driving

MODEL:	MODEL YEAR:	VIN:	ASSEMBLY PLANT:
Discovery Sport (LC)	2017 Onwards	606801 Onwards	Halewood
Range Rover Evoque (LV)	2017 Onwards	136146 Onwards	Halewood

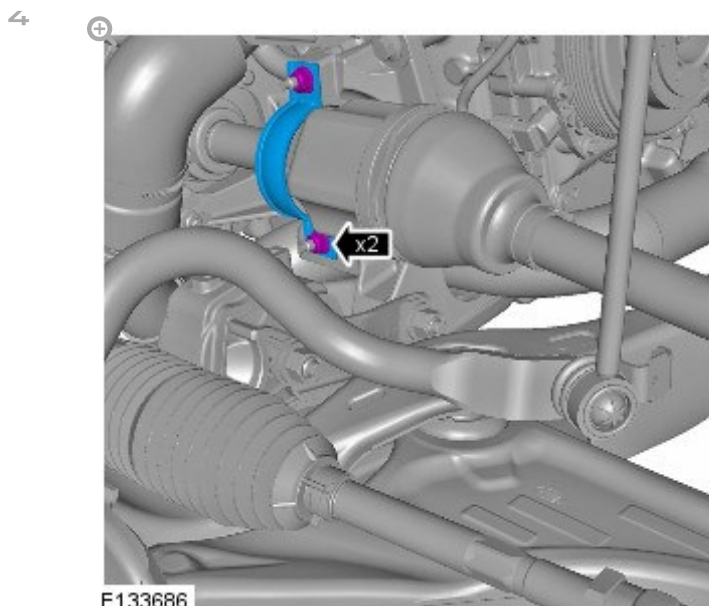
Remove the front right halfshaft bearing retainer.

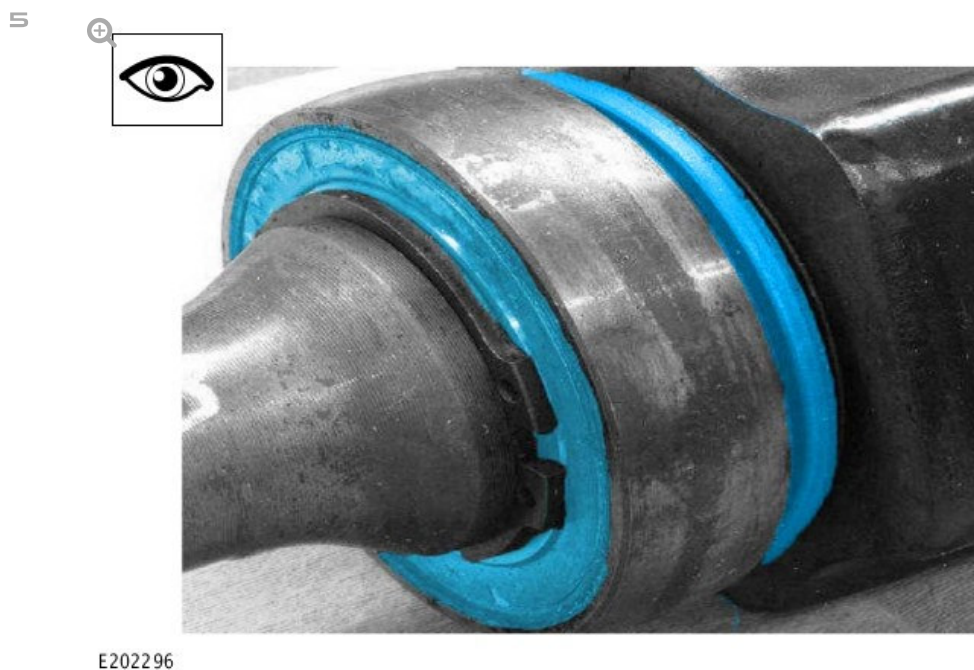
Visually inspect the halfshaft bearing outer seals to check they are not out of position or damaged.

- If either seal is damaged or out of position, go to Step 7.
- If both seals are not damaged and are in the correct position, continue to Step 6.
