# Tech Tips

TT 64-16-04

## 2009 – 2017 Tiguan – Vibration Noise When Operating Rear Window

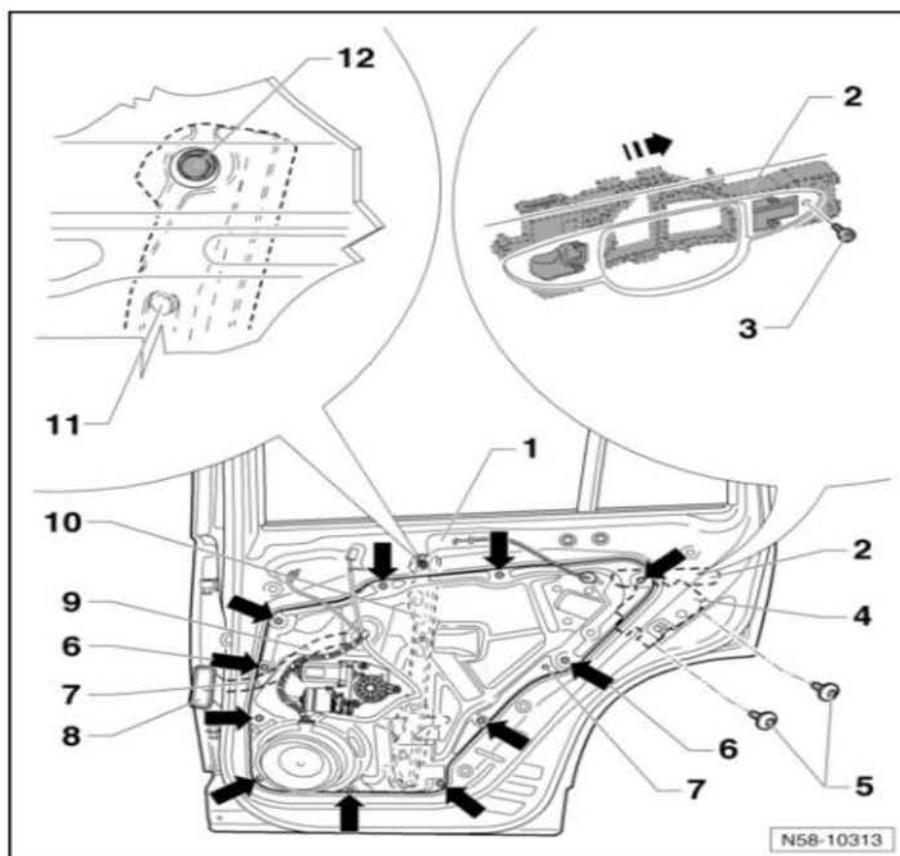
A vibration or rumbling noise which is heard when operating the rear window can be caused by a window regulator sub-frame that was not properly torqued. An incorrect torque sequence or specification, can cause the upper regulator roller to become pinched by the regulator rail. This prevents the wheel from turning properly during the regulator operation. The regulator cable sliding across the stationary wheel causes the vibration/noise. If this occurs, the regulator will need to be replaced.

**It is crucial that the torque sequence outlined in ELSA is followed to prevent damaging the window regulator.** As outlined below, once the regulator is aligned in the door opening with the alignment pins -7-. Insert all of the bolts, but do not torque. Torque the bolts -6- nearest the alignment pins -7- first to 8 Nm. Torque the remaining bolts surrounding the sub-frame -arrows- in any desired sequence to 8 Nm. Finally, torque the upper bolt for the regulator rail -12- to 8 Nm.
