Technical Bulletin

57 16 03 April 8, 2016 2014599 Supersedes T. B. V571105 dated September 30, 2011 to include additional model year applicability.

Front Door Deformed by Ice

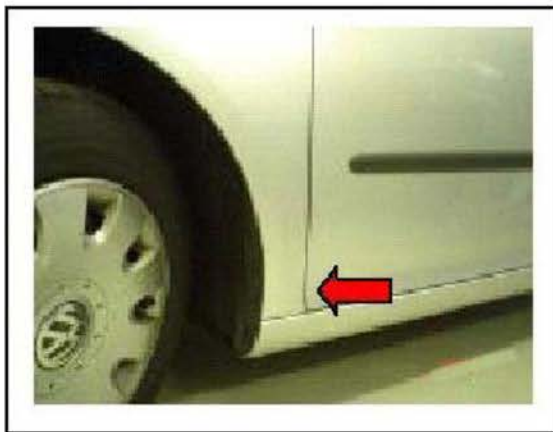
In cold climates door(s) becomes damaged in the lower area while opening.

Water draining from the front cowl drains into the rear of the front fender area. Water seeps out behind the lower front door and freezes causing door obstruction and damage to door panel. This condition may also occur at rear lower corner of front fender.
