# Technical Bulletin

55 16 13 July 13, 2016 2039446 Supersedes Technical Bulletin V551612 dated June 9, 2016 to clarify 2002 thru 2005 Jetta Wagon applicability.

### Corrosion Hood Edge

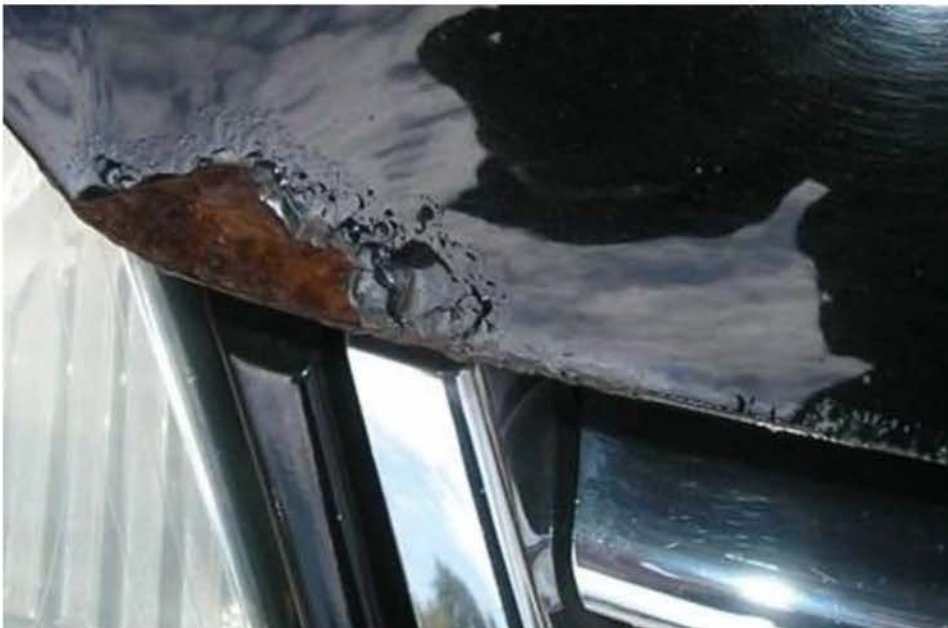
Corrosion may be found on the folded edge of the hood. The corrosion may be found on this edge anywhere around the hood.

- Remove the Hood from the vehicle. See Repair Group 55 in Elsa.
- Remove the corrosion with Pneumatic Brush Grinder Set -VAS6446 or similar tool.
- Sand the overlapping areas with P360 - P400 sandpaper.

- Clean the base surface with a VOC compliant cleaning solution.
- After a corrosion repair and before sealing, insulate the base surface with a Two-Part Wash Primer and then fill with Two-Part HS Performance Filler. (Both Locally Sourced).

- After the filler has dried, the filled area must be dry sanded with P400- P500. While doing so, make sure to avoid "sanding through". Then clean the sanded areas with a VOC compliant cleaning solution.

- After the filler has dried and has been sanded, the metal edges in the fold area must be thinly sealed with Polyurethane adhesive -AKD 476 KD5 05.
- Paint the hood according to Volkswagen specifications.
