00317-01777 Version 2

Excessive Vibration Between 30 and 65 MPH

Supersedes 14-078, dated December 20, 2014, to revise the information highlighted in **yellow**

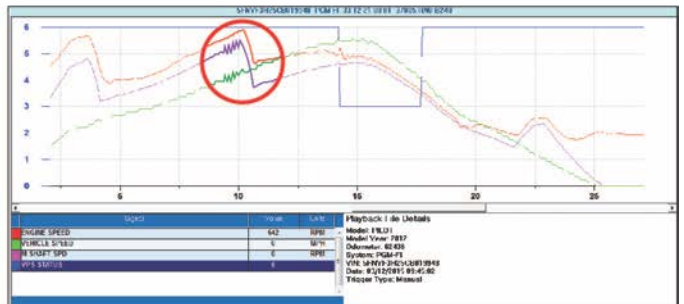
POSSIBLE TORQUE CONVERTER ISSUES

- The customer indicated the vibration occurred under braking or hard acceleration.
- The engine is not in valve pause when the vibration occurs.
- The snapshots 1 and 2 indicate fluctuations in the main shaft but the engine speed is steady – review the job aid *Torque Converter Clutch Shudder and Vibration*.

Refer to the Job Aid.

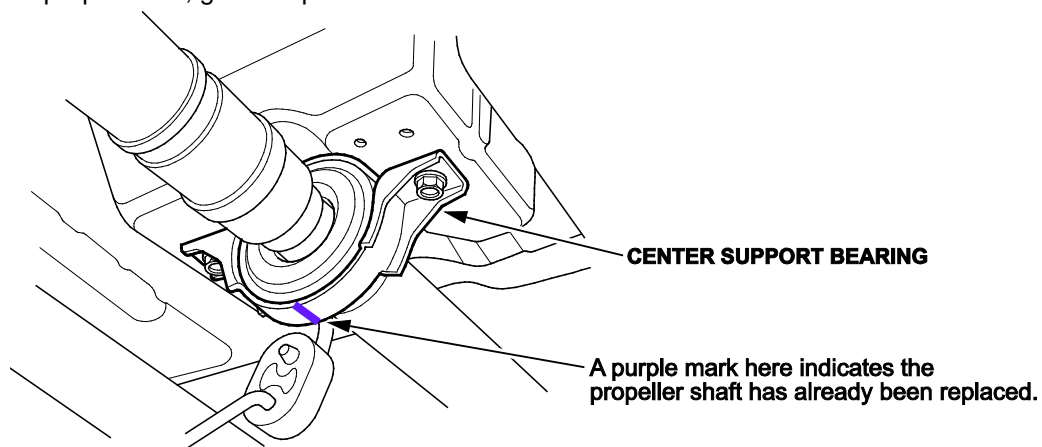
Additionally for 4WD vehicles, the propeller shaft's center support bearing bushing material may not effectively dampen vibrations in cold (below 32°F) temperatures.

1. Raise and support the vehicle.
2. Check that the propeller shaft has not already been replaced. Check if there is a purple mark on the center support bearing as shown below.
 - If there is a purple mark on the center support bearing, the propeller shaft has already been replaced with a new part. Do not replace the propeller shaft again. If there is still a vibration, this bulletin does not apply. Continue with normal troubleshooting.
 - If there is no purple mark, go to step 3.
