06492 Version 1

Vibration While Driving Under Light Acceleration After Software Update

Year	Model	Trim	VIN Range
2012-14	CR-V	ALL	ALL

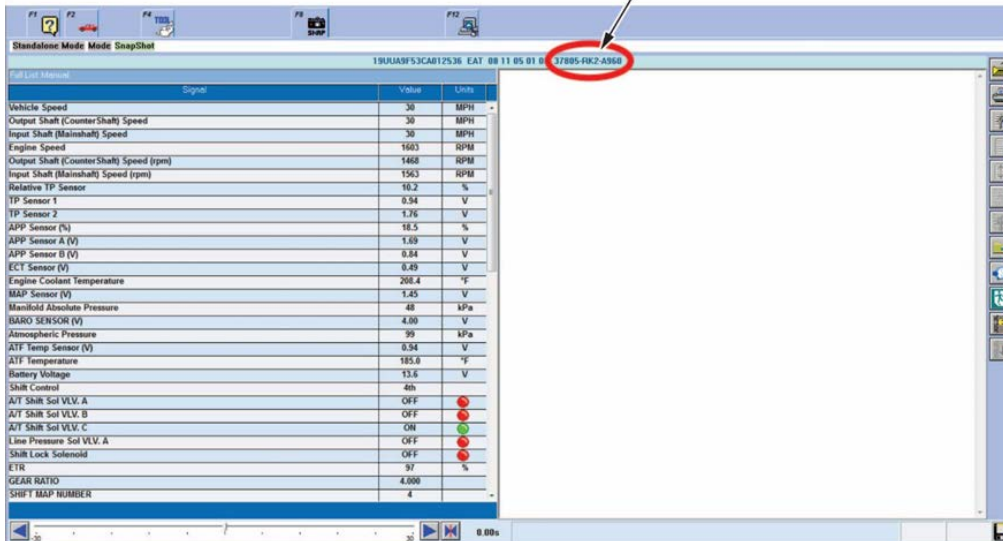
PROGRAM PART NUMBER

1. Connect the i-HDS, and go to the **AT Data List**. Check to see if the software has been updated by comparing the program P/N against the table below.

- If the program P/N is listed below (or later), the vehicle has been updated. Go to step 2.

- If the program P/N is not listed, the vehicle has not been updated. Go to Service Bulletin 15-086, *Vibration While Driving Under Light Acceleration*.
2. Take an automatic transmission snapshot and review the data. For more information about capturing and interpreting the data, refer to the job aid *Torque Converter Clutch Shudder and Vibration* and the *Tech2Tech®* video: *Interpreting Torque Converter Judder Snapshot Data*.
 - If the snapshot indicates the torque converter is damaged, go to REPAIR PROCEDURE.
 - If the snapshot indicates the torque converter is OK, this bulletin does not apply. Continue with normal troubleshooting.
