FORD:

2014-2016 Fusion

2015-2016 Edge

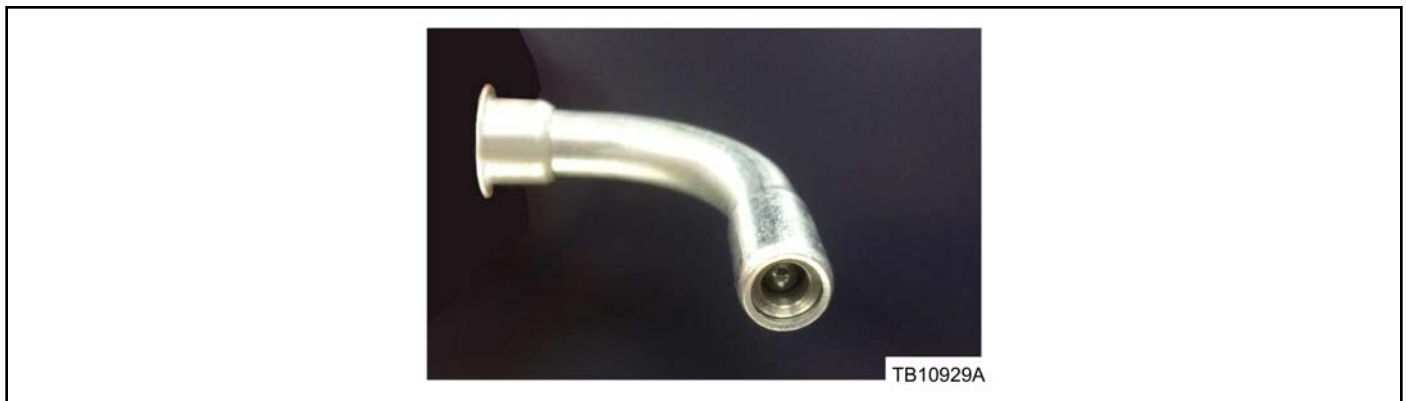
Figure 1 - Article 16-0111

Some 2014-2016 Fusion and 2015-2016 Edge vehicles equipped with a 6F35 transmission and active start/stop feature may exhibit an illuminated malfunction indicator lamp (MIL) with a harsh transmission engagement after an active stop/start event. Diagnostic trouble code (DTC) P0C27 will be stored in the powertrain control module (PCM) memory. This condition may be caused by air entering the transmission fluid auxiliary pump supply tube.

1. Using an Integrated Diagnostic System (IDS) or equivalent scan tool retrieve DTCs. Is DTC P0C27 present in the PCM memory?
 - a. Yes - proceed to Step 2.
 - b. No - this article does not apply. Refer to Workshop Manual (WSM), Section 307-01.
2. Check the transmission build date. Refer to WSM, Section 307-01. Was the transmission built on or before 2/26/2016?
 - a. Yes - proceed to Step 3.
 - b. No - this article does not apply. Refer to WSM, Section 307-01.
3. Remove the transmission fluid auxiliary pump. Refer to WSM, Section 307-01.
4. Remove and discard the transmission fluid auxiliary pump supply tube. (Figure 1)

5. Install a new transmission fluid auxiliary pump supply tube which contains a check ball.
6. Reinstall the transmission fluid auxiliary pump. Refer to WSM, Section 307-01.
7. Clear DTCs.
