SERVICE BULLETIN

Classification: EC15-005b	Reference: NTB15-053b	Date: October 13, 2016
------------------------------	--------------------------	---------------------------

2015 JUKE; MIL ON WITH DTC FOR REAR OXYGEN SENSOR

APPLIED VEHICLE: 2015 Juke (F15)

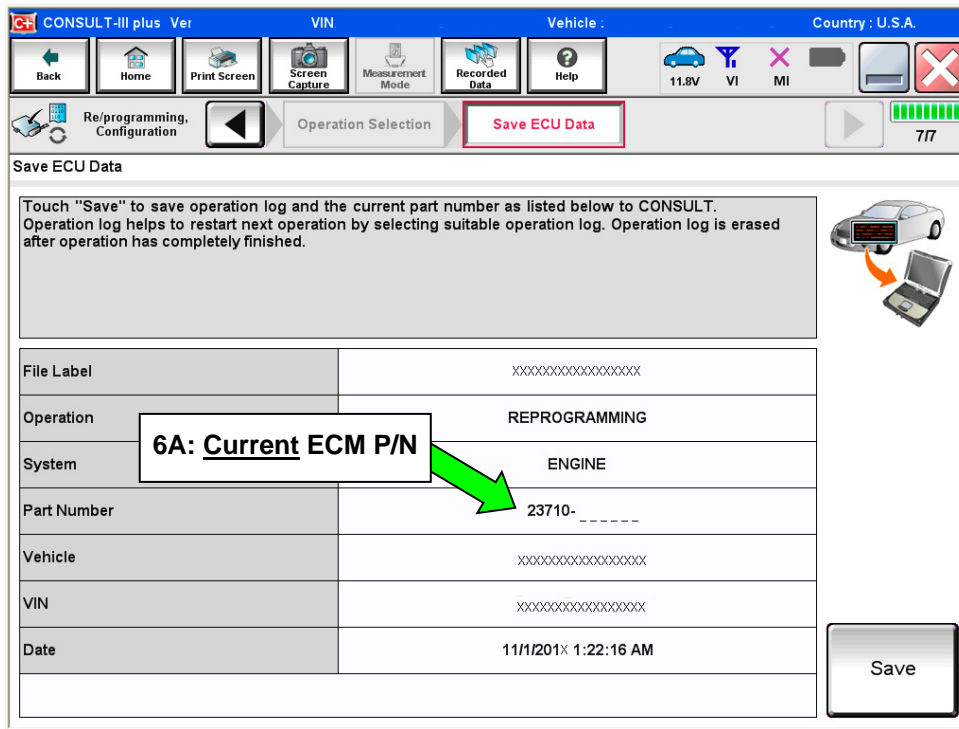
Figure 2

6. When you get to the screen shown in Figure 2, confirm this bulletin applies as follows.

A. Find the ECM **Part Number** and write it on the repair order.

NOTE: This is the current ECM Part Number (P/N).

B. Compare the P/N you wrote down to the numbers in the **Current ECM Part Number** column in **Table A**.

- If there is a match, this bulletin applies. Continue with the reprogramming procedure.
- If there is not a match, this bulletin does not apply. Close C-III plus and refer to ASIST for further diagnostic information.

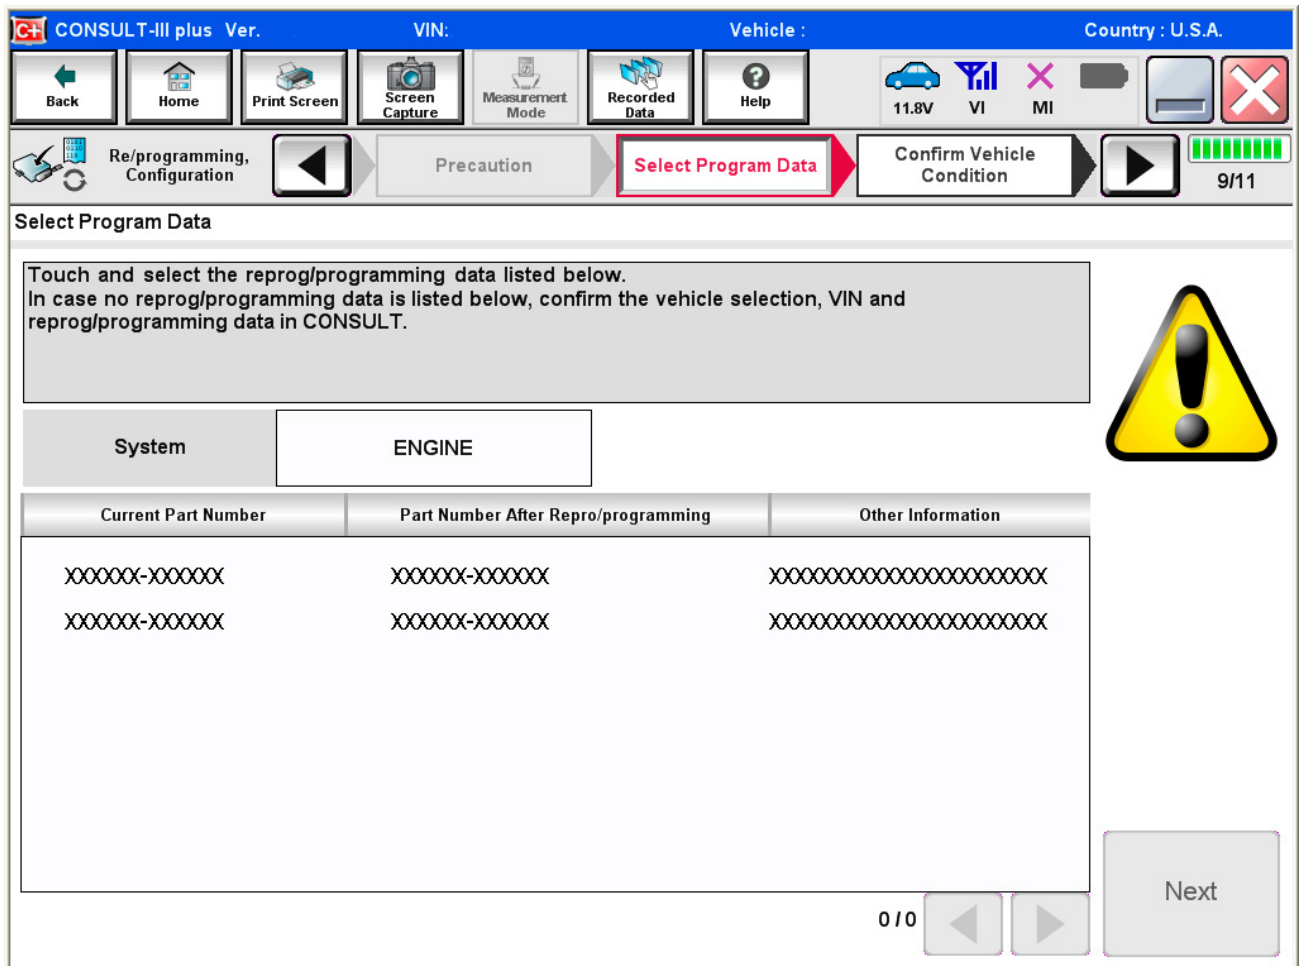
- In some cases, more than one new P/N for reprogramming is available.
 - In this case, the screen in Figure 3 displays.
 - Select and use the reprogramming option that **does not** have the message “Caution! Use ONLY with NTBXX-XXX”.
- If you get this screen and it is blank (no reprogramming listed), it means there is no reprogramming available for this vehicle. Close C-III plus and refer back to ASIST for further diagnosis.

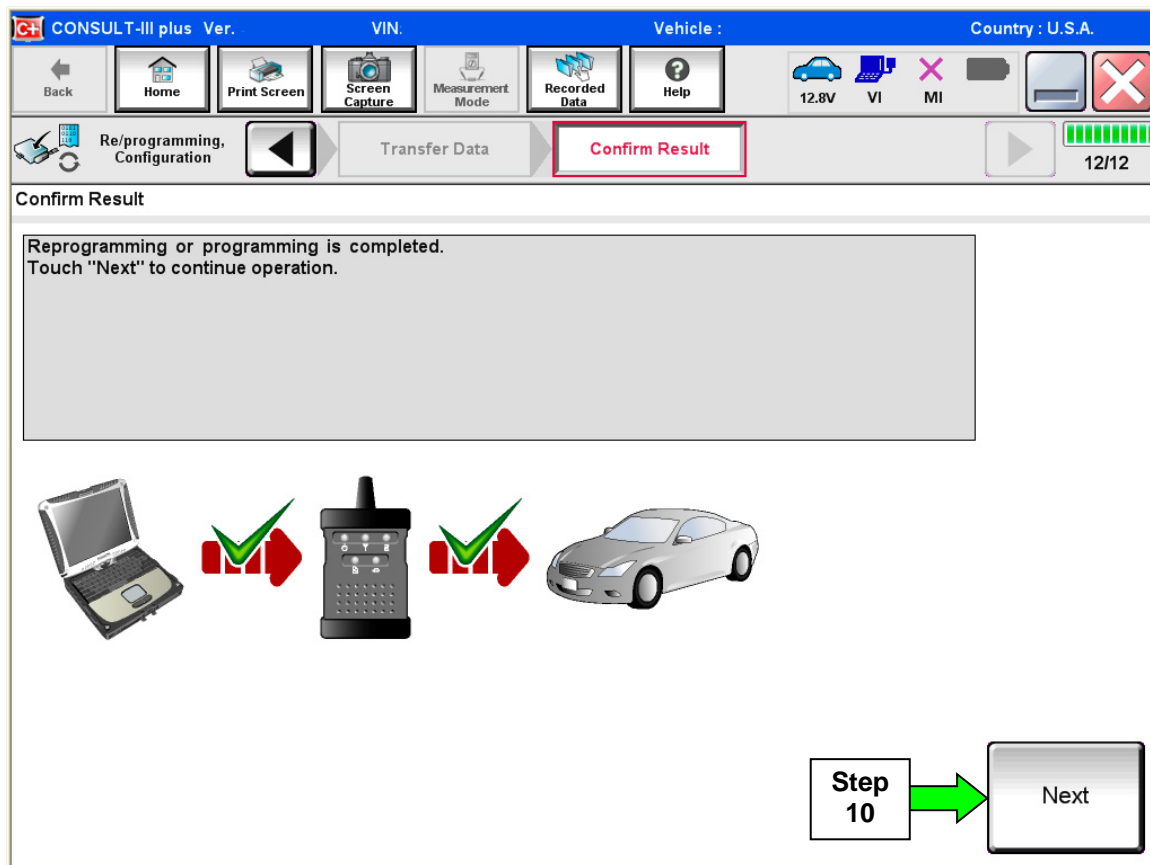
8. When the screen in Figure 4 displays, reprogramming is complete.

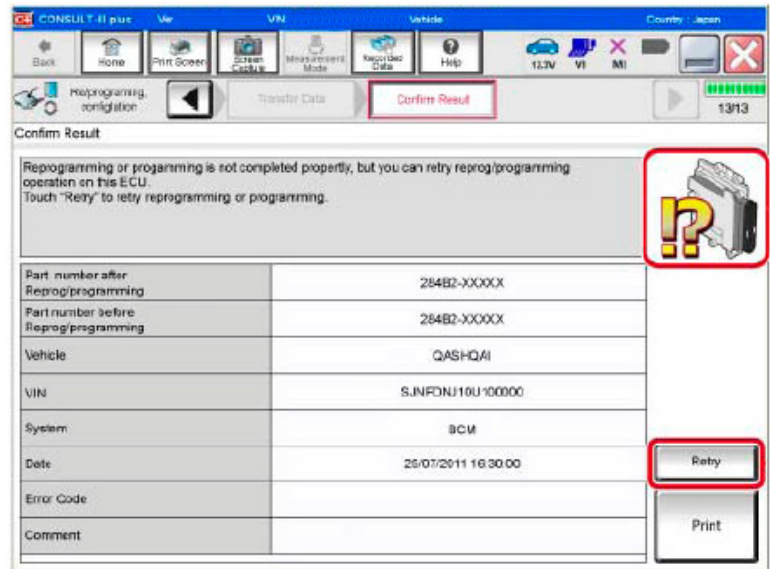
Figure 5

If reprogramming does not complete and the “!” icon displays as shown in Figure 5:

- Check battery voltage (12.0–15.5 V).
- Ignition is ON, engine OFF.
- External Bluetooth® devices are OFF.
- All electrical loads are OFF.
- **Select retry and follow the on screen instructions.**
- “Retry” may not go through on first attempt and can be selected more than once.

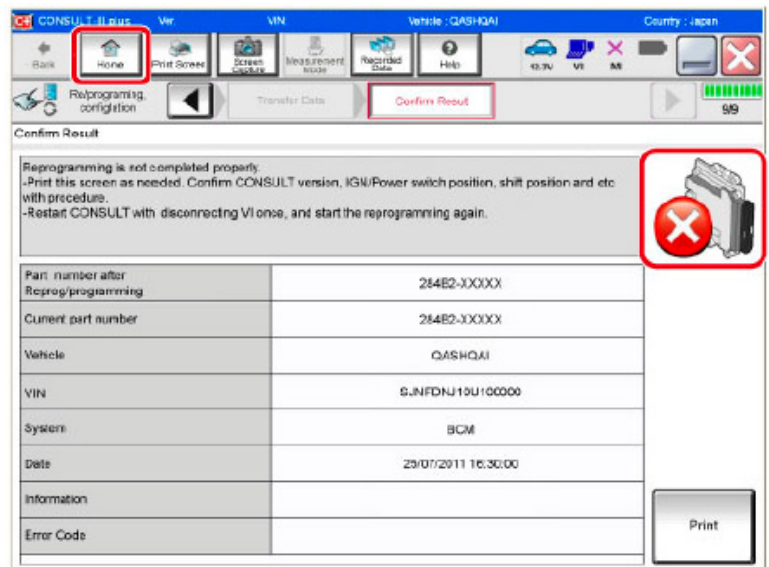
Figure 6

If reprogramming does not complete and the “X” icon displays as shown in Figure 6:

- Check battery voltage (12.0 – 15.5 V).
- CONSULT A/C adapter is plugged in.
- Ignition is ON, engine OFF.
- Transmission is in Park.
- All C-III plus / VI cables are securely connected.
- All C-III plus updates are installed.
- **Select Home, and restart the reprogram procedure from the beginning.**

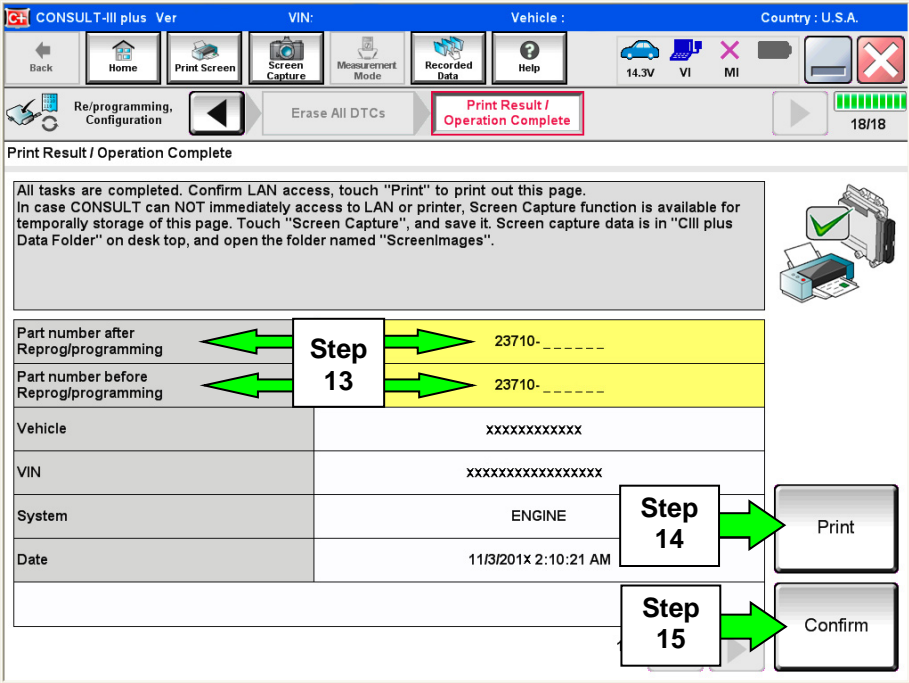
12. When the entire reprogramming process is complete, the screen in Figure 7 will display.

13. Verify the before and after part numbers are different.

14. Print a copy of this screen (Figure 7) and attach it to the repair order for warranty documentation.
