# SERVICE CAMPAIGN BULLETIN

NTB16-121a

## VOLUNTARY SERVICE CAMPAIGN 2013-2016 ALTIMA AND 2014-2016 ROGUE; TCM REPROGRAMMING

**CAMPAIGN ID #:** PC490

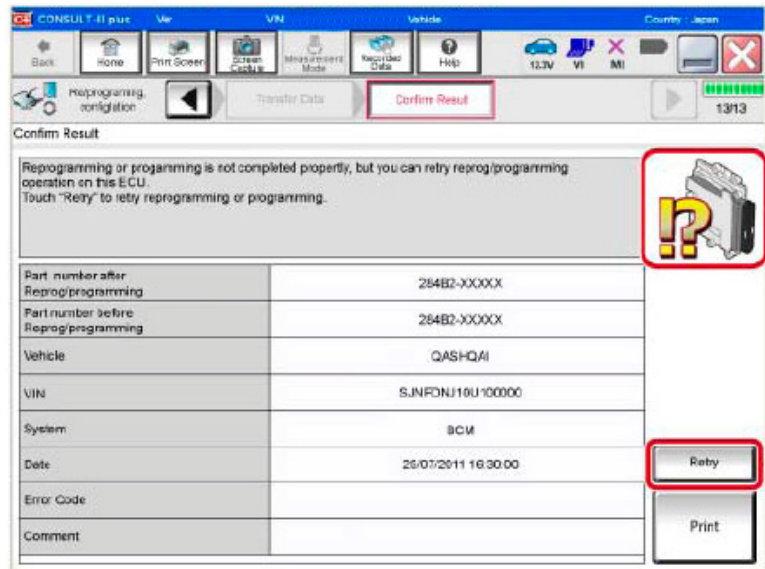
Figure 19

If reprogramming does not complete and the “!?” icon displays as shown in Figure 19:

- Check battery voltage (12.0–15.5 V).
- Ignition is ON, engine OFF.
- External Bluetooth® devices are OFF.
- All electrical loads are OFF.
- **Select retry and follow the on screen instructions.**
- “Retry” may not go through on first attempt and can be selected more than once.

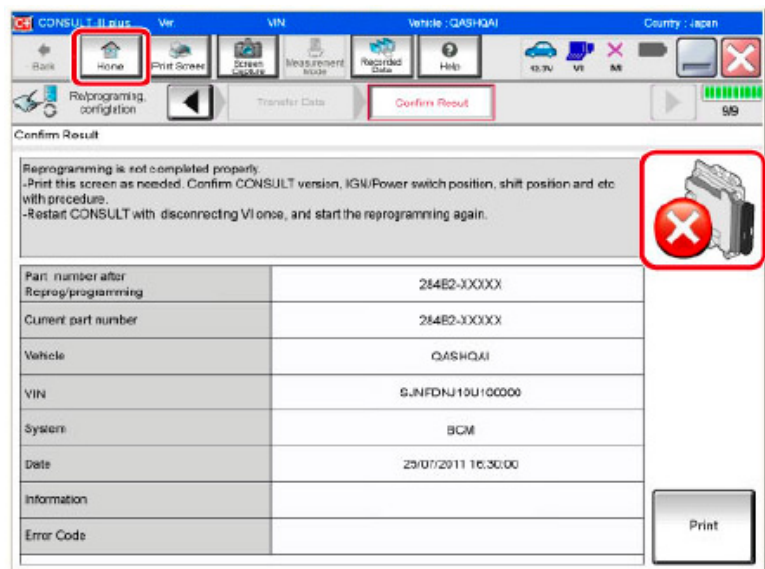
Figure 20

If reprogramming does not complete and the “X” icon displays as shown in Figure 20:

- Check battery voltage (12.0 – 15.5 V).
- CONSULT A/C adapter is plugged in.
- Ignition is ON, engine OFF.
- Transmission is in Park.
- All C-III plus / VI cables are securely connected.
- All C-III plus updates are installed.
- **Select Home, and restart the reprogram procedure from the beginning.**
