AT16-009a

2015-2017 QX60; ENHANCED DIAGNOSTIC LOGIC FOR CVT

APPLIED VEHICLE: 2015-2017 QX60 (L50) with V6 engine only

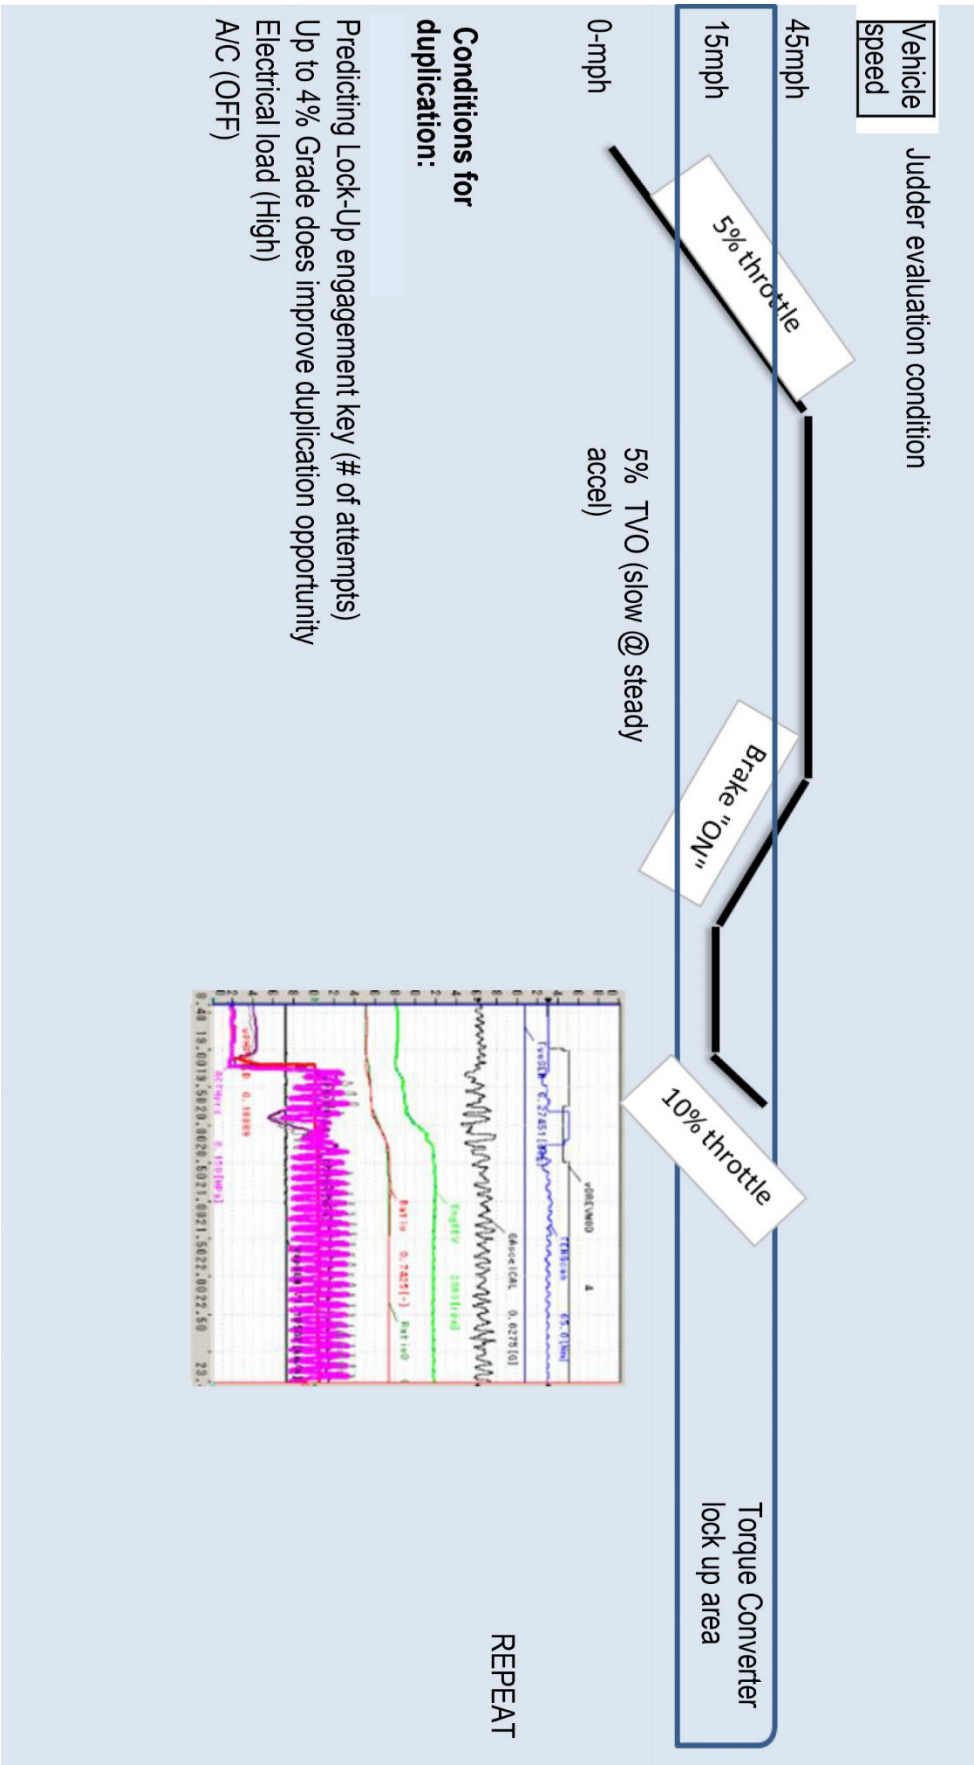
Figure 8

DTC detection drive pattern for P17F0 / P17F1

- This new diagnostic logic will monitor conditions in the CVT while the customer is operating their vehicle in their usual daily drive patterns.
- Figure 8, on the next page, illustrates conditions under which judder can be reproduced.
- Specific drive conditions that can be used to test for judder (shake, shudder, single or multiple bumps or vibration) are:
 1. Slowly accelerate from a stop (zero mph), applying only slight accelerator pedal (**0% - 10% throttle opening**) until 40 mph is reached.
 - During acceleration, torque converter engagement (full lock up) can occur between 20-35 mph.
 2. Prior to torque converter lock up, slowly modulate the accelerator pedal:
 - A. Decrease accelerator pedal pressure slowly, approaching a closed throttle position.
 - B. Smoothly and slowly reapply accelerator pedal pressure back to approximately 10% throttle opening.

IMPORTANT:

- Slight grade (climbing hill) may aid in performing the above drive conditions.
- DTC detection logic will require three events before storing a DTC.
- If DTC P17F1 or P17F0 is stored, refer to ITB15-012 for repair information.
