SERVICE BULLETIN

Classification: AT16-008a	Reference: NTB16-085a	Date: March 31, 2017
------------------------------	--------------------------	-------------------------

ENHANCED DIAGNOSTIC LOGIC FOR CVT

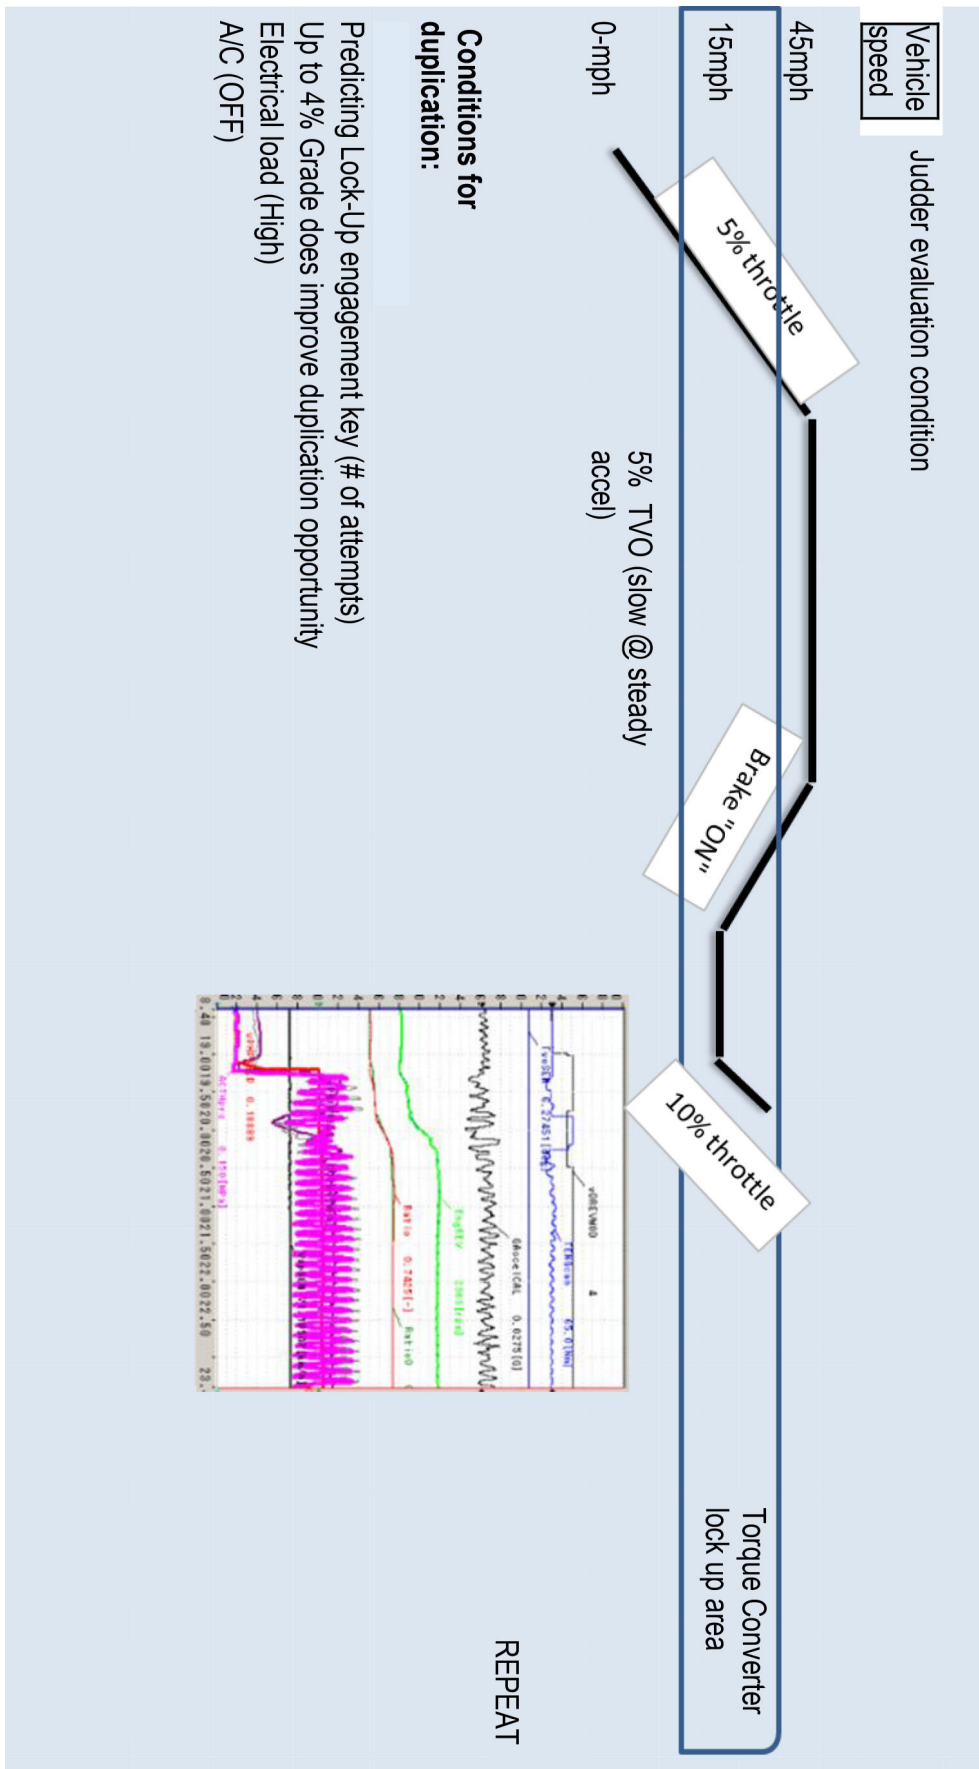
Figure 8

- This new diagnostic logic will monitor conditions in the CVT while the customer is operating their vehicle in their usual daily drive patterns.
- Figure 8, on the next page, illustrate conditions under which judder can be reproduced.
- Specific drive conditions that can be used to test for judder (shake, shudder, single or multiple bumps or vibration) are:
 1. Slowly accelerate from a stop (zero mph), applying only slight accelerator pedal (**0% - 10% throttle opening**) until 40 mph is reached.
 - During acceleration, torque converter engagement (full lock up) can occur between 20-35 mph.
 2. Prior to torque converter lock up, slowly modulate accelerator pedal:
 - A. Decrease accelerator pedal pressure slowly, approaching a closed throttle position.
 - B. Smoothly and slowly reapply accelerator pedal pressure back to approximately 10% throttle opening.

- Slight grade (climbing hill) may aid in performing the above drive conditions.
- DTC detection logic will require three events before storing a DTC.
