CAMPAIGN BULLETIN

Body Seal Retailer Inventory

Reference: PG7B3

PG7B3 - 2017 Q30/QX30 (H15) BODY SEAL REPAIR

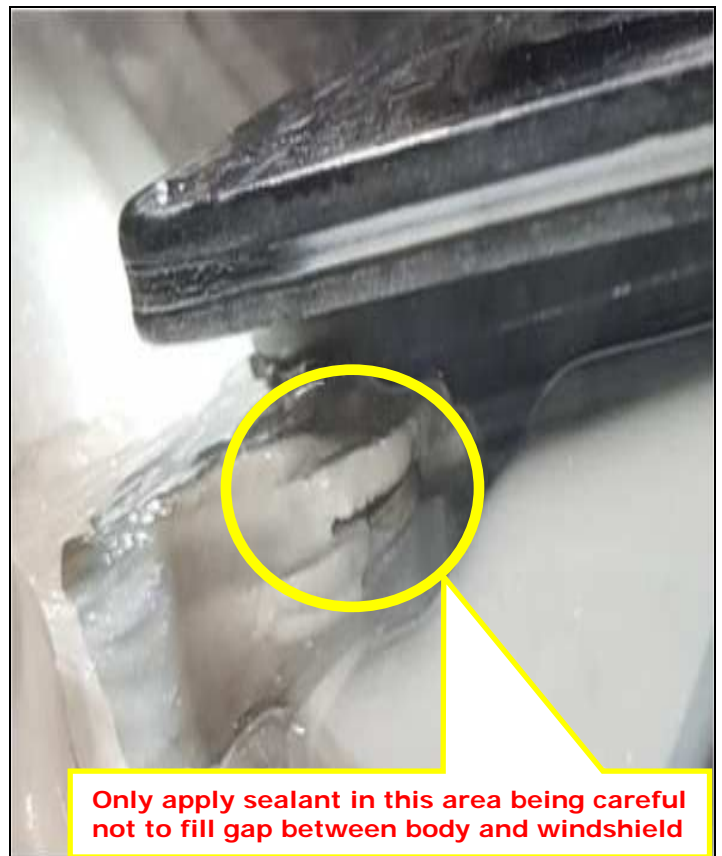
14. Figure 10 is a close up of a potential leak area under passenger side windshield.

- Apply sealer to this area on both sides of the car, driver and passenger.

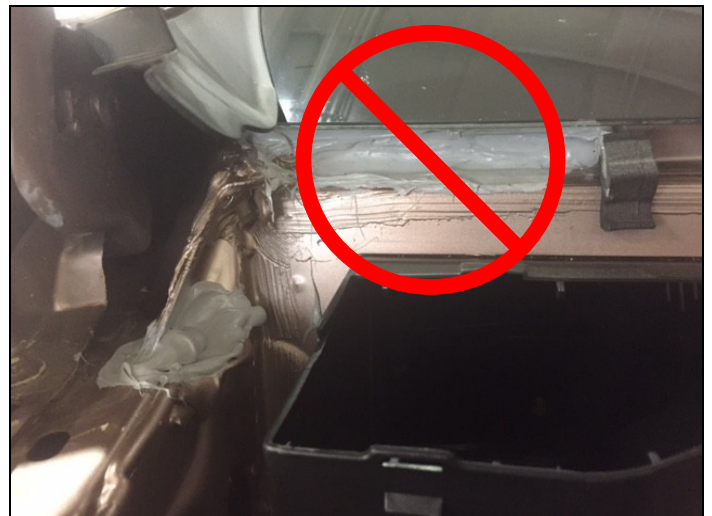
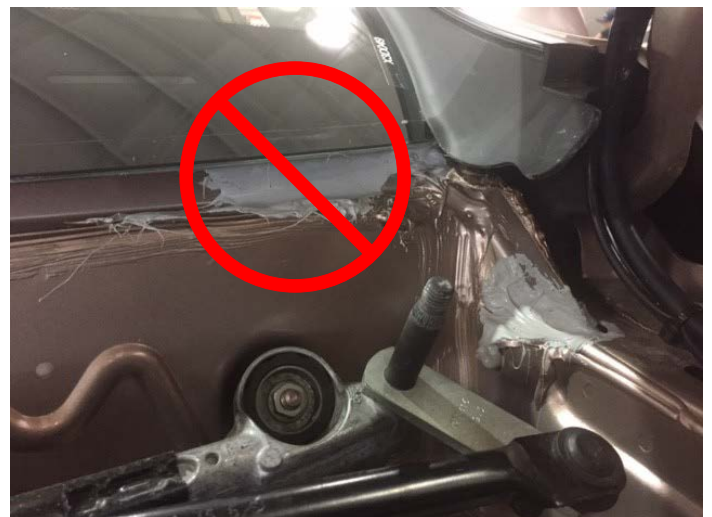
BELOW ARE EXAMPLES OF WHERE NOT TO APPLY SEALANT. SEALANT APPLIED IN AREAS CIRCLED IN RED WILL CAUSE DAMAGE TO THE WINDSHIELD

- **IMPORTANT:** Do not apply any sealant along the bottom edge of the windshield on either side of the vehicle. Doing so will cause windshield breakage when reinstalling the cowl top cover!
