**WD49 - Tightening Fastening Screw on Tailpipe Covers (Stop Sale Campaign/Workshop Campaign)**

Vehicle Type: **911 Turbo (991)/911 Turbo S (991)**

Model Year: **2014**

Concerns: **Tailpipe covers**

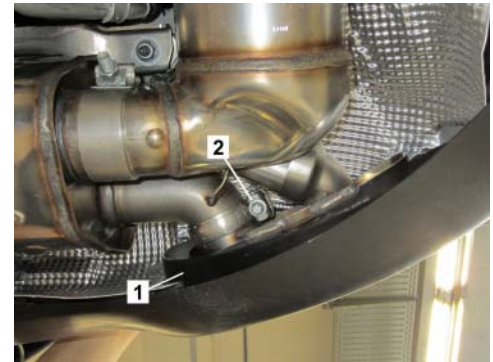
*Tightening fastening screw*

Information: This is to inform you of a voluntary Workshop Campaign on the above-mentioned vehicles. **There is a possibility that the fastening screw on the tailpipe covers on the affected vehicles was not tightened to the specified tightening torque.**

- 2.2 Tighten fastening screw ⇒ *Tightening fastening screw -2-* on the tailpipe cover ⇒ *Tightening fastening screw -1-* on the main muffler on the left in direction of travel.  
**Tightening torque 30 Nm (22 ftlb.)**
