43/12 ENU **WC35**

WC35 - Checking Relays for Engine-Compartment Blower (Workshop Campaign)

Vehicle Type: 911 Carrera (991)/911 Carrera S (991) - Cabriolet

Concerns: Relay for engine-compartment blower

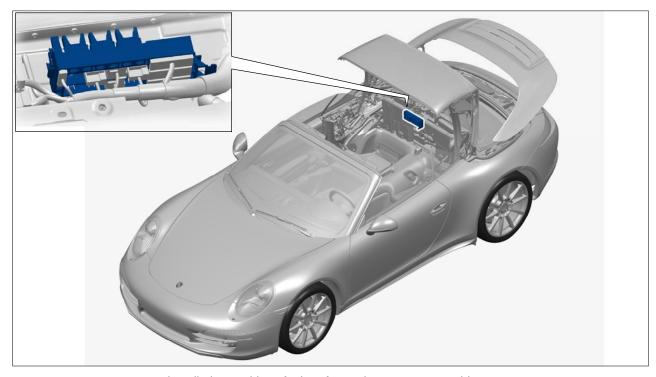
Installation position of relays for engine-compartment blower

The engine-compartment blower relays to be checked are in relay carrier 2 close to the right convertible top mechanism, between the roll-over protection system frame and the engine bulkhead \Rightarrow *Installation position of relays for engine-compartment blower*.
