Secondary Air Injection System - MIL "ON" DTC P2440 and/or P2442

Service Category Engine/Hybrid System

Section Emission Control

YEAR(S)	MODEL(S)	ADDITIONAL INFORMATION
2012 – 2013	Sequoia	
2012 – 2013	Tundra

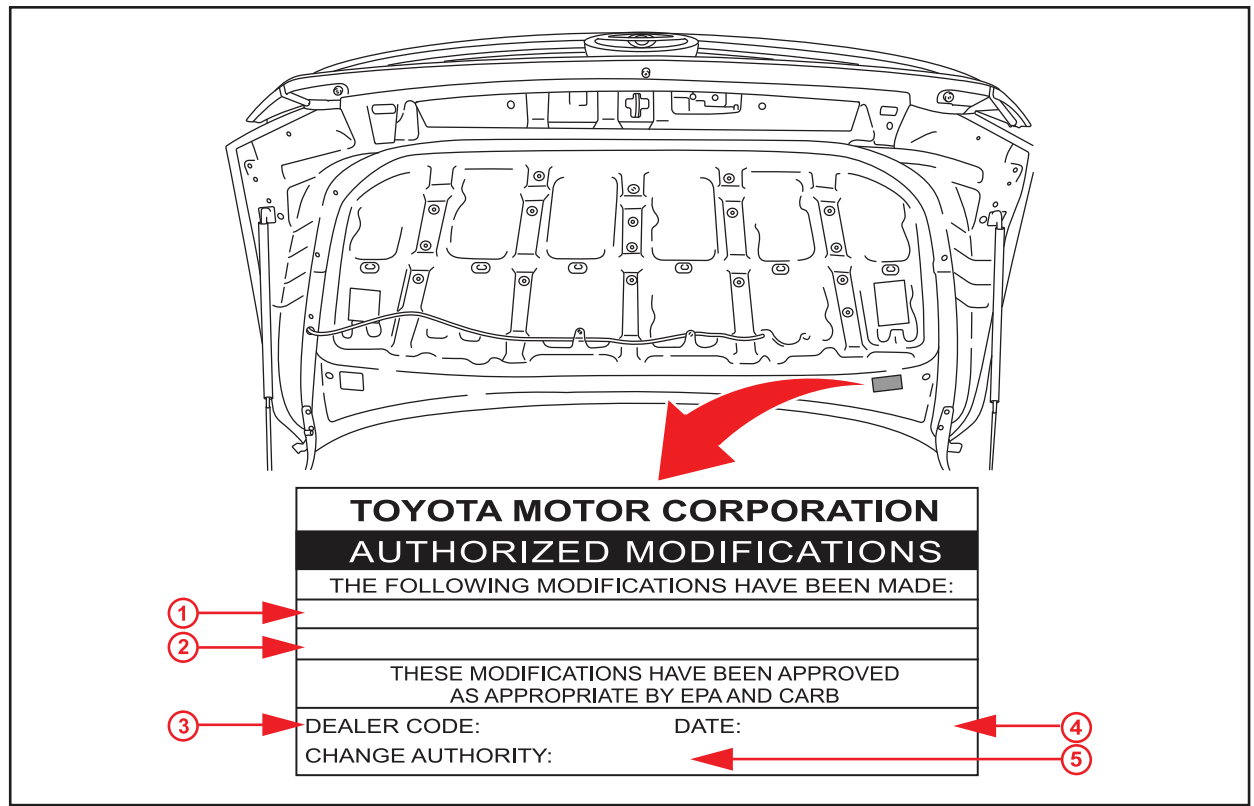
Figure 1. Location of Authorized Modifications Label on 2012 – 2013 Sequoia and Tundra

1	Replacement ECM (PCM) Part Number (i.e., 89661-0CM94)
2	New Calibration ID(s) (i.e., 30CK2400)
3	Dealer Code

4	Date Completed
5	This SB Number

If any of the above DTCs is present, reprogram the ECM (PCM). Proceed to step 2.
2. Check for the Authorized Modifications Label affixed to the vehicle in the location shown in Figure 1. Confirm if the ECM (PCM) calibration has been updated.
 - If the calibration ID listed is NOT the latest ECM (PCM) calibration — go to step 3.
 - If the calibration ID listed is the latest ECM (PCM) calibration – this bulletin does NOT apply. Continue diagnosis using the applicable Repair Manual.
