MODEL  
2014MY  
Soul (PS)

NUMBER  
PS300

**SUBJECT:** INCORRECTLY ROUTED HIGH PRESSURE A/C LINE

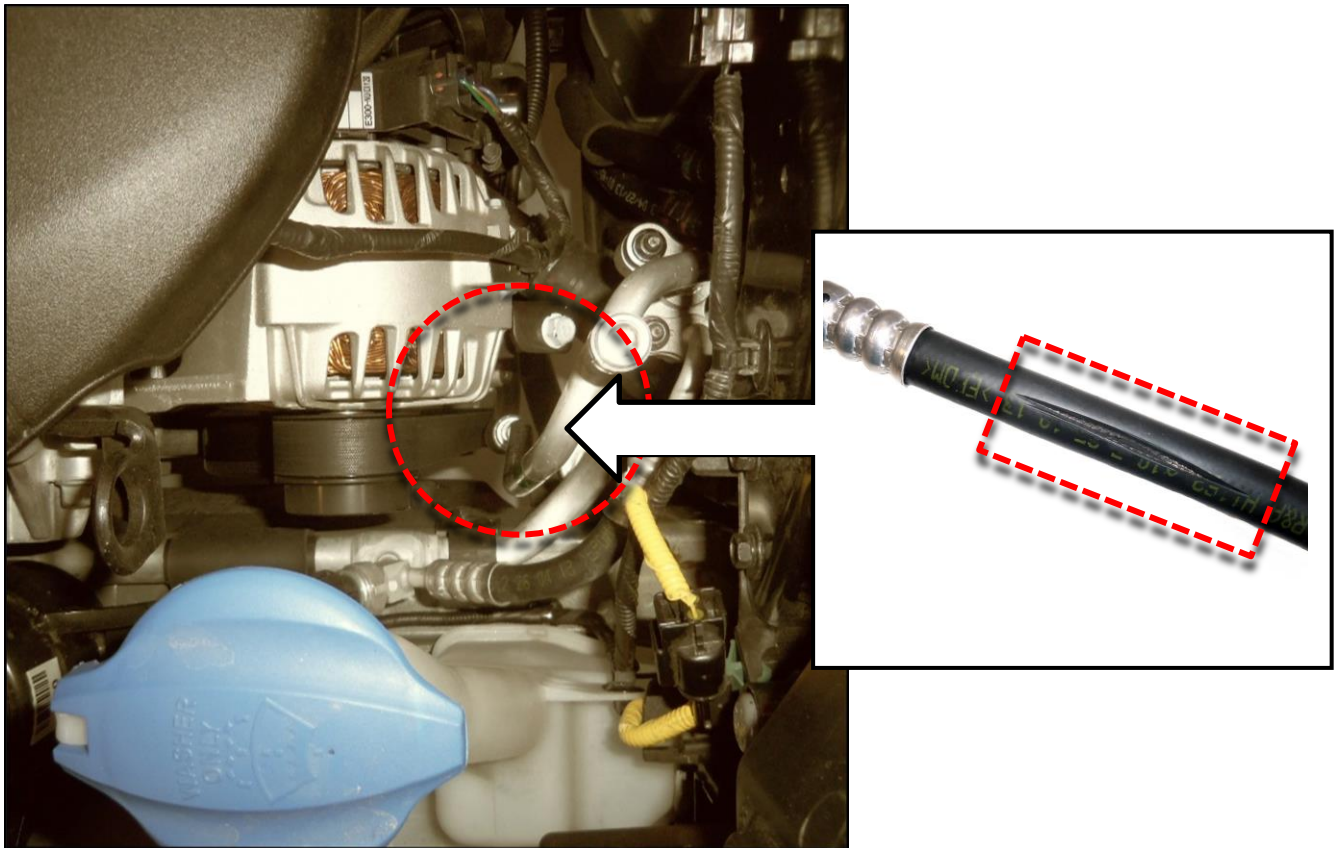
When addressing a customer concern related to the A/C system not cooling the vehicle properly and/or a case with low refrigerant; check the routing for the A/C high pressure line to make sure it is not coming into contact with the accessory drive belt (see image). If the line has come into contact with the belt and has sustained damage, replace the line and recharge the system to resolve the concern.
