MODEL
Optima Hybrid (TF HEV)

NUMBER
PS316

SUBJECT: "HYBRID SYSTEM WARNING!" MESSAGE IN CLUSTER AND MIL-ON WITH DTC P1784

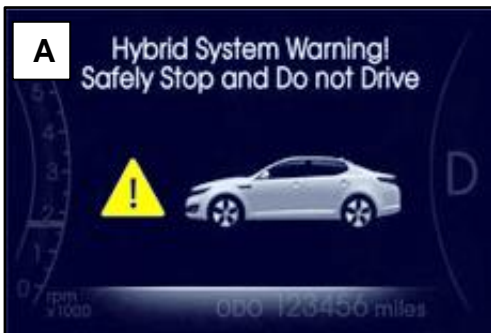
When diagnosing an Optima Hybrid with a "Hybrid System Warning!" message (A) in the cluster, the malfunction indicator lamp (MIL) on and DTC P1784 (EOP 3-Phase Wiring Line Open), in either active or in history, check for contact between the Electric Oil Pump (EOP) harness and the oil cooler hose clamp (B). If the harness is visibly damaged from contact (C), repair or replace as needed.
