GROUP BOD	MODEL Sportage (SL)
	NUMBER PS329	DATE July 2014

SUBJECT: ADJUSTING REAR HATCH CLOSING EFFORT

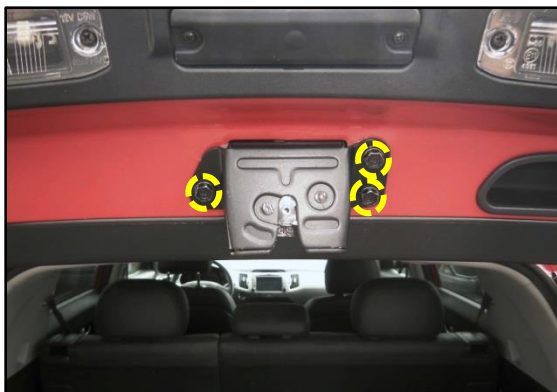
When encountering a customer concern related to excessive rear hatch closing effort on some 2011MY to 2014MY Sportage (SL) vehicles, first, verify the customer concern by comparing the closing effort on the affected vehicle to other like vehicles. Make sure all windows are rolled up and use minimal effort to try and close the hatch. If more effort is required to close the hatch than on like vehicles, perform the following procedure:

1. Loosen three bolts securing the latch to the tailgate.
