MODEL
2014MY
Forte (YD)

NUMBER
008

TECHNICAL SERVICE BULLETIN

SUBJECT: SERVICE ACTION: GAP BETWEEN FORTE SPOILER
AND TRUNK LID (SA154)

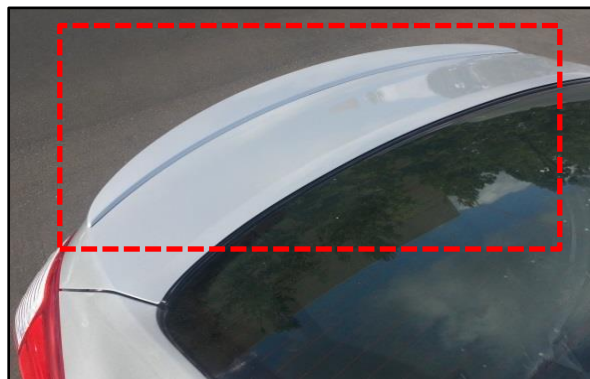
Some 2014MY Forte vehicles produced from April 24, 2013 to August 27, 2013 and equipped with a Kia accessory spoiler, may exhibit a gap forming between the adhesive tape on the spoiler and the trunk lid. To inspect for and to correct this condition, follow the procedure outlined in this TSB. If a gap has formed, remove the original spoiler and follow the instruction sheet enclosed with the new accessory part to install the replacement spoiler. Kia is requesting the completion of this Service Action on all affected vehicles, including dealer stock. Before conducting the procedure, verify the vehicle is included in the list of affected VINs.

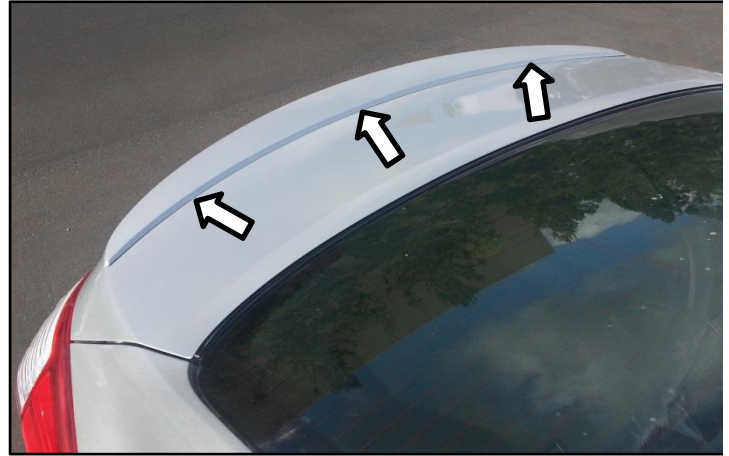
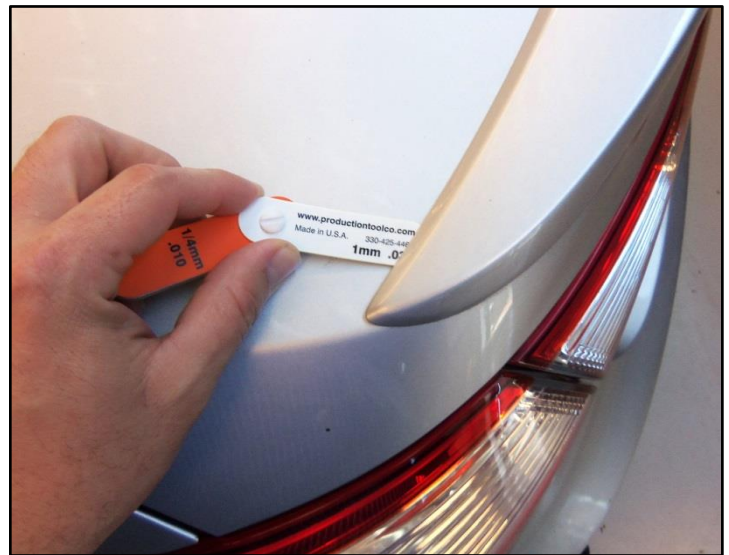
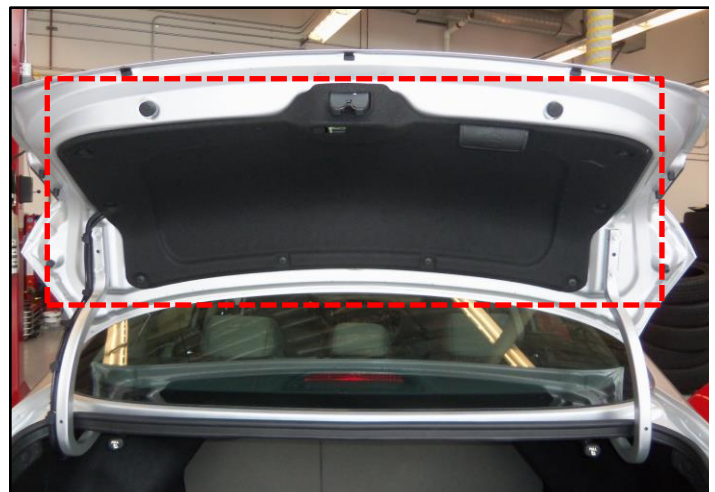
1. Inspect leading edge of the spoiler for a possible gap forming between the spoiler and the trunk lid.
2. If any gaps are present, use a 1mm plastic feeler gauge to measure the separation.
 - If the gap is equal to or greater than 1.0 mm, remove and replace with a new spoiler by carefully following the instructions included with the new accessory part.
 - If the gap is less than 1.0 mm, proceed to Step 3.

3. Open the trunk and remove the insulation trim panel.

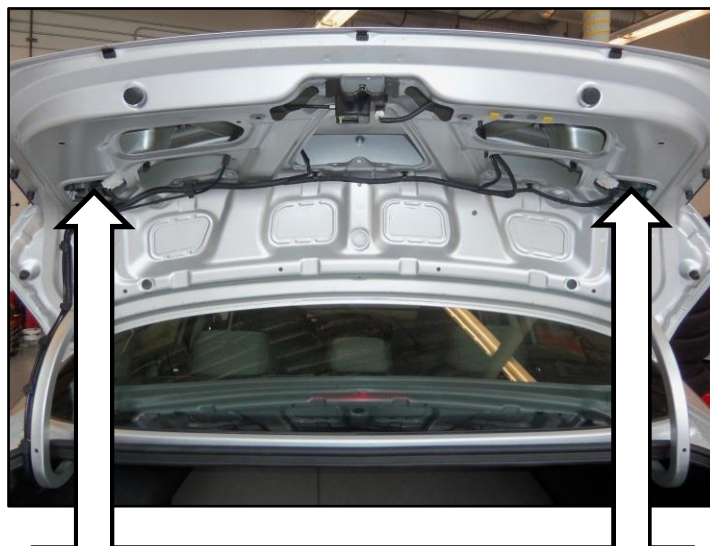
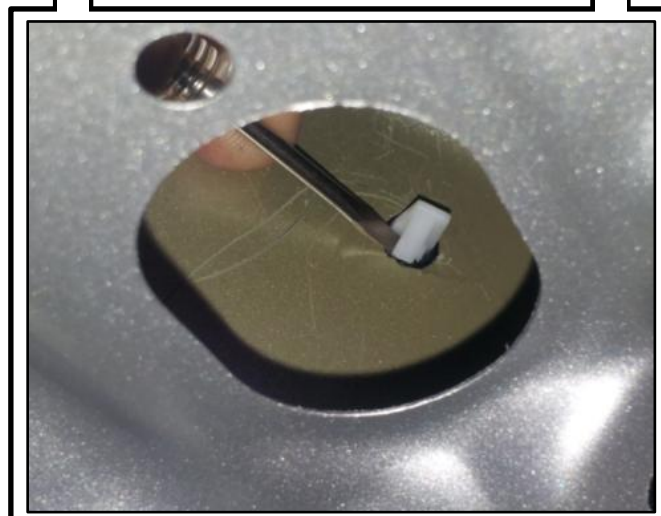
4. Inspect the retaining clips to make sure the hooks are properly engaged on the underside of the trunk.

5. If the hooks are not properly engaged, use a flat-head screwdriver to gently spread the clip open, as shown.

If necessary, have an assistant apply downward pressure to the spoiler while spreading the clip open.
