GROUP ELE	MODEL 2017MY Sorento (UMa) Optima (JFa)
	NUMBER 131	DATE April 2017
TECHNICAL SERVICE BULLETIN		
SUBJECT: SERVICE ACTION: VOLTAGE REGULATOR PERFORMANCE ENHANCEMENT (SA278)

SUBJECT: VOLTAGE REGULATOR PERFORMANCE ENHANCEMENT (SA278)

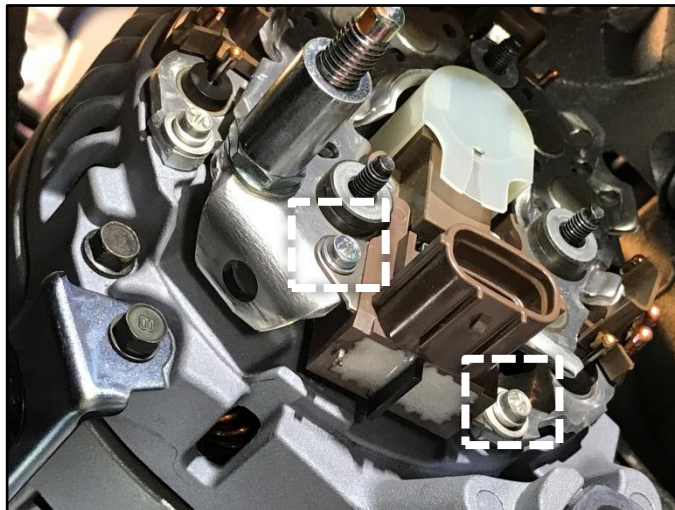
Voltage Regulator Screws

This bulletin provides the procedure to increase the torque on the voltage regulator screws on some 2017MY Sorento (UMa), produced from October 3, 2016 to January 24, 2017, and 2017MY Optima (JFa) vehicles, produced from October 3, 2016 to January 26, 2017, which may experience low battery voltage or a no-start condition. Follow the procedure outlined in this bulletin to increase the two (2) screws' torque on the voltage regulator. Before conducting the procedure, verify that the vehicle is included in the list of affected VINs.
