2014-2016MY
Soul (PS)

PS476

INTERMITTENT LACK OF POWER OR HESITATION
UPON ACCELERATION – RESTRICTED FUEL LINE

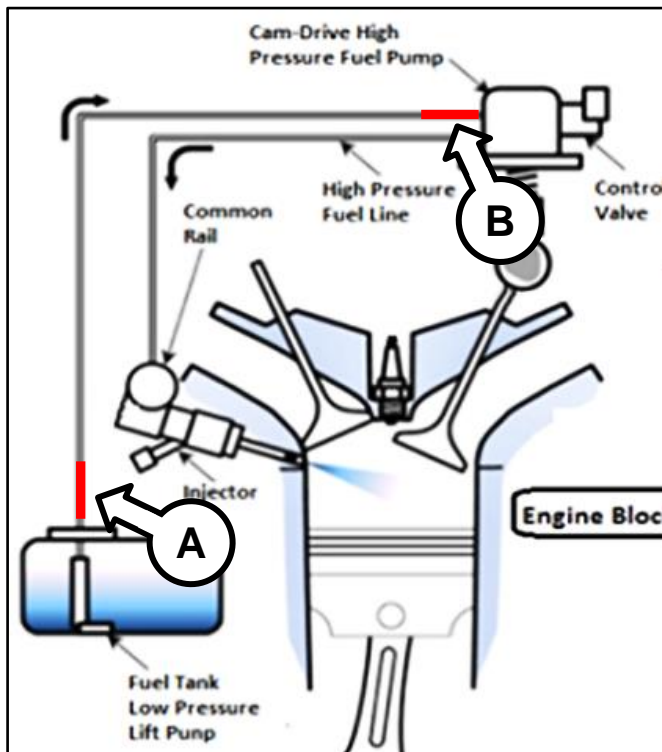
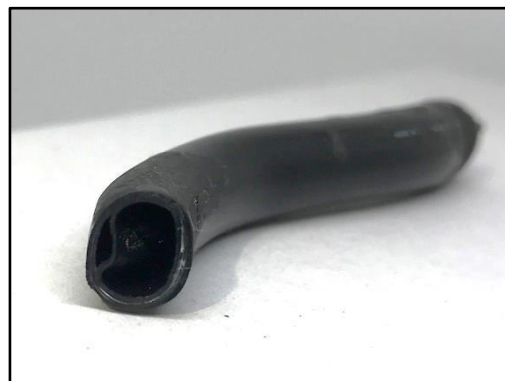
Customers may experience an intermittent lack of power or hesitation upon acceleration. The malfunction indicator lamp may not illuminate or DTC P0087 may be stored (history). This is possibly due to a restricted low pressure fuel line.

Restricted Fuel Line

Begin by checking the fuel pressure at the low pressure pump fuel output line (A) in the fuel tank using a fuel gauge kit, tool number: FPG2200. The gauge should display above 71 PSI if there is no restriction in the low pressure pump. When the lack of power/hesitation occurs and the fuel pressure at the fuel tank is within specifications, disconnect the fuel pressure gauge from the low pressure pump and connect it at the high pressure pump fuel feed line (B). When the lack of power/hesitation occurs and the gauge drops below 71 PSI, the fuel feed line from the low pressure pump to the high pressure pump may be restricted. Replace the low pressure fuel line from the tank to the high pressure pump by referring to the “Engine Control / Fuel System → Fuel Delivery System → Fuel Line → Repair procedures” chapter in the applicable Shop Manual on KGIS.
