MODEL
2015-2016MY
Sedona (YP)

NUMBER
036

TECHNICAL SERVICE BULLETIN

SUBJECT: COMBINATION TSB / SERVICE ACTION:
A/C DISCHARGE HOSE REPLACEMENT (SA267)

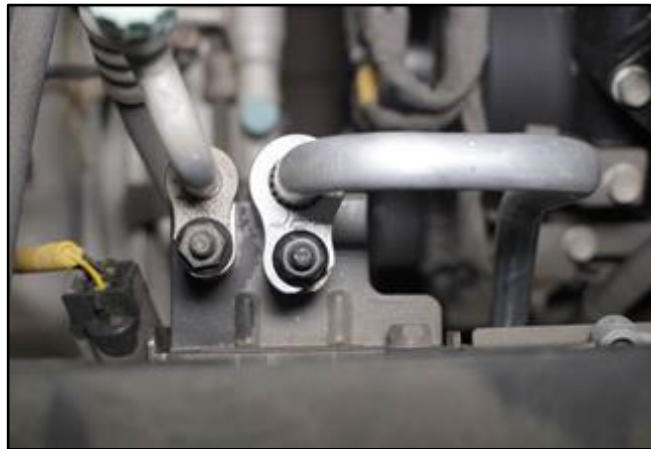
This bulletin provides information about the A/C discharge hose replacement on certain 2015-2016MY Sedona (YP) vehicles produced from March 1, 2015 through March 29, 2016, which may exhibit a refrigerant leak due to poor heat resistance at the swaging spot of the A/C discharge hose. Kia is requesting the completion of this Service Action on all affected vehicles. Before conducting this procedure, verify that the vehicle is included in the list of affected VINs.
