TSB170042

Technical Service Bulletin

Improper Removal of Ignition Coil Extension Dielectric Heat Shrink

- ISX12 G CM2180 EJ

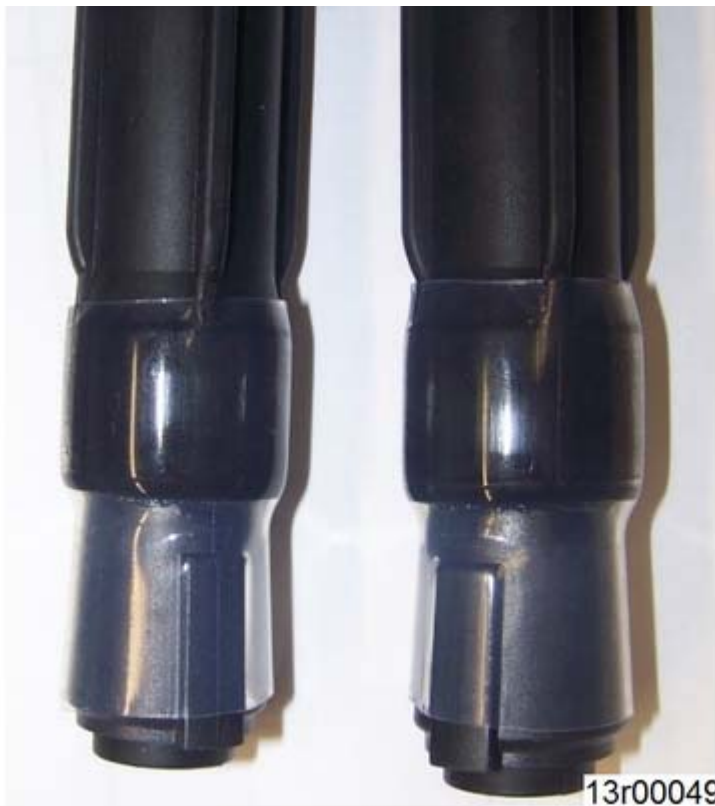
Ignition coil extension dielectric heat shrink is improperly being removed prior to installation of ignition coil. Removing ignition coil extension dielectric heat shrink will reduce life of ignition coil extension.

Figure 1, Example of Dielectric Heat Shrink Installed on Ignition Coil Extension.

Never remove clear dielectric heat shrink wrap from ignition coil extension.

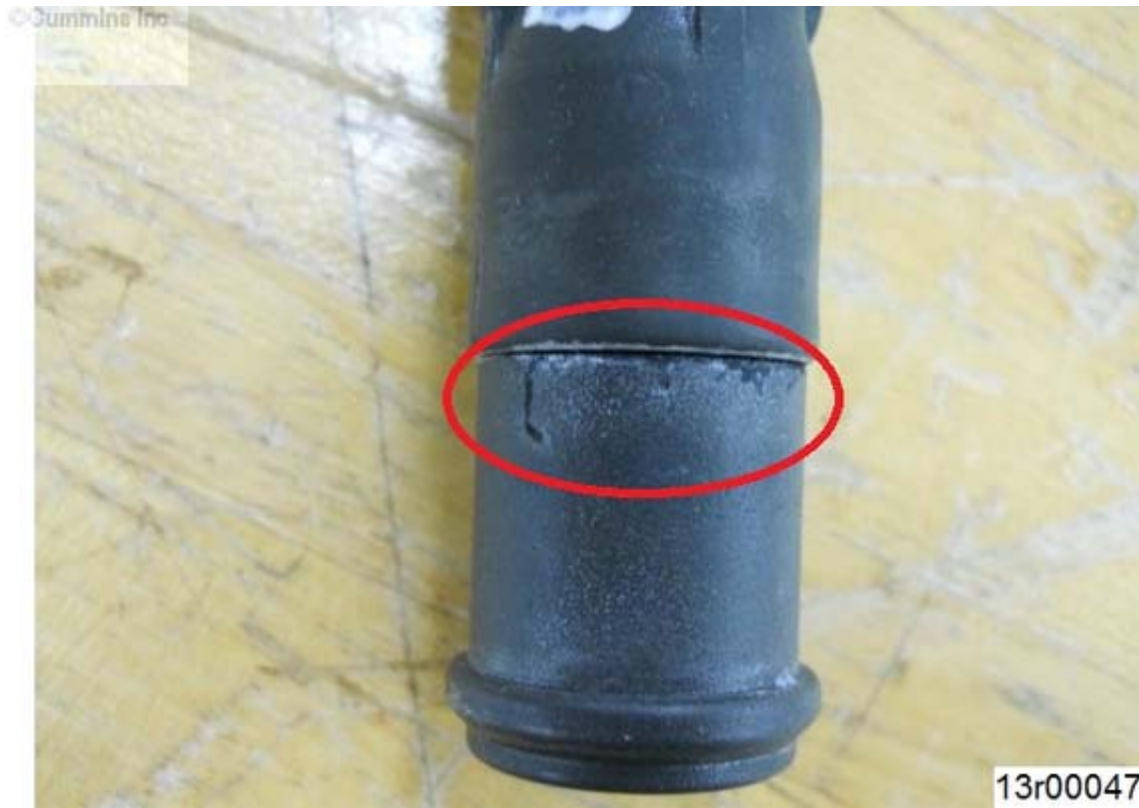
Electrical arcing through ignition coil extension in area where silicone extension tube is connected to spark plug boot adapter can cause visible damage and burn marks to ignition coil extension tube. See Figure 2 and Figure 3 below.

Figure 2, Example of Signs of Arching on Ignition Coil.

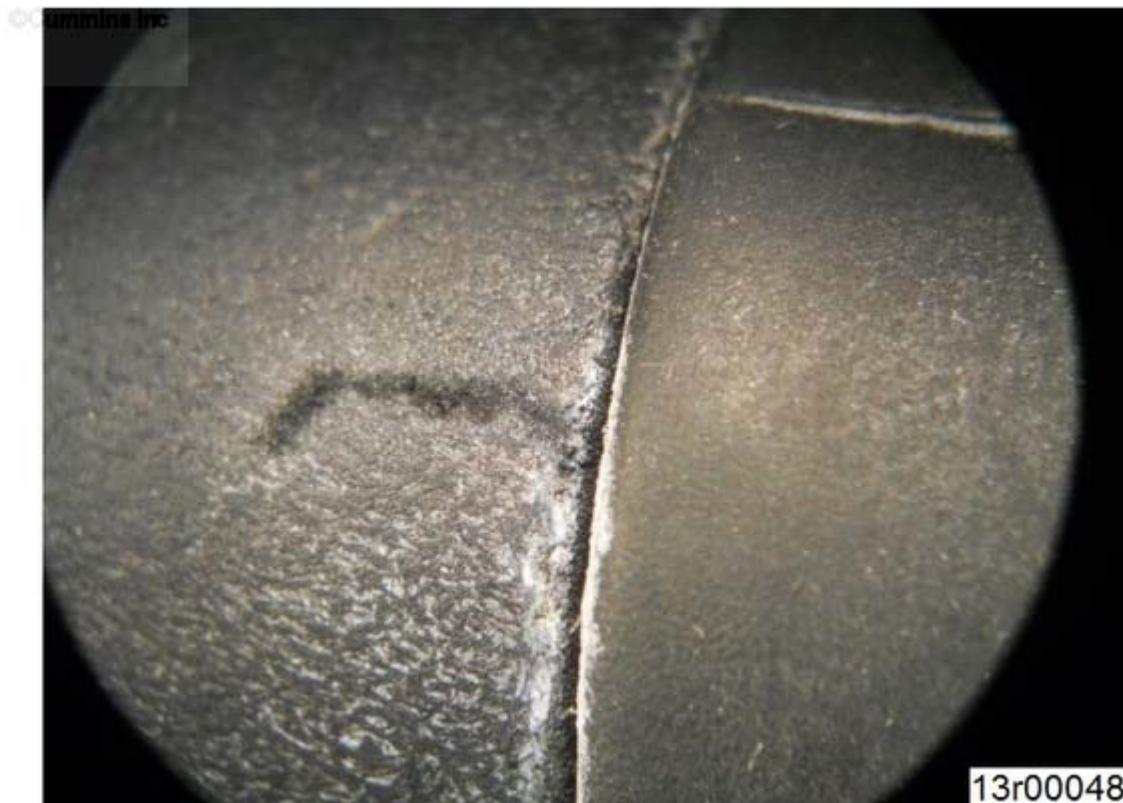
Figure 3, Magnified Example of Signs of Arching on Ignition Coil.
