Service Bulletin

E178

PACCAR MX-13 EPA2013 P1490 EGR Pressure Differential Sensor Moisture/Freezing

4/13/2017

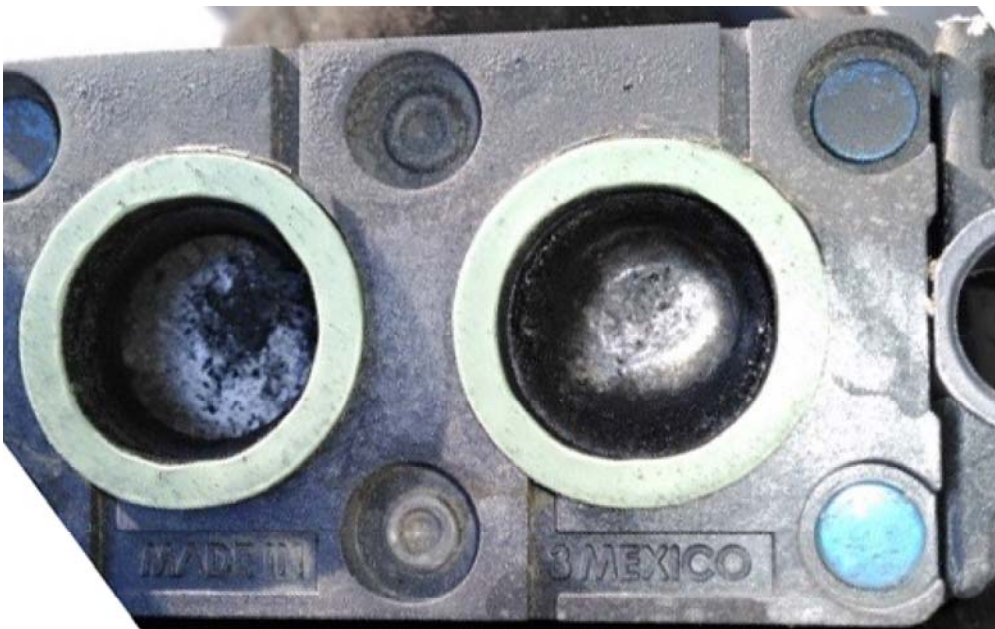
Peterbilt has determined on all PACCAR MX-13 EPA2013 engines, that water may build up and freeze on the EGR pressure difference sensor causing a P1490 fault code, which is EGR stuck in the open position fault. This could result in a stop engine lamp illumination.

Figure 1 Example of water frozen on the sensor membrane

1. Check and clear faults using DAVIE4.

2. Start and run the engine at operating temperature for 5 Minutes.
 - Continuously monitor critical engine systems for proper operation.
 - a. Start the engine and idle it at 1100 RPM or until the engine reaches operating temperature.

- b. Continue to idle the engine at 1100 RPM for an additional 5 minutes.
3. Run Quick Check using DAVIE4.
 - **If the fault remains active:** check temperature of venturi using temperature gun or multi-meter and idle engine until venturi temperature exceeds 10°C [50°F]. Continue to Idle the Engine for 5 minutes, key cycle engine and check to see if fault is active.

- **If the fault remains active and venturi temperature is above 10°C [50°F]:** troubleshoot the EGR pressure difference sensor (F751) as detailed in Engine Rapido. (System and component information | PCI, PACCAR Common rail injection | Technical data | Sensors and inputs | Checking data, EGR pressure difference sensor (F751)
